2007 Bridge Inspection Report

MARYLAND DEPARTMENT OF TRANSPORTATION
STATE HIGHWAY ADMINISTRATION
BRIDGE INSPECTION AND REMEDIAL ENGINEERING DIVISION
STRUCTURAL / MECHANICAL / ELECTRICAL
2007 BRIDGE INSPECTION REPORT

BRIDGE NO. 2300700
MD ROUTE 50 OVER SINEPUXENT BAY
WORCESTER COUNTY, MARYLAND

MODJESKI AND MASTERS, INC
CONSULTING ENGINEERS
HARRISBURG, PENNSYLVANIA

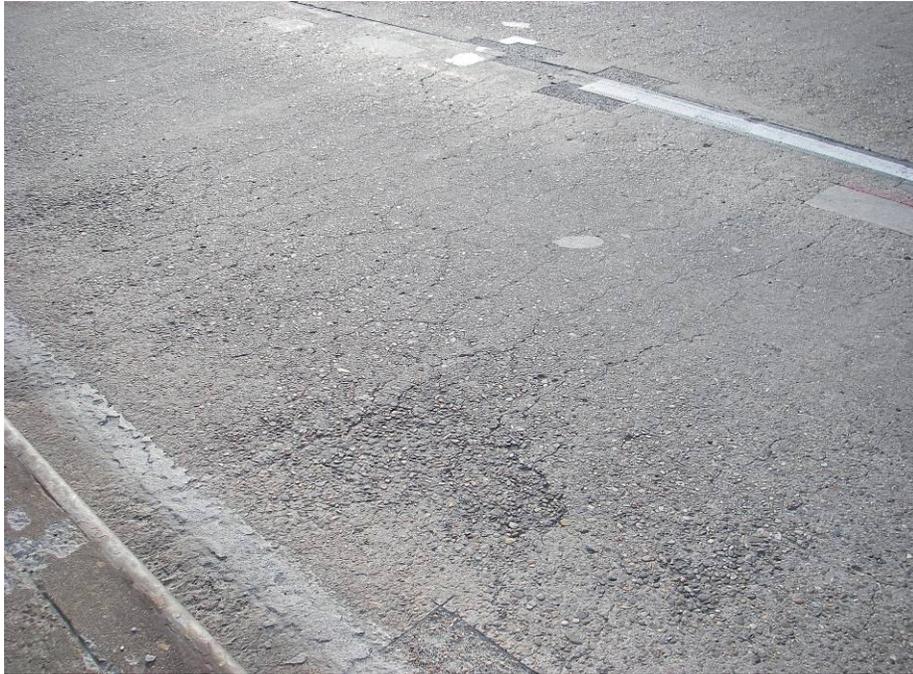
Span Unit 2 (Spans 3, 4, 5 and 6): There are two, 1 SF repaired areas along the joint. Numerous transverse cracks and map cracking areas were noted throughout the north half of the span unit (see Photograph S5). There are twenty-five concrete patches within the unit totaling 33 SF.

Photograph S5 - Span Unit 2. View of map cracking in Lane 1.

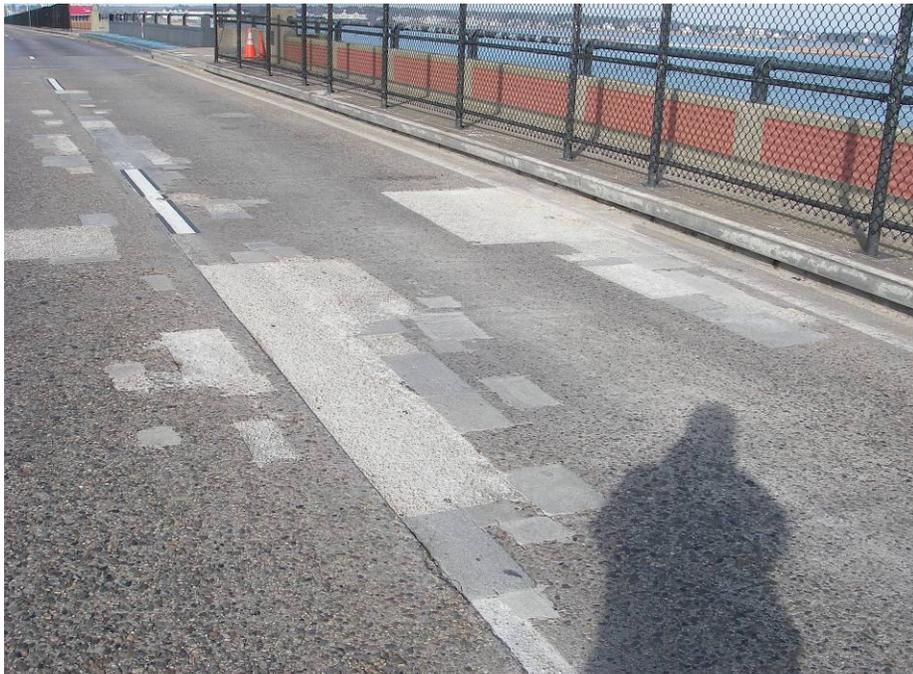
Span Unit 3 (Spans 6, 7, 8, 9 and 10): There is minor spalling along the west joint. There are three failed patches over construction cuts in the deck 12" east of the west joint up to 6"x 4"x 1/2" deep with exposed bolt holes. There is a 12'-0" x 4'-0" area of map cracking located 30'-0" west of the east joint in Lane 4. There are thirty-three concrete repair patches in the span unit totaling 75 SF (see Photograph S6).

Photograph S6 - Span Unit 3. View of typical patches throughout deck.

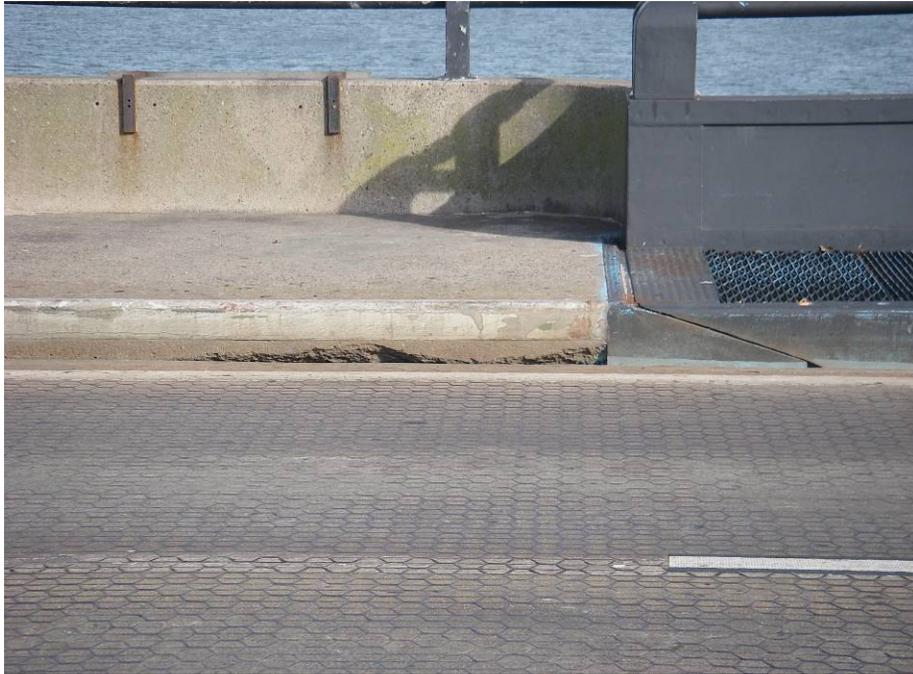
deck (see Photograph S7). There is a 1'-6" x full width repair adjacent to the east span unit joint that is in good condition with minor spalls along the west edge. Approximately, 35'-0" west of the east span unit joint, in Lane 4, there is a 6" diameter x 3/4" deep spall. The heel joints at the east and west ends of the Bascule Span are corroded with 5% section loss at the north end of the east heel joint and the south end of the west heel joint. The vertical face of the south curb is spalled adjacent to the east heel joint. There is a 3" x 4'-0" x 5" deep spall on the vertical face of the south sidewalk above the filled grid deck 112'-0" west of the east span unit joint. There is a 4" x 1'-4" x 7" deep spall in the vertical face of the north curb 6'-0" east of the west heel joint and a 4" x 5" x 6" deep spall in the vertical face of the north curb at the east heel joint. The north and south edge of the open grid deck of the west leaf is distorted at the toe of the bascule leafs (see Photograph S8). At the west heel joint, there is a 6" x 3" x 2" spall at the bridge centerline (see Photograph S9). There is a 12" x 12" repair that is cracked in the center of the westbound travel lanes 30'-0" east of the filled grid. There is a 12" x 5'-0" x 1/2" deep spall in the deck soffit located at the north sidewalk 37'-0" east of the filled grid. There are two 5" x 9" x 1/2" deep spalls in Lane 1 15'-0" west of the east span unit joint. Approximately 70'-0" east of the west span unit joint, there is a 12" x 3" x 1/2" spall in the Lane 3. At 62'-0" east of the west span unit joint, there is an 8" x 3" x 1/2" spall in the Lane 3. A 6" diameter x 1/2" deep spall is located 40'-0" east of the west span unit joint. There is a 2'-0" x full deck width repair adjacent to the west span unit joint in good condition. There is a 2'-0" x 2'-6" failed repair in Lane 2. The north end of the joint between the open and filled grid of the east leaf is deteriorated up to 1'-6" wide from the north curb. There are seventy seven concrete patches in the span unit totaling 692 SF.

Photograph S7 - Span Unit 4, concrete filled grid deck portion of the west bascule leaf. The north fixed sidewalk curb underside is spalled adjacent to the filled grid deck

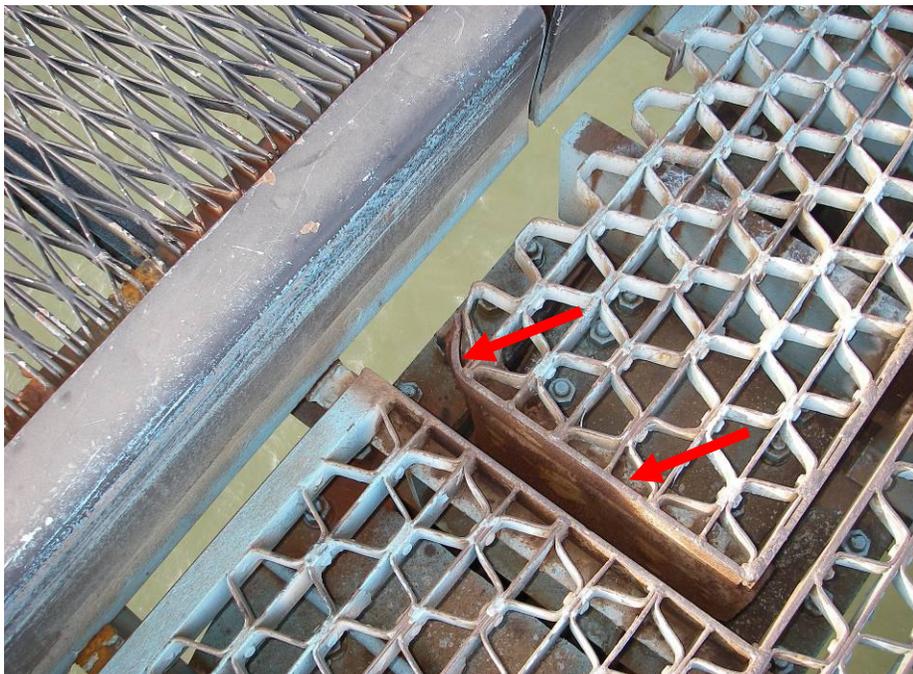
Photograph S8 - Span Unit 4, west leaf, north side of the open grid deck. View if the open grid deck with bent grating at the opening between leaves (arrows).

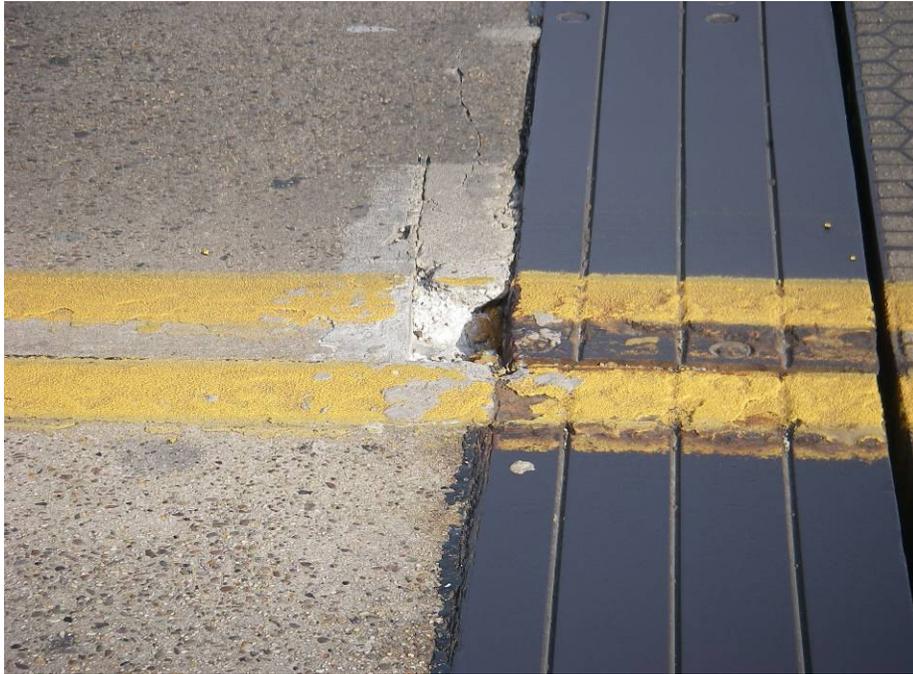
Photograph S9 - Span Unit 4, west leaf heel joint. View of a 6" x 3" x 2" spall in a repair at the centerline of the bridge.

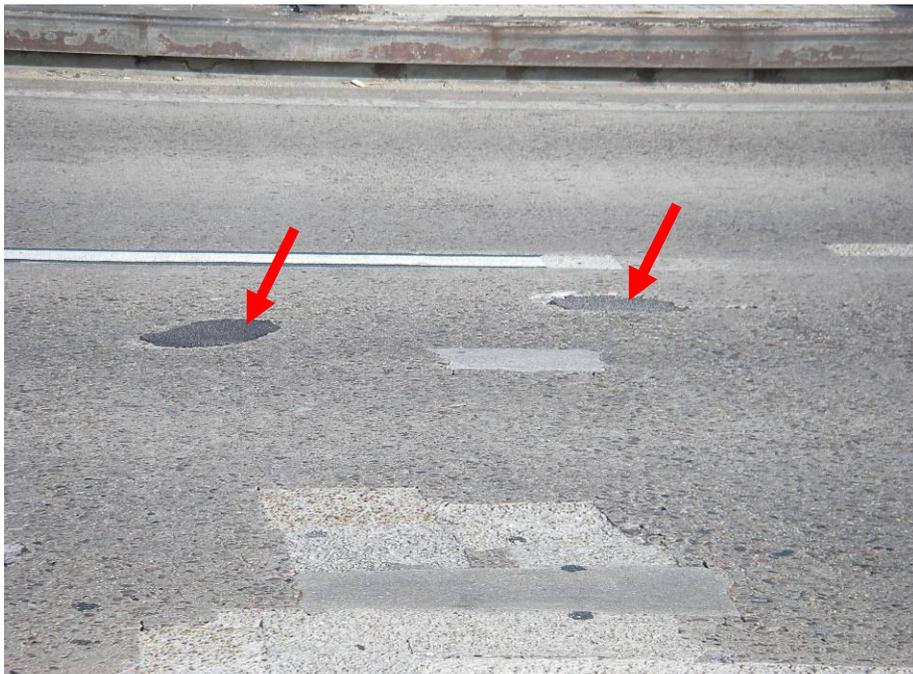
Span Unit 6 (Spans 20, 21, 22, 23 and 24): The two 5" diameter x 1/2" deep spalls located 35'-0" west of the east joint near the south curb mentioned in the previous inspection report have been repaired (see Photograph S10). There are twenty-six concrete patches in the span unit totaling 875 SF.

Photograph S10 - Span Unit 6, 35'-0" west of the east joint. View of two repaired 5" diameter x 1/2" deep spalls.

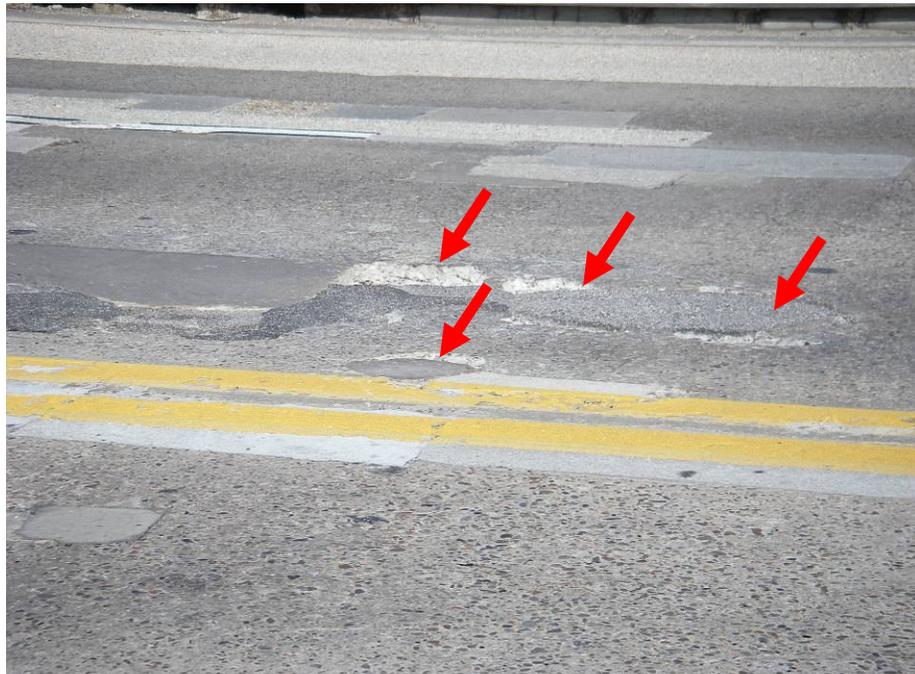
Span Unit 10 (Spans 36, 37, 38, 39 and 40): There is a 9" x 9" x 1" deep spall in a repair patch near the center of the eastbound travel lanes 24'-0" east of the west joint. There is a 12" x 1'-8" x 1" deep spall in Lane 1, 30'-0" east of the west joint adjacent to repair patches. There is a 6" x 8" x 1/2" deep spall and a 12" x 1'-2" x 1/4" deep spall in the deck beneath the north curb at 35'-0" and 43'-0" east of the west joint. There is a 4'-0" x 12" area of significant scaling beneath the south curb 45'-0" from the west joint. There is a 12" diameter x 3/4" deep spall and a 7" diameter x 3/4" deep spall in Lane 1, 50'-0" east of the west joint. There is a 4" x 10" x 1/4" deep spall near the center of the roadway 50'-0" east of the west joint in Lane 4. Approximately 64'-0" east of the west joint in Lane 2, there is a 5'-0" x 3'-0" x 1" area of failed patches and spalls (see Photograph S12). There are fifty-four concrete patches in the span unit totaling 871 SF.

Photograph S12 - Span Unit 10. View of typical deck spalls and failing patches (arrows)

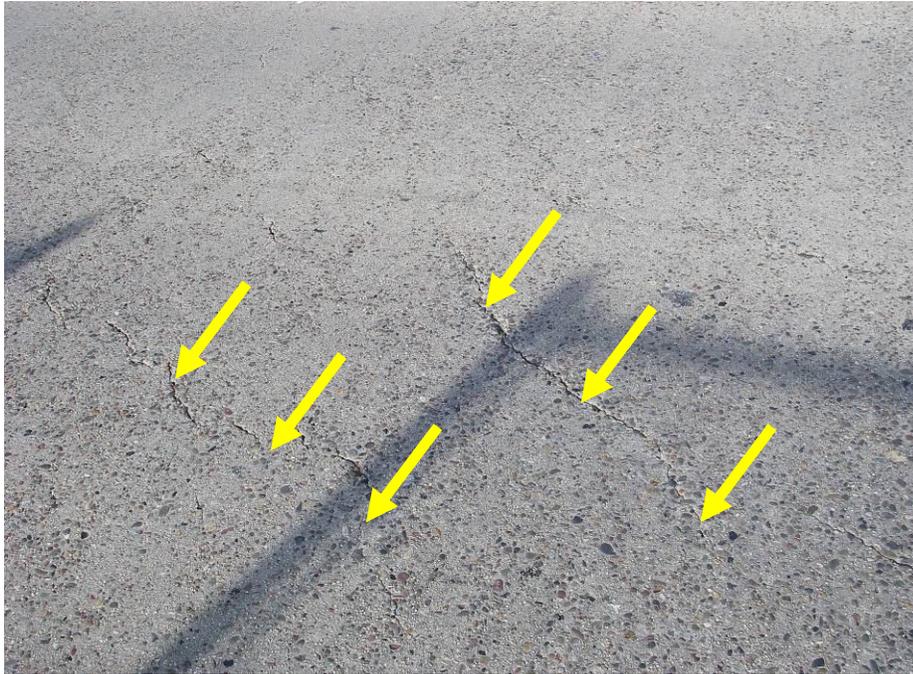
Photograph S13 - Span Unit 18. View of numerous 1/8" wide cracks near mid-span in Lane 3 (arrows).

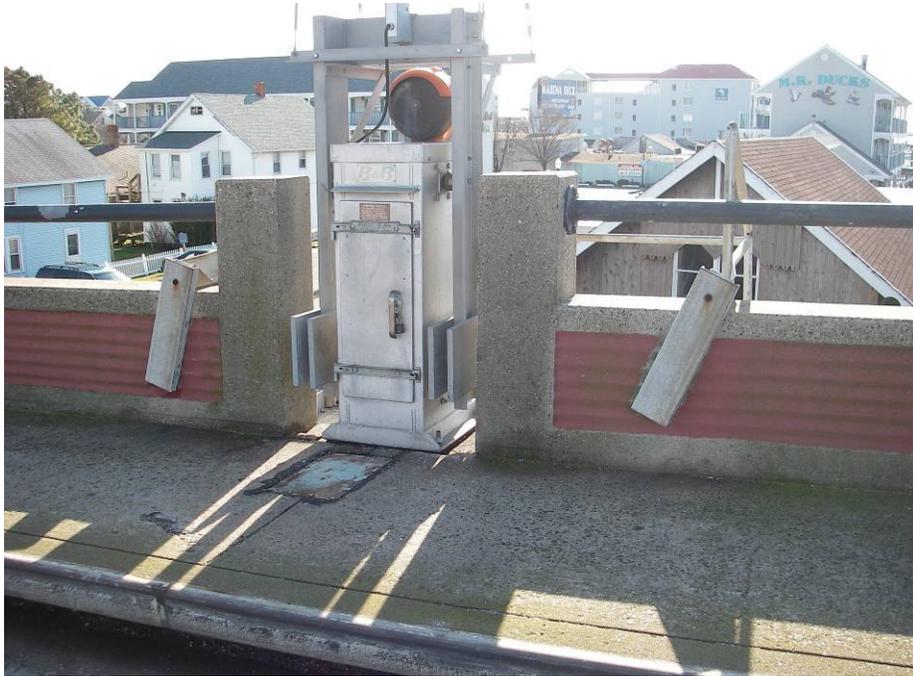
Photograph S15 - Southeast crossing gate. View of the misaligned platform attachment brackets.

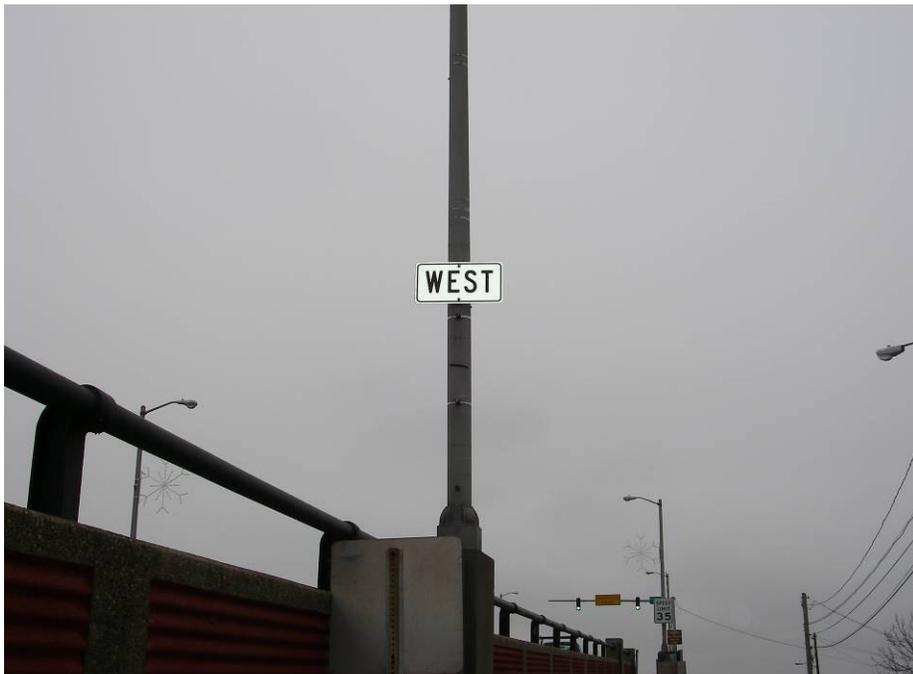
Photograph S16 - East approach, north parapet. View of the missing route number sign.

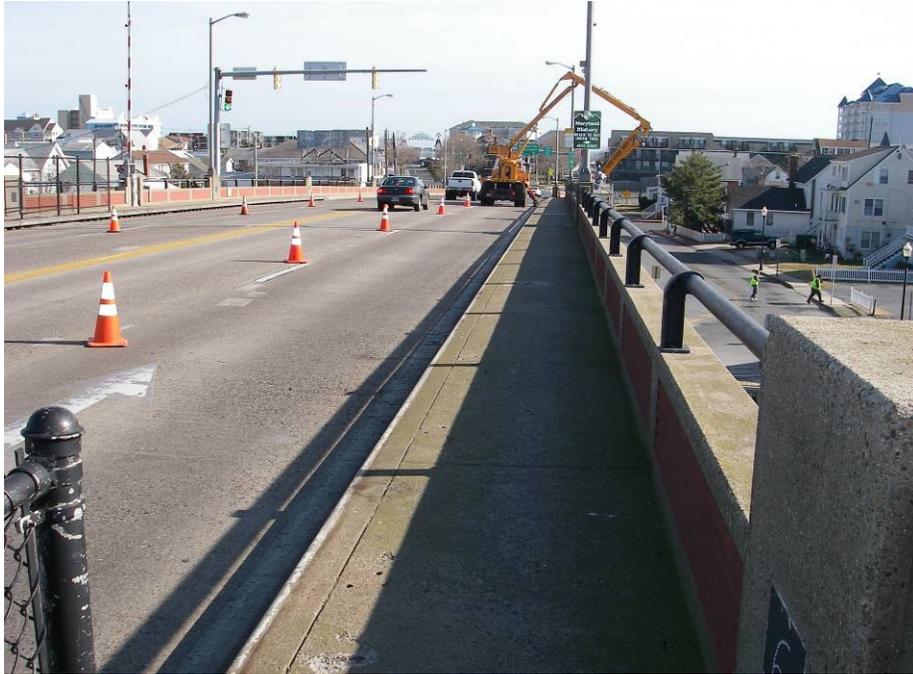
Photograph S17 - East approach, south sidewalk. There is no chain link fence in Span Unit 3.

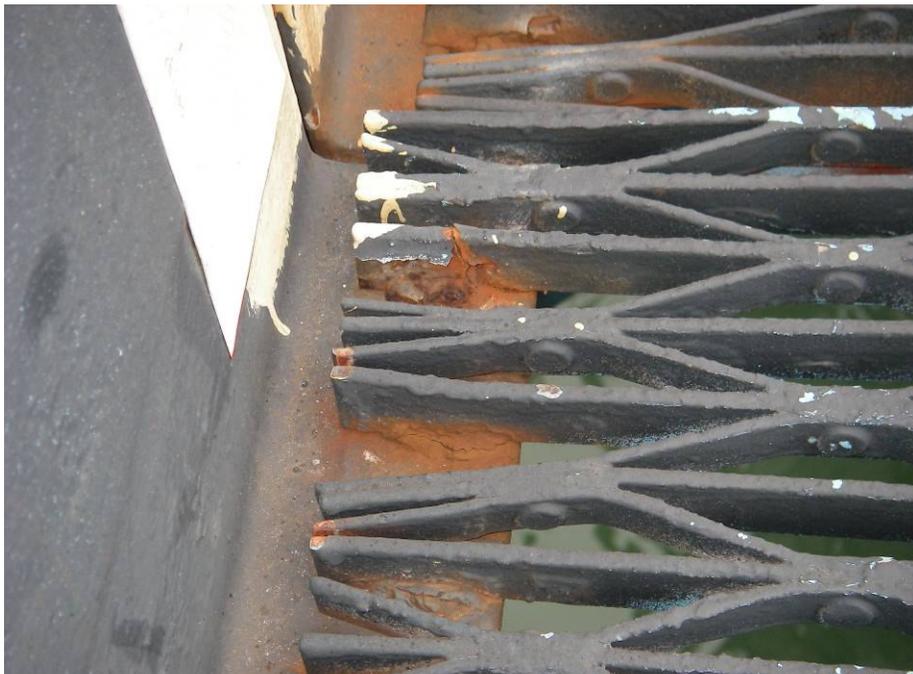
Photograph S18 - View of the typical bascule span sidewalk grating with minor corrosion and deterioration.

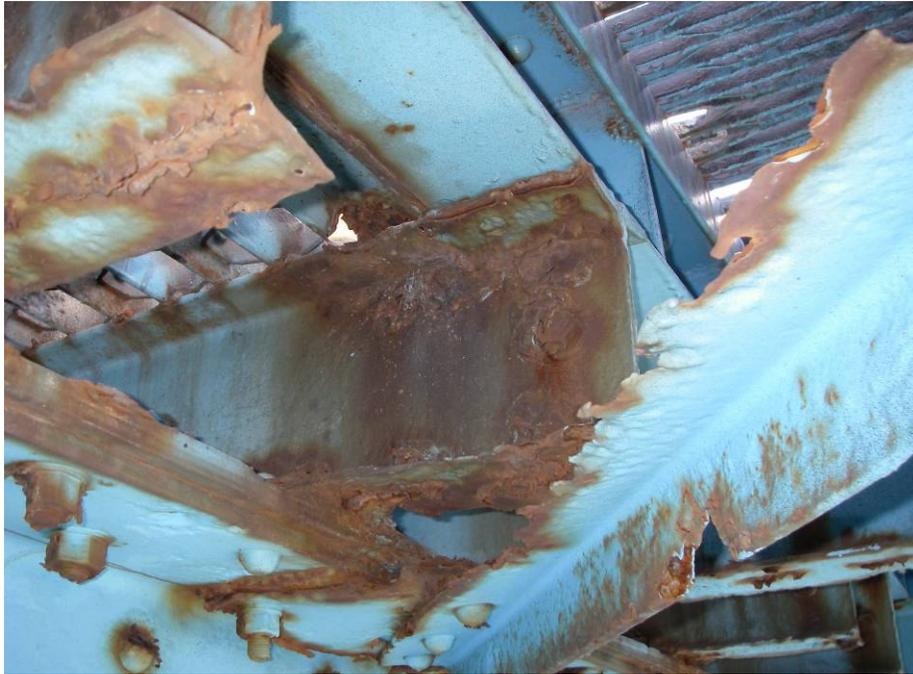
Photograph S19 - North sidewalk underside of the bascule span. View of the typical bascule span sidewalk supporting steel in serious condition.

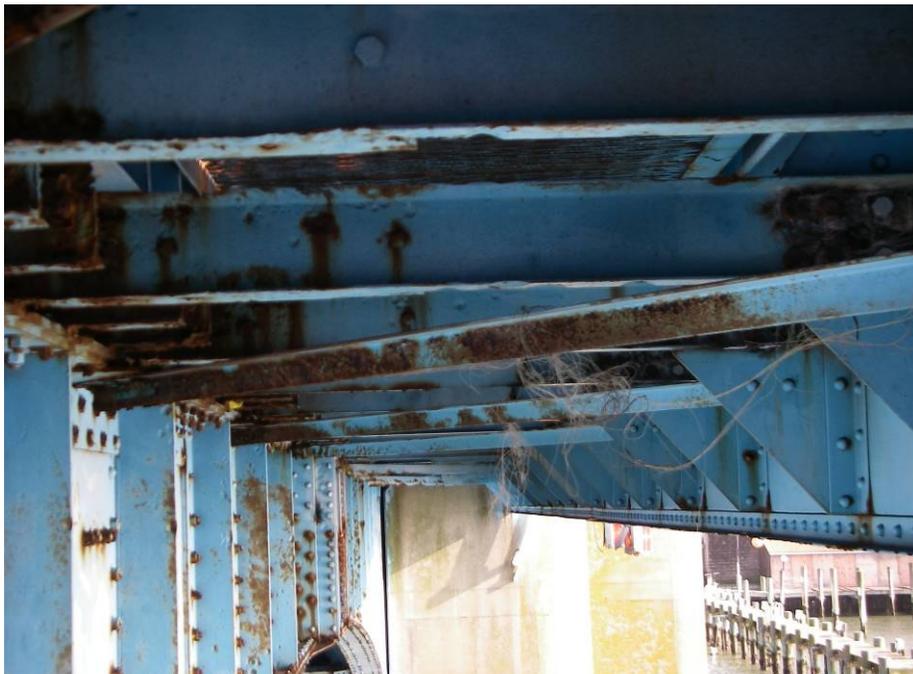
Photograph S20 - South sidewalk underside, south end of bascule span. View of the typical bascule span sidewalk supporting steel minor to moderate corrosion.

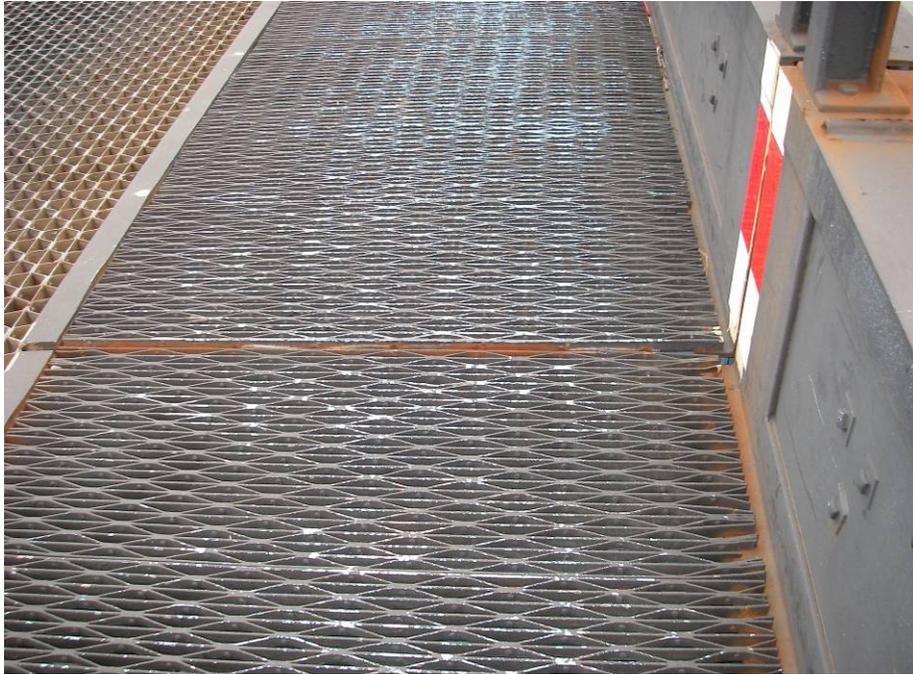
Photograph S21 - North bascule sidewalk, mid-span between the east and west leaves.
View of the east leaf sidewalk which is 1" lower than the west leaf sidewalk.

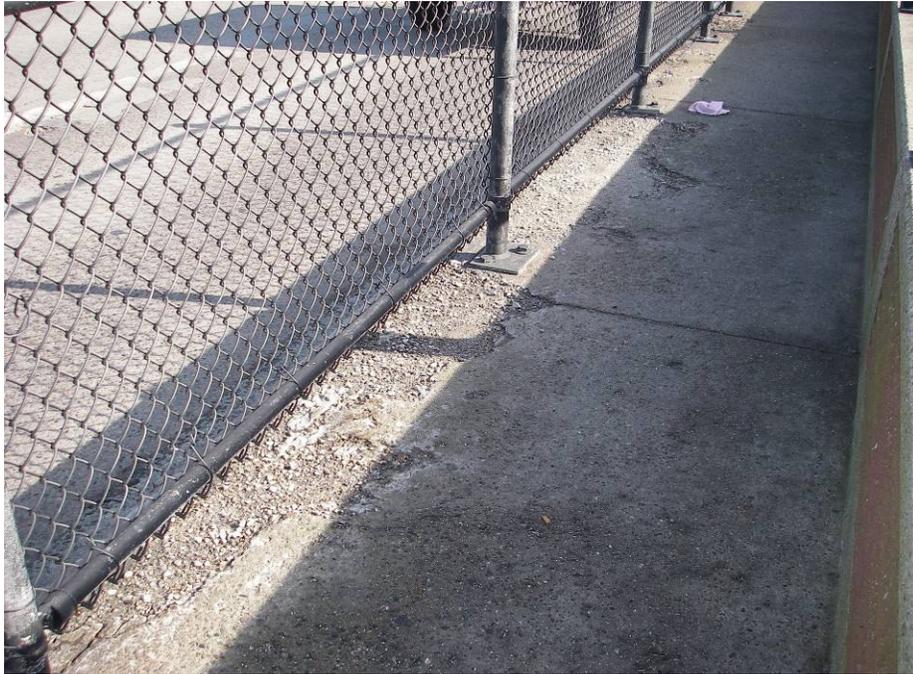
Photograph S23 - Span Unit 4, south sidewalk. View of typical spalling and scaling throughout the entire bridge sidewalk.

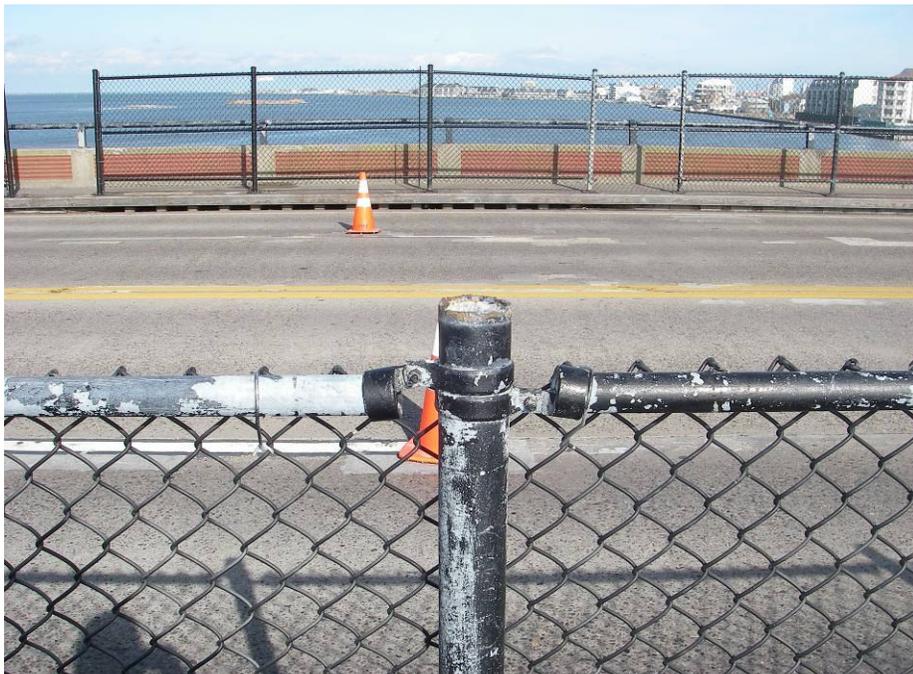
Photograph S24 - Span Unit 5, south sidewalk. View of the chain link fence with missing post cap.

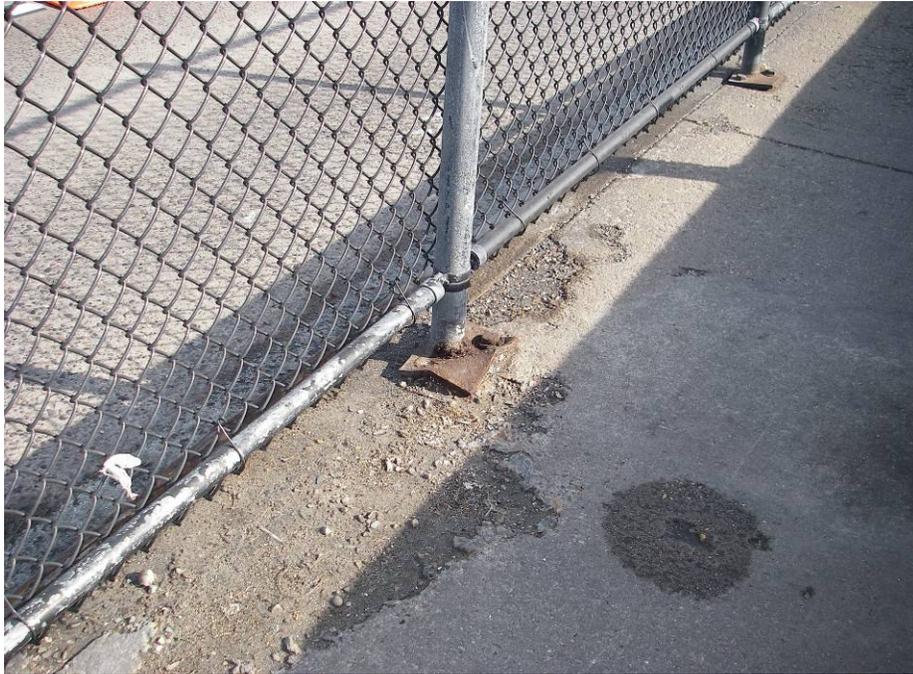
Photograph S25 - Span Unit 5, south sidewalk. View of the typical bent chain link fence base plate with surrounding spalls.

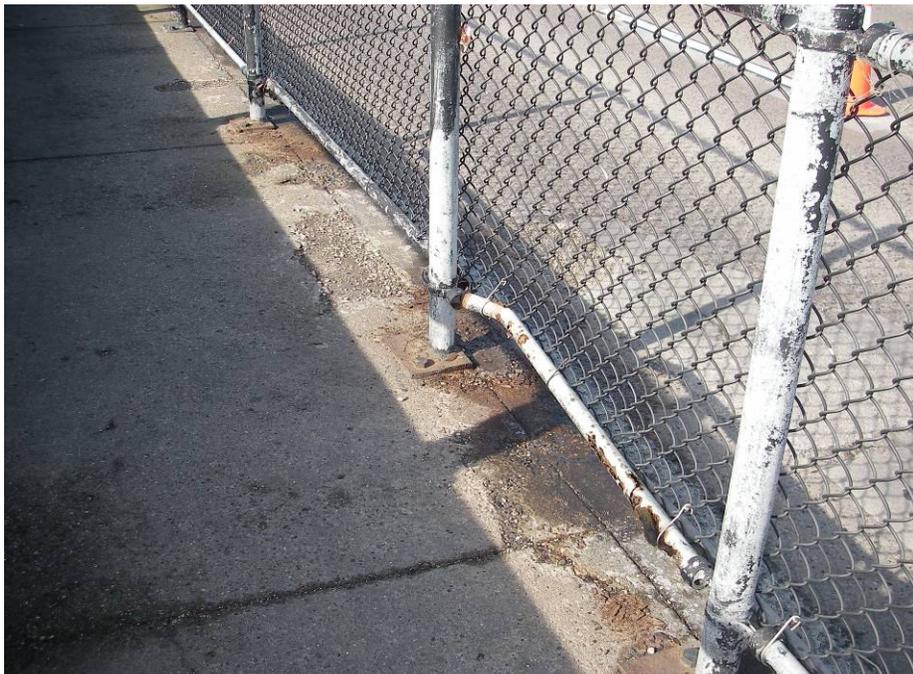
Photograph S26 - Span Unit 5, south sidewalk. View of the typical horizontal chain link fence rail deterioration/bent/disconnection.

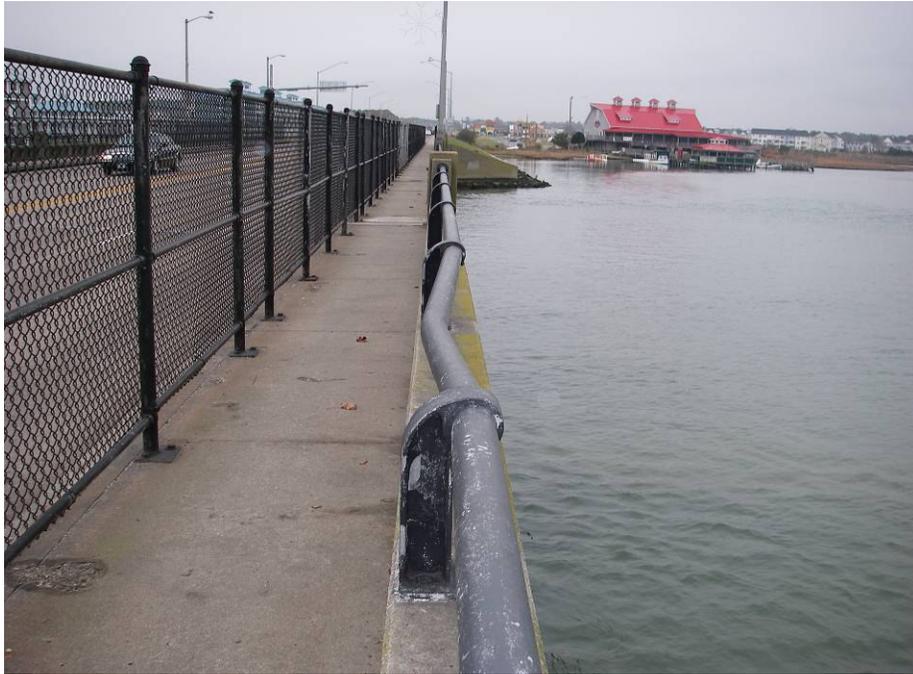
Photograph S27 - Span Unit 20, north bridge railing. View of the bent railing.

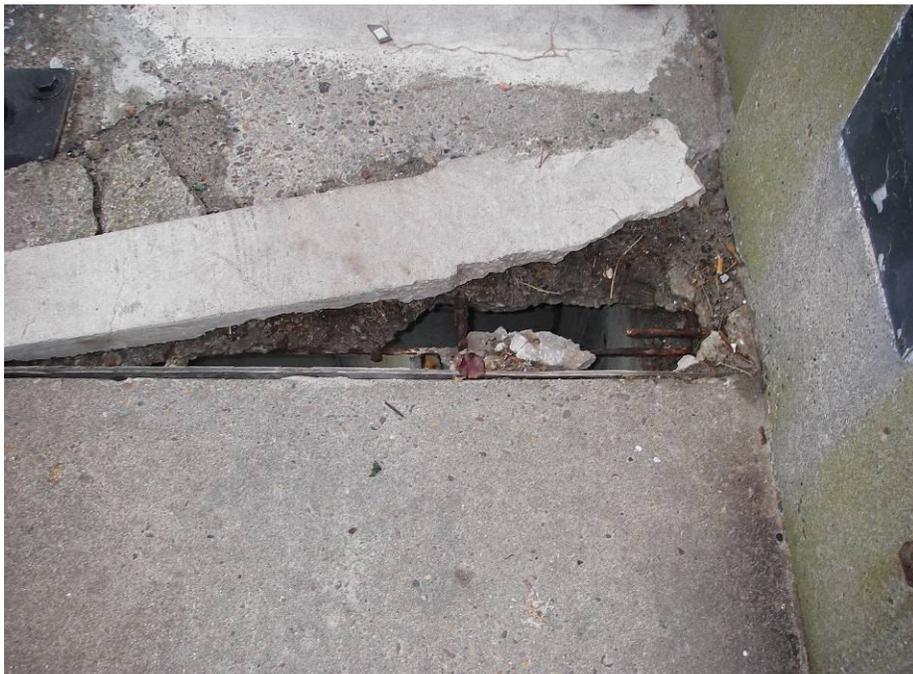
Photograph S28 - Span Unit 21, north sidewalk, east joint. View of the full depth spall.

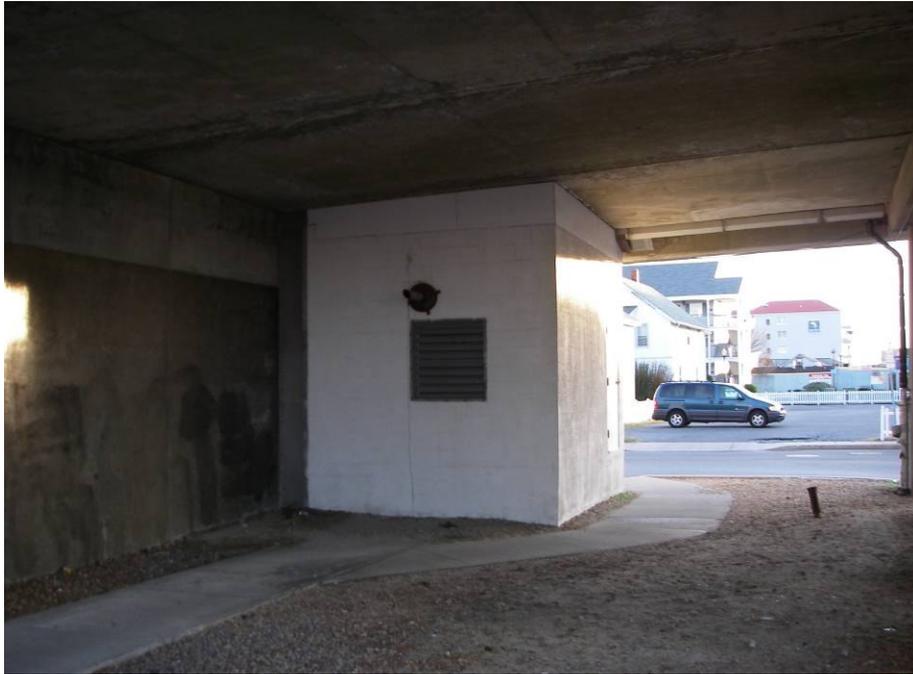
Photograph S29 - Span 1, south end. View of the power generator housing which prevents inspection of the south portion of the deck soffit.

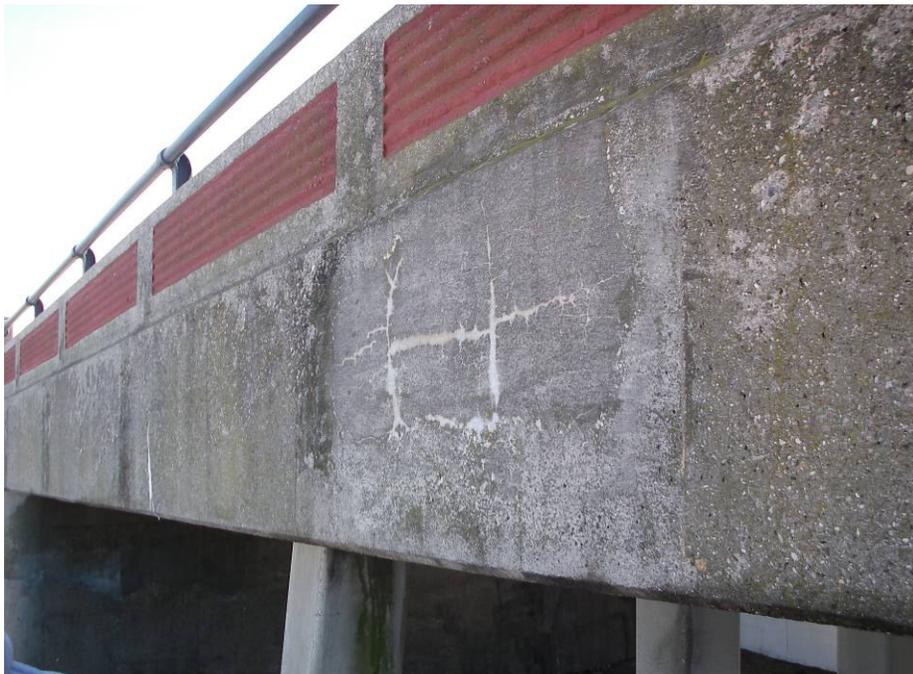
Photograph S30 - Span 7, south exterior beam. View of three transverse hairline cracks with efflorescence.

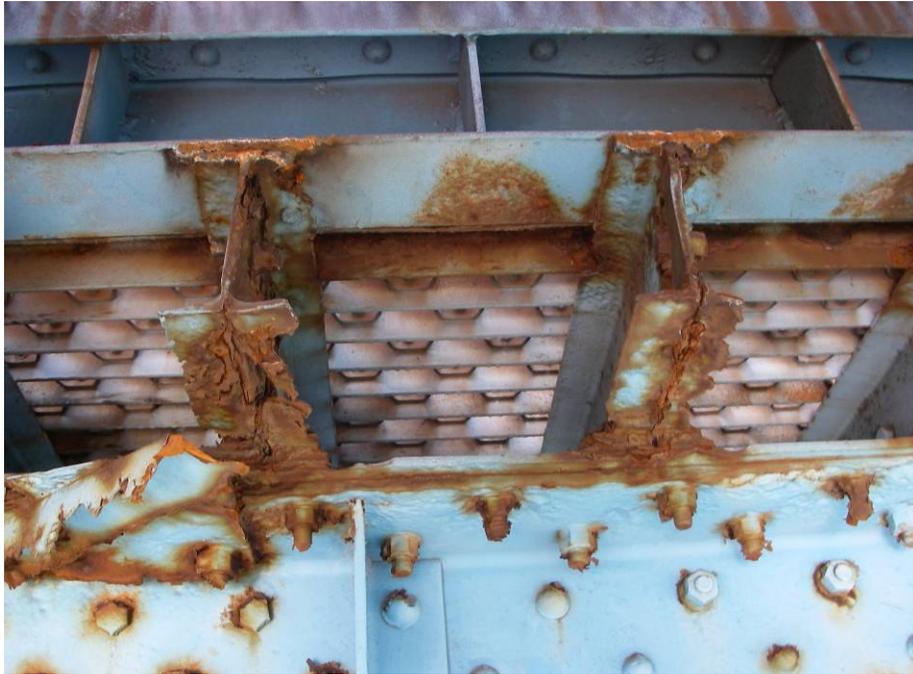
Photograph S31 - East Bascule Leaf, south edge. View of the typical substringer serious condition.

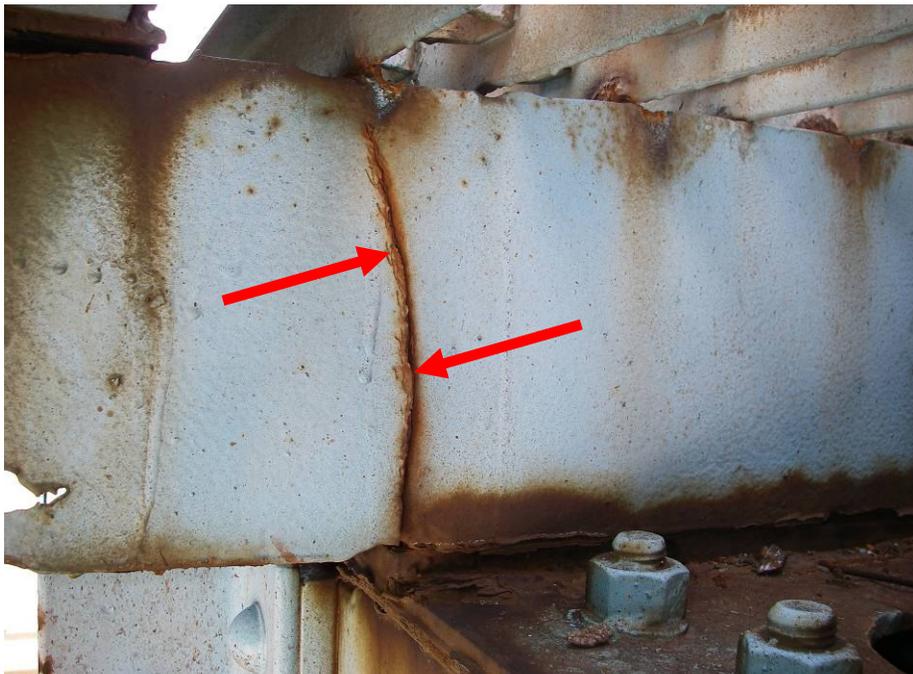
Photograph S32 - Substringer 2, west bascule leaf, south end. View of the full height web crack (arrows).

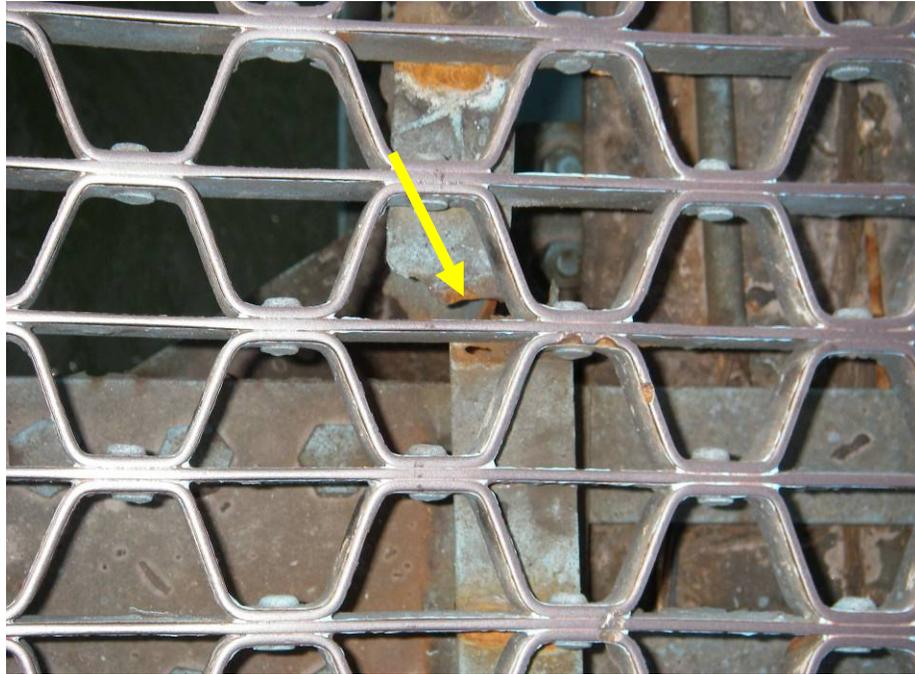
Photograph S33- Substringer 3, east bascule leaf, Stringers 2 to 3 at Stringer 2. View of the completely separated substringer (arrow).

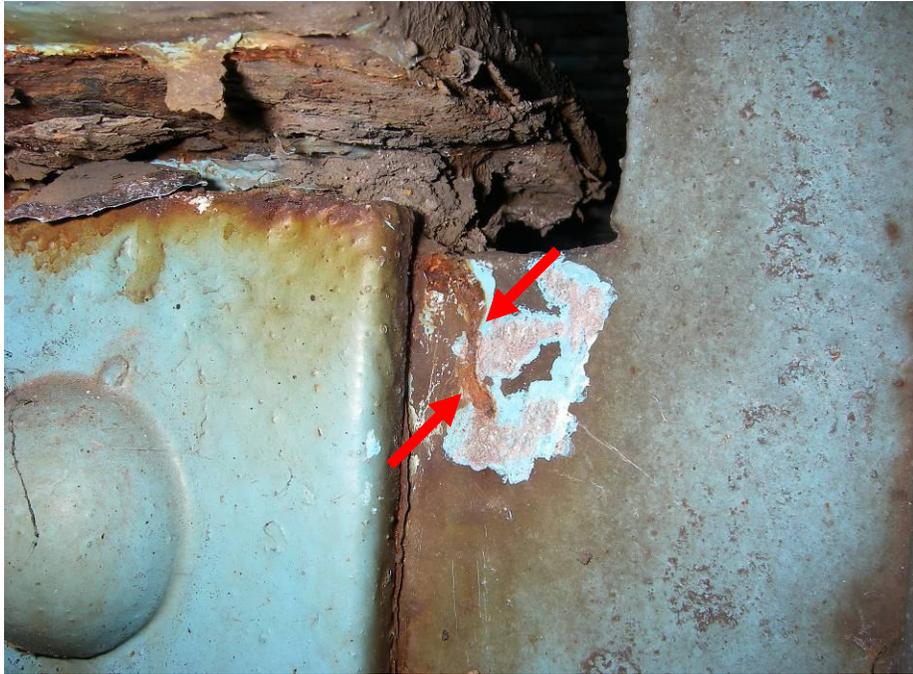
Photograph S35- Stringer 4 at Floorbeam 3, the east leaf. The top cope crack measures $\frac{3}{4}$ " in length (arrows).

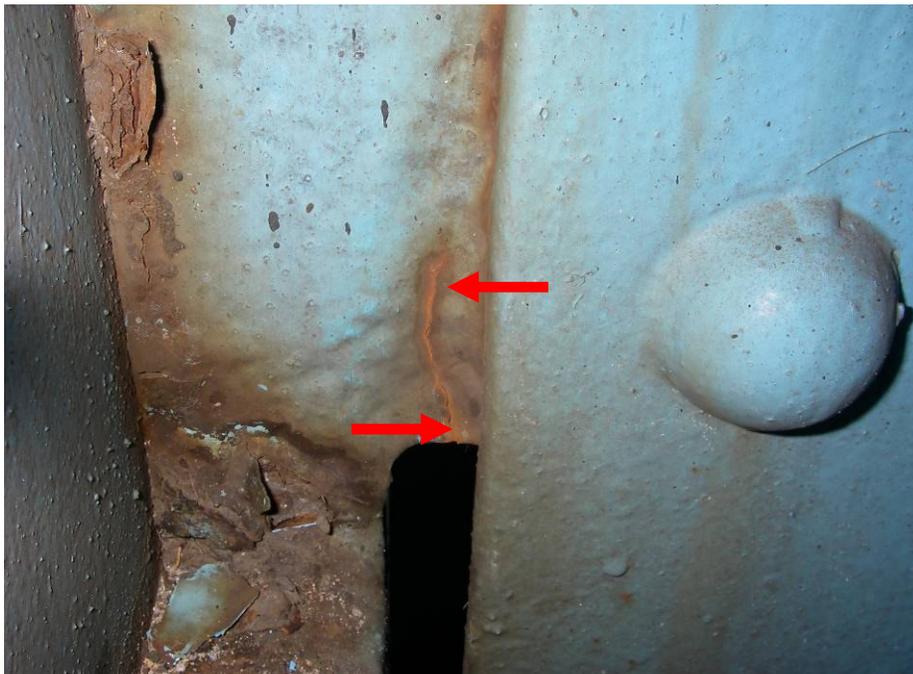
Photograph S36- Stringer 4 at Floorbeam 3, east leaf. The bottom cope crack measures $1\frac{1}{2}$ " in length (arrows).

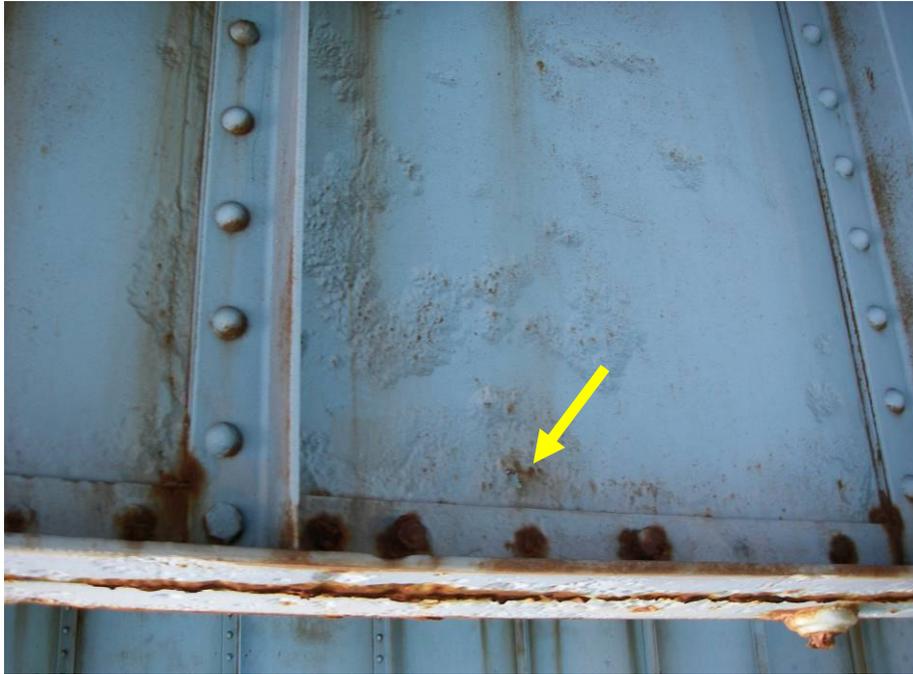
Photograph S37 - Floorbeam 1, west face, east bascule leaf. View of the typical pitting, bottom flange corrosion, and 2" diameter corrosion holes (arrow).

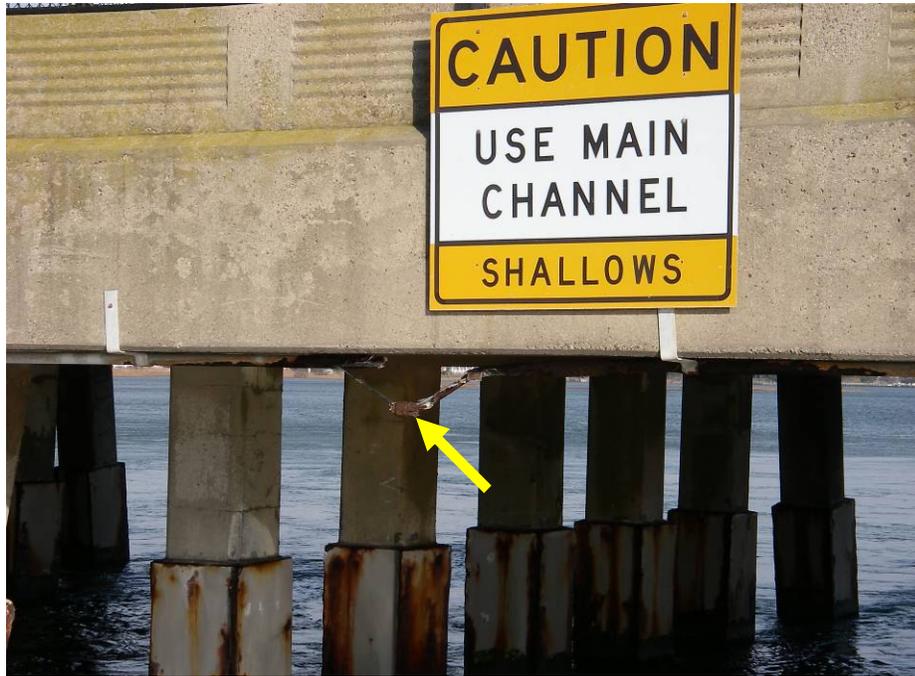
Photograph S56 - Span 89, north exterior beam. View of the conduit severely corroded and disconnected (arrow).

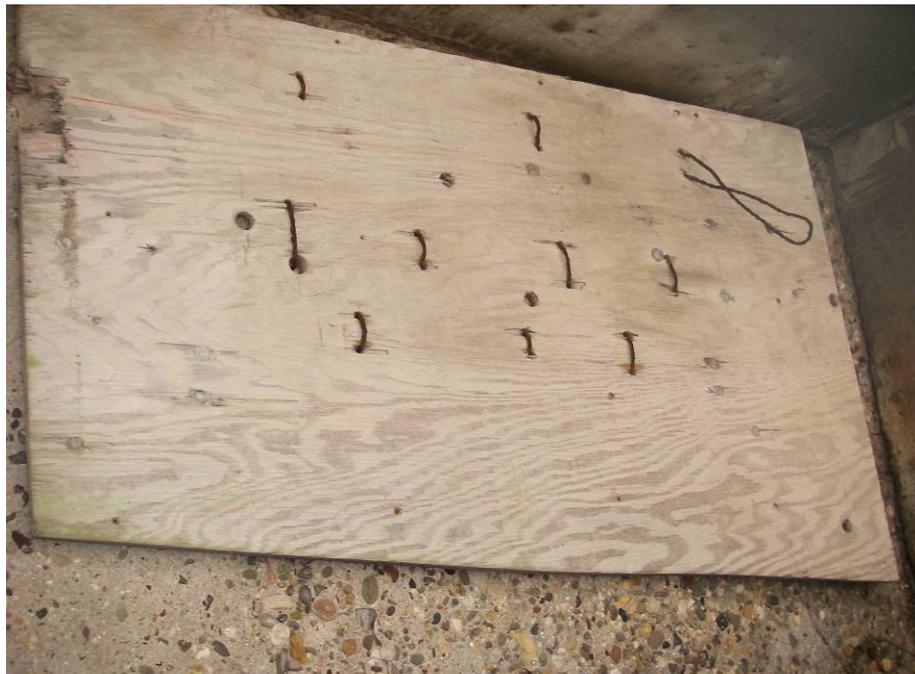
Photograph S57 - Span 92, east end, south sidewalk soffit. View of the plywood formwork.

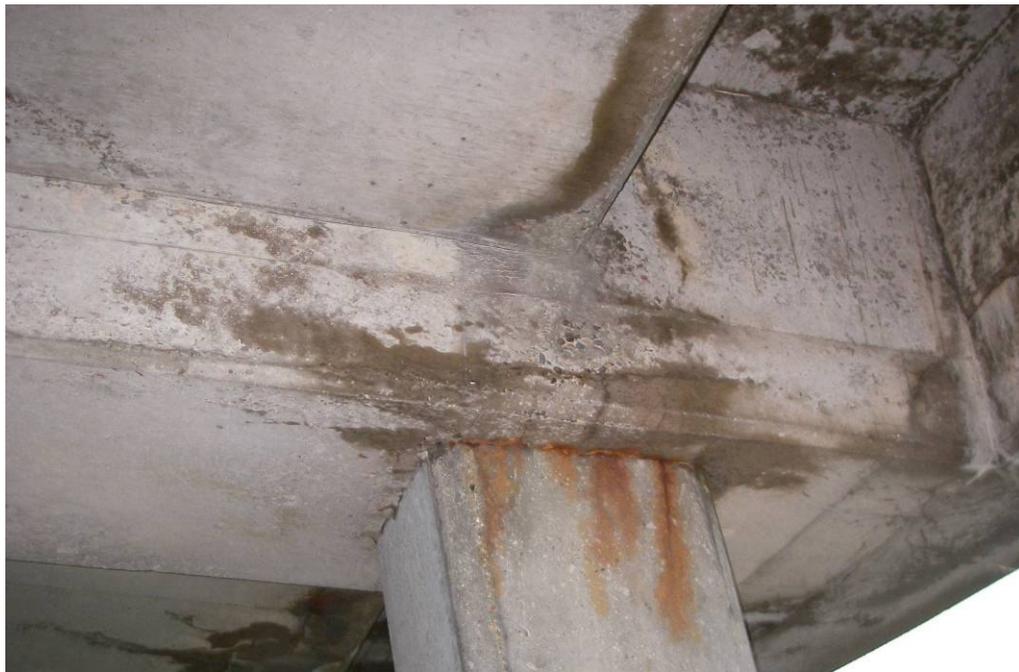
Photograph S61 - Bent 34, Pile 1, east face. View of typical minor cracking in the pier cap.

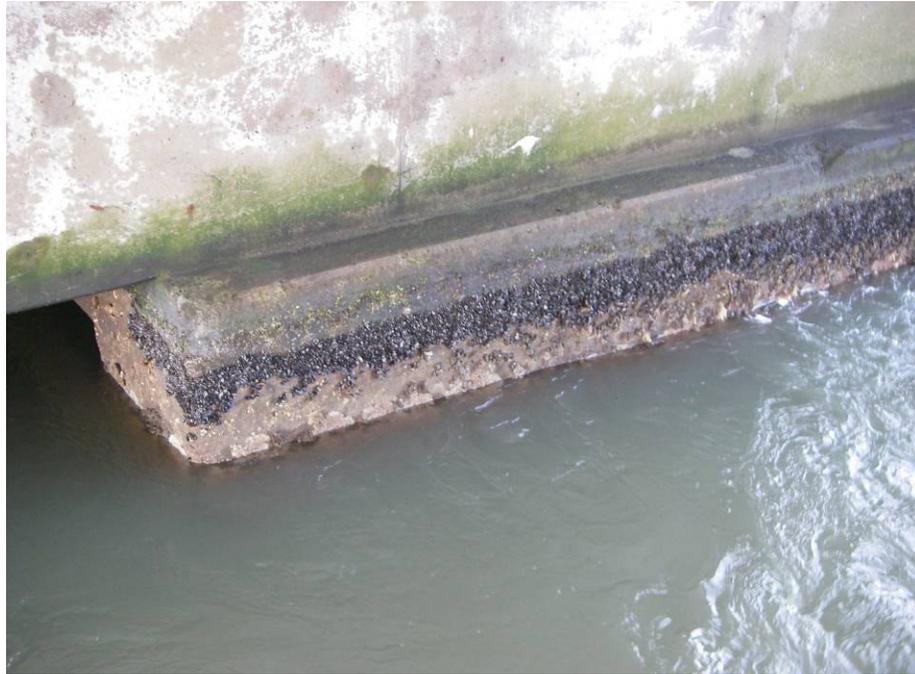
Photograph S68 - East bascule pier, east face. View of minor marine growth at the water level
