2007 Bridge Inspection Report

MARYLAND DEPARTMENT OF TRANSPORTATION
STATE HIGHWAY ADMINISTRATION
BRIDGE INSPECTION AND REMEDIAL ENGINEERING DIVISION
STRUCTURAL / MECHANICAL / ELECTRICAL
2007 BRIDGE INSPECTION REPORT

BRIDGE NO. 2300700
MD ROUTE 50 OVER SINEPUXENT BAY
WORCESTER COUNTY, MARYLAND

MODJESKI AND MASTERS, INC
CONSULTING ENGINEERS
HARRISBURG, PENNSYLVANIA

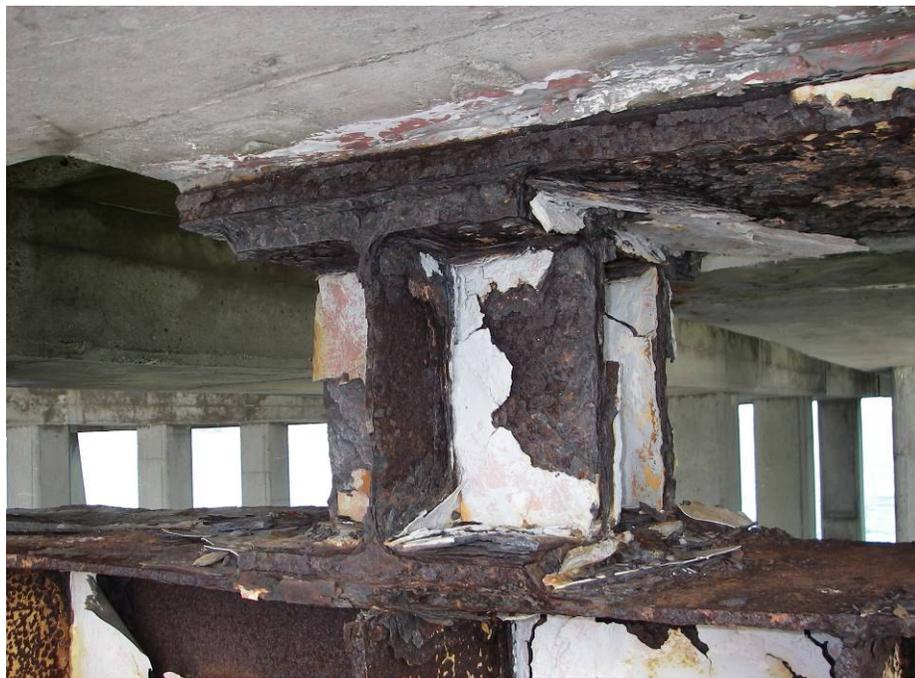
Photograph S71 - Bent 19, Pile 5, west upper built-up W-section. View of the severe section loss.

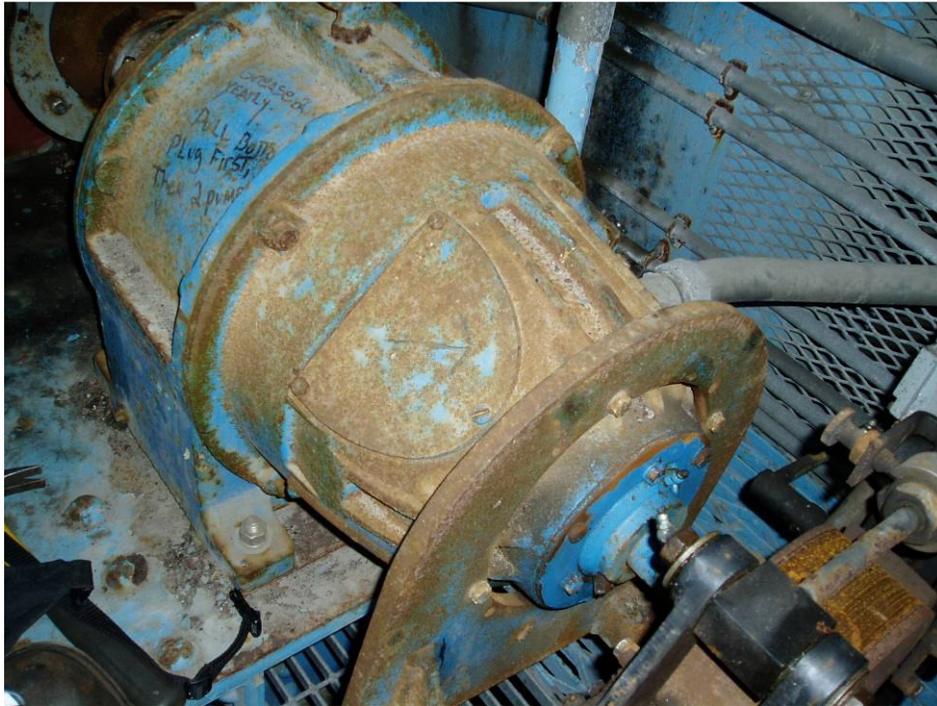
Photograph M1 – Typical span drive motor housing and motor brake frame support paint failure and minor to moderate corrosion.

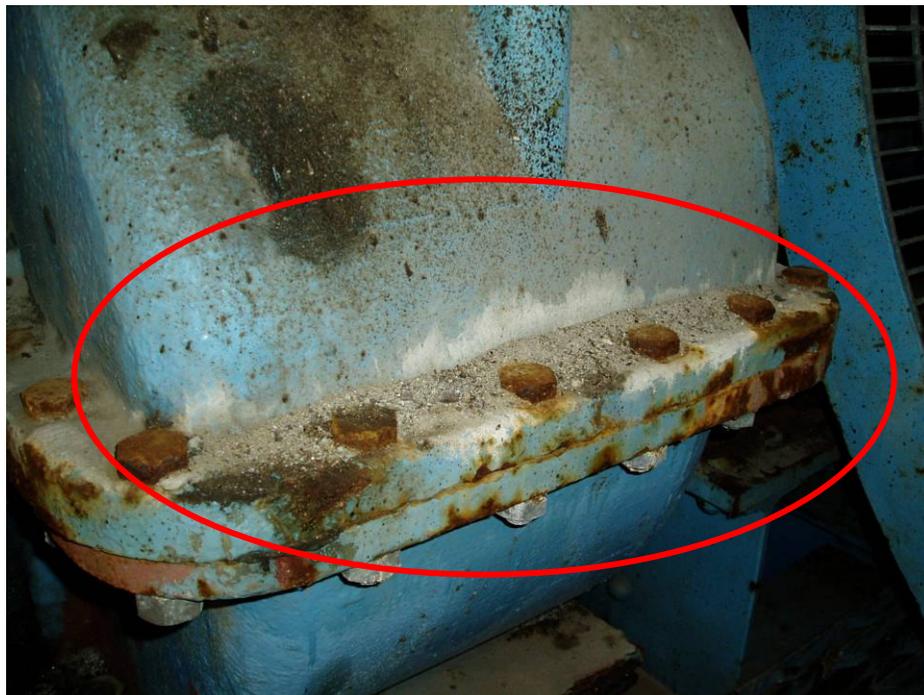
Photograph M2 – East primary differential reducer, debris build-up on channel side of housing split.

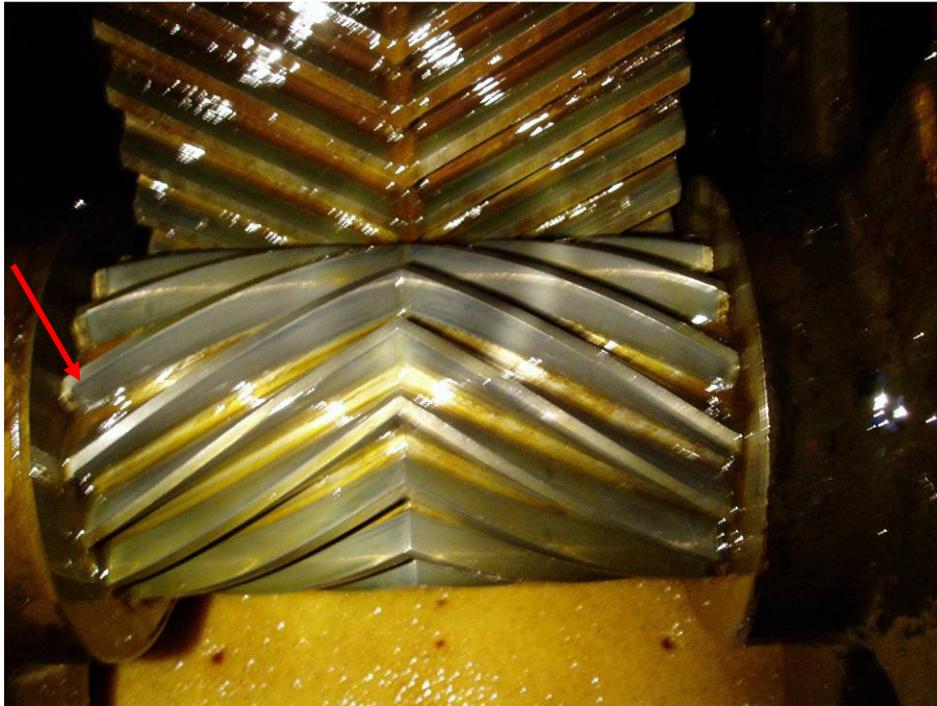
Photograph M3 – East primary differential reducer low speed pinion. Minor wear on the opening face.

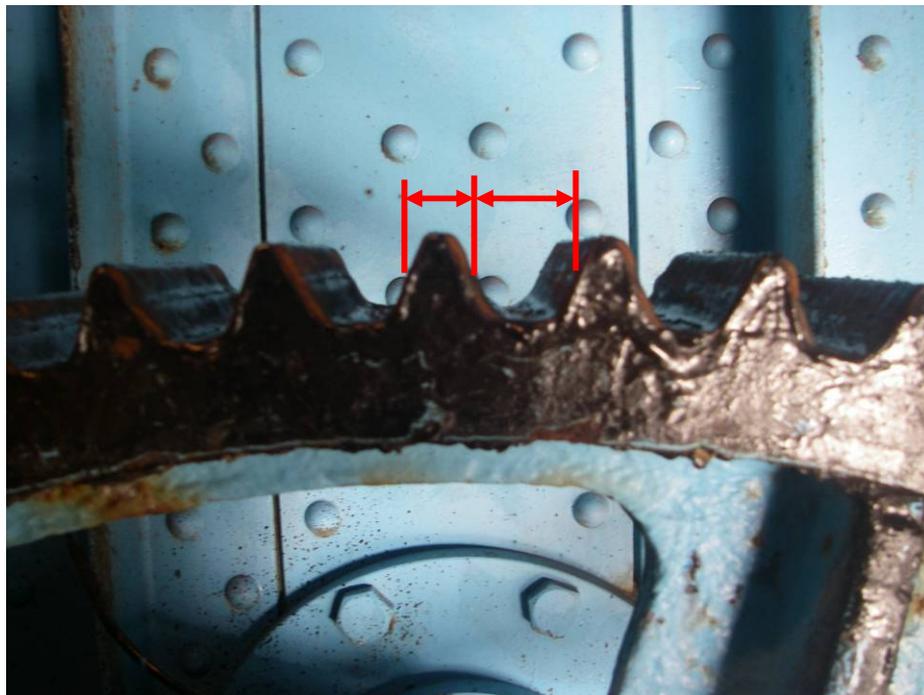
Photograph M4 – Typical significant west leaf open gear G2 tooth wear. Note the relation in tooth space width much greater than current tooth thickness.

| Immediate Repairs (<2 years) | | | | |
|---|---|---|---|---|
| Replace northwest and southwest G2/G3 open gear sets. | LS | - | Currently Contracted | |

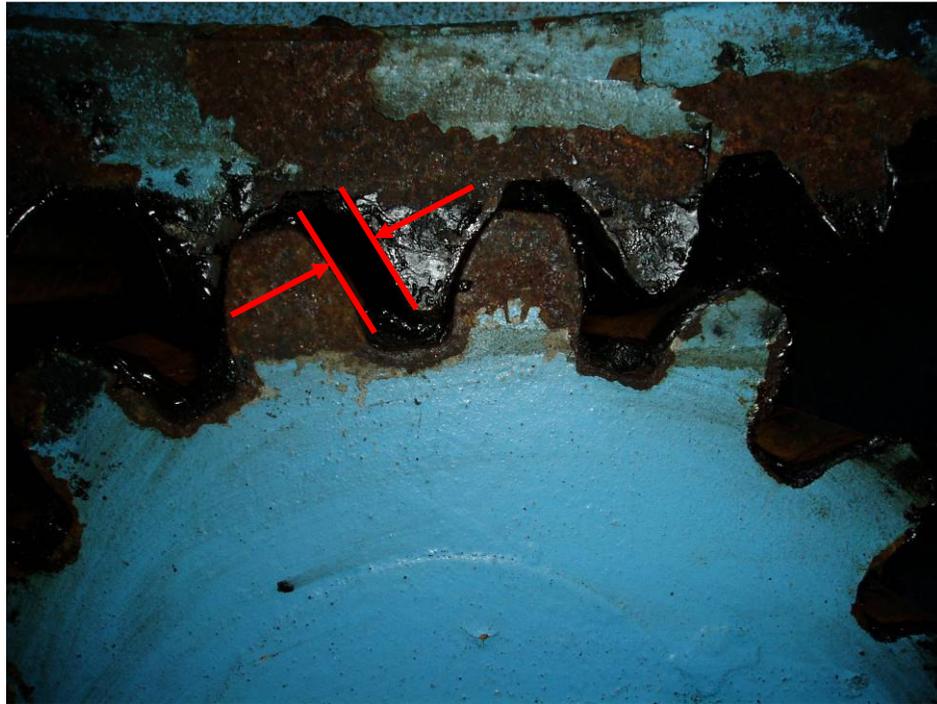
Photograph M5 – Typical east leaf open gear G2 wear and excessive backlash with mating pinion G3.

| Immediate Repairs (<2 years) | | | | |
|---|---|---|---|---|
| Replace northeast and southeast G2/G3 open gear sets. | LS | - | 100,000 | 100,000 |

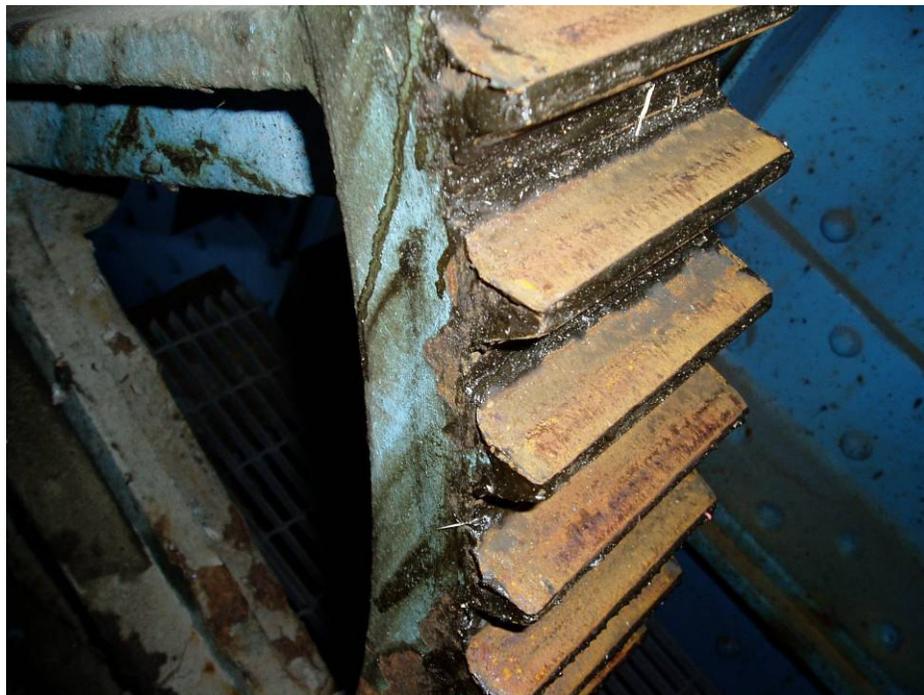
Photograph M6 – Typical inadequate lubrication giving way to minor to moderate tooth face corrosion.

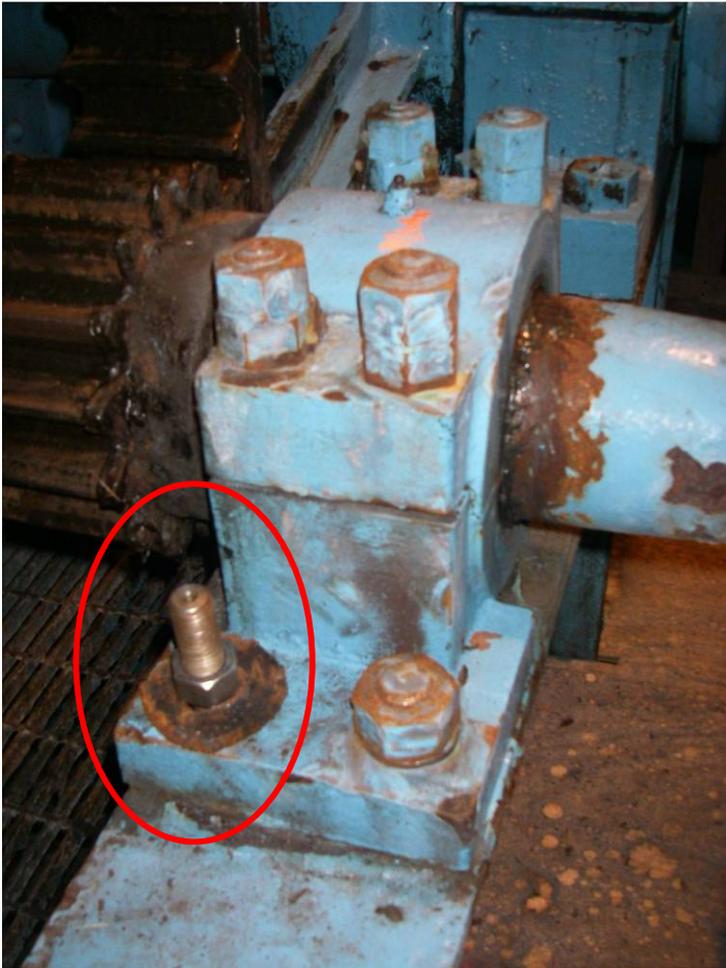
Photograph M7 – The northwest bearing B3 exhibits temporary undersized mounting bolt.

| Immediate Repairs (<2 years) | | | | |
|---|---|---|---|---|
| Replace temporary mounting bolt at northwest bearing B3. | LS | - | Maintenance | |

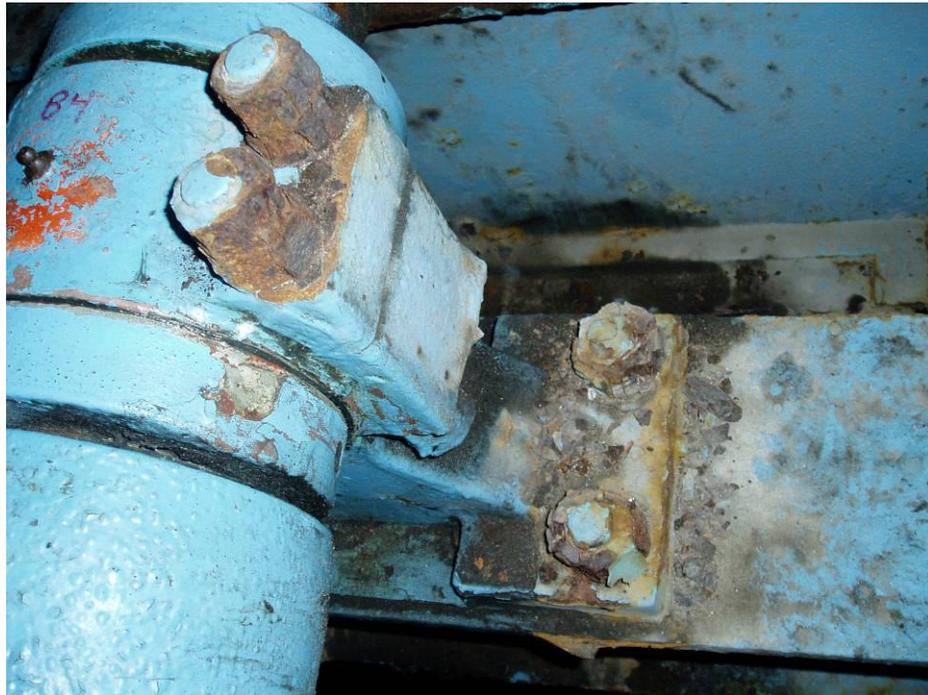
Photograph M8 – Typical severe corrosion and delamination on the channel side of the

east leaf bearing housing feet and fasteners.

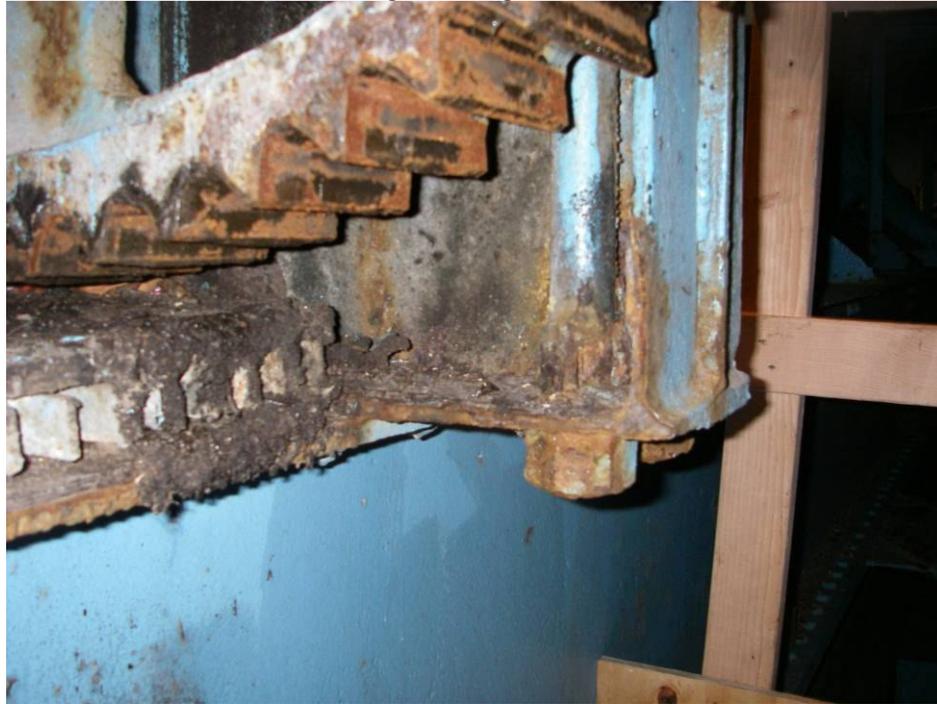
Photograph M9 – West leaf, south bearing B2, southeast mounting bolt severe corrosion.

| Immediate Repairs (<2 years) | | | | |
|---|---|---|---|---|
| Replace the southwest bearing B2 mounting and cap bolts. | LS | - | 2,000 | 2,000 |

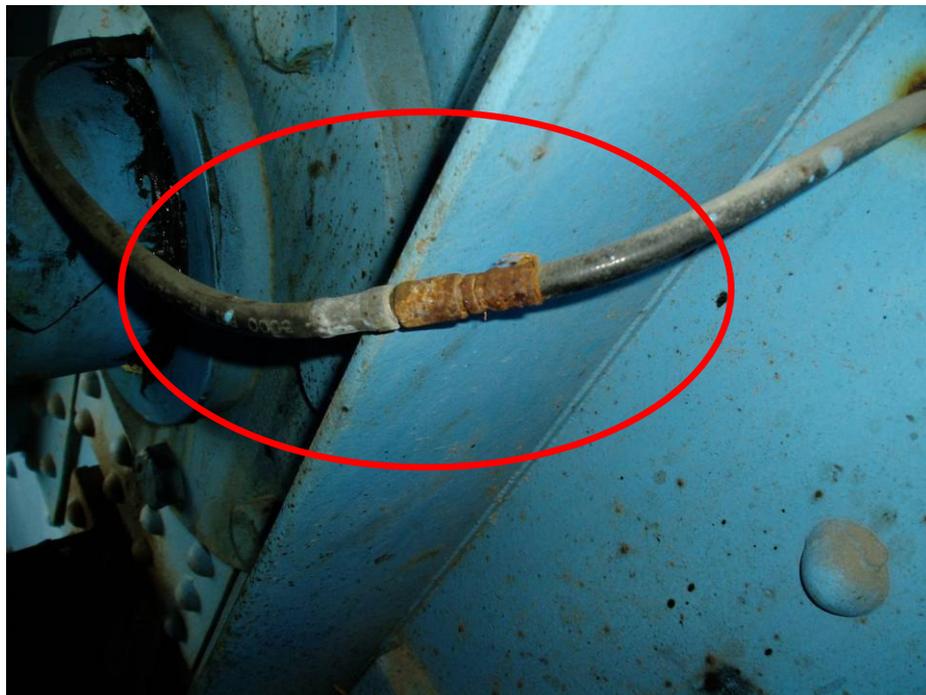
Photograph M10 – Typical corrosion on B1 bearing lubrication line couplers.

| Immediate Repairs (<2 years) | | | | |
|---|---|---|---|---|
| Replace the B1 bearing lubrication line couplers. | LS | - | Maintenance | |

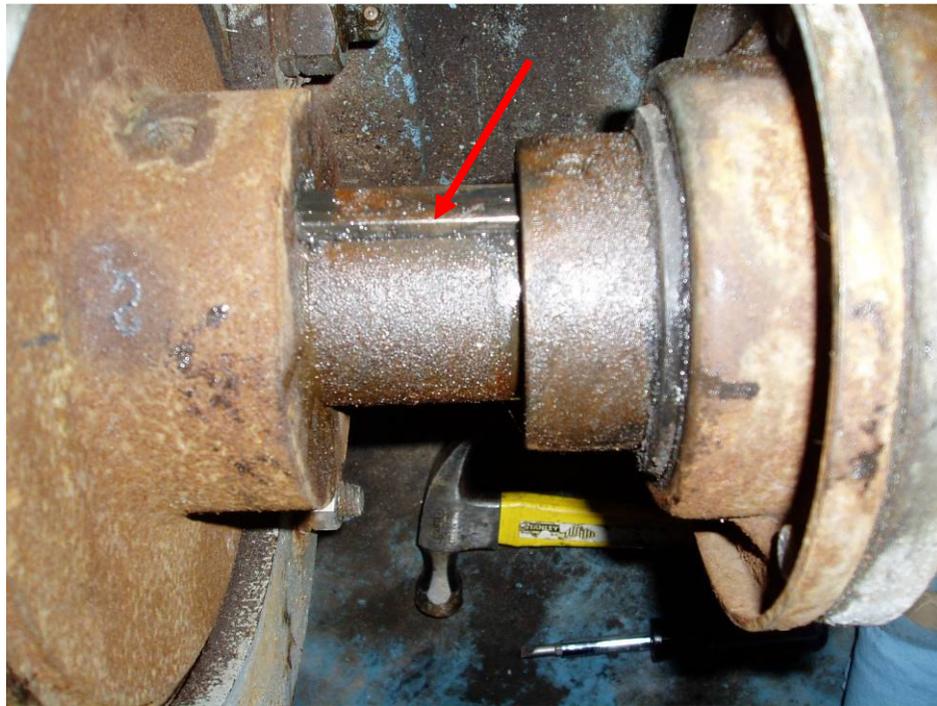
Photograph M11 – The north motor coupling/emergency brake key on the east leaf is loose radially and axially.

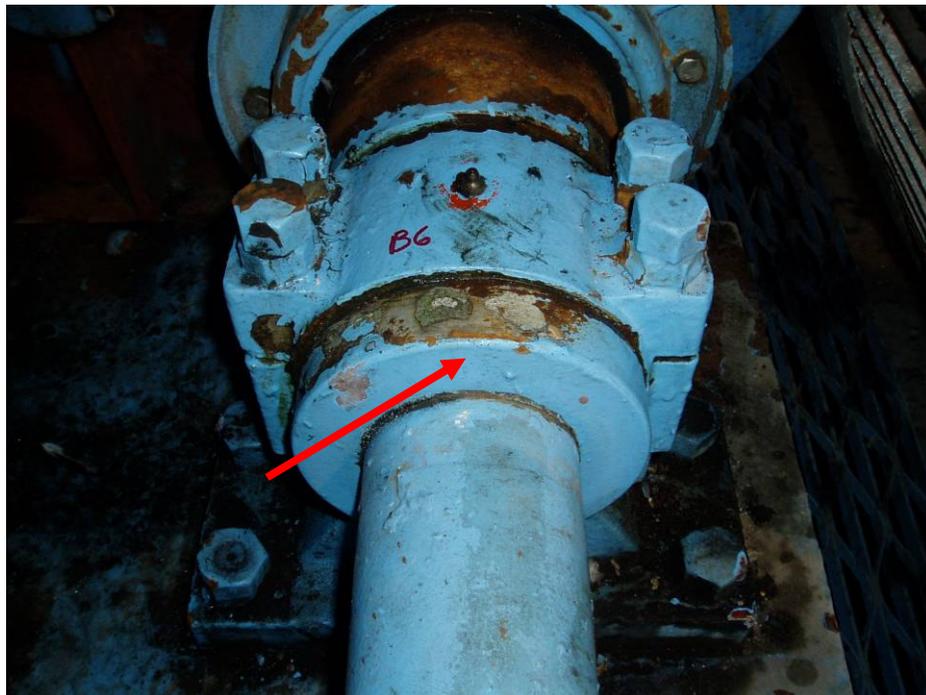
Photograph M14 – Typical shaft collar condition with failed paint but little to no surface corrosion.

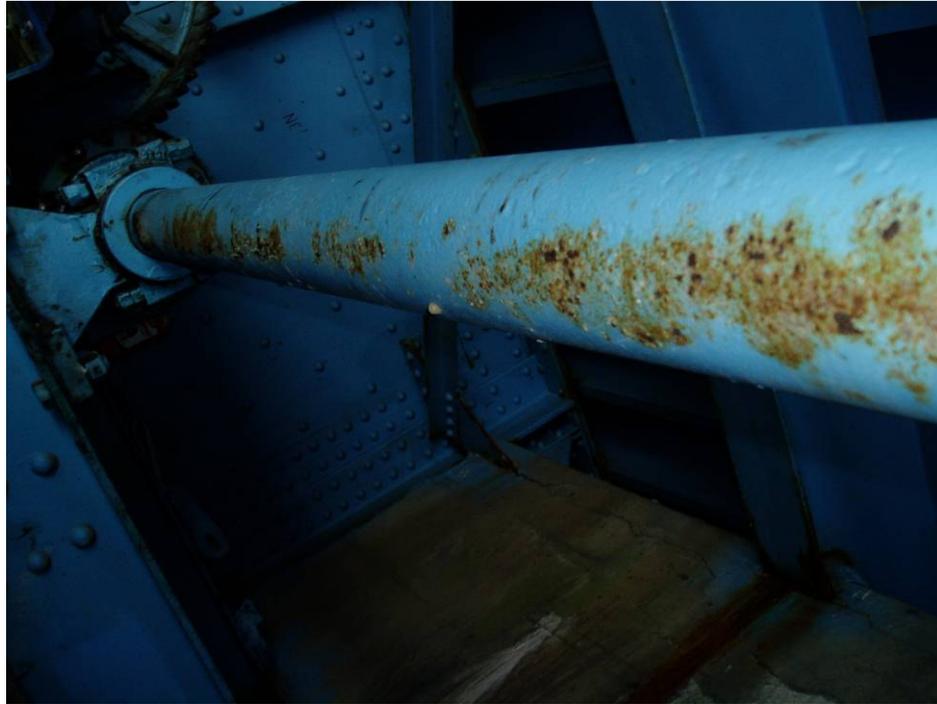
Photograph M15 – Moderate to significant corrosion on the shafting is isolated to the areas which are oriented downward in the bridge fully closed position.

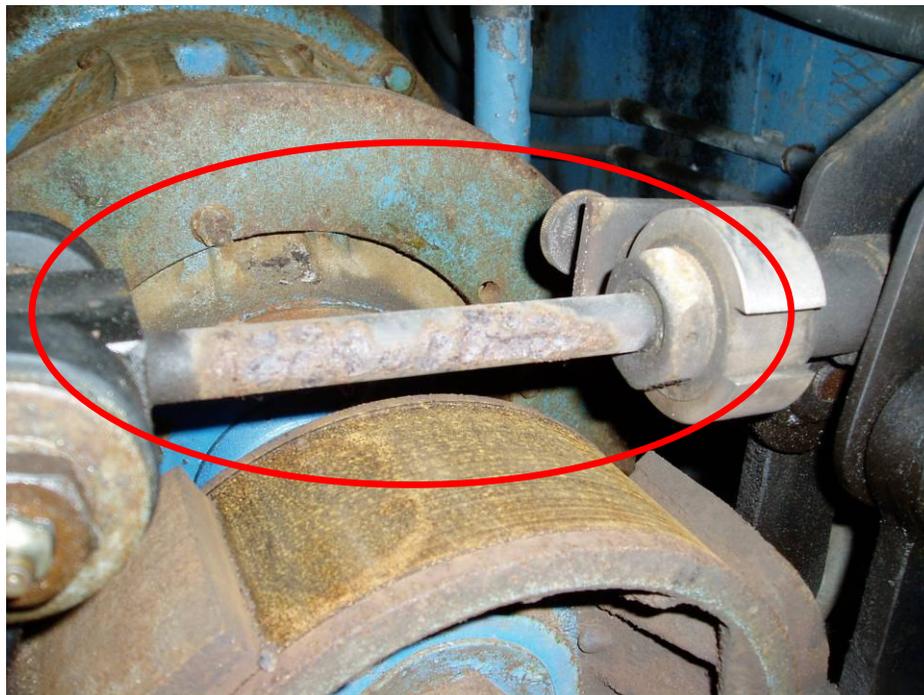
Photograph M16 – Southeast motor brake, typical significant corrosion in general with advanced corrosive pitting of the brake pull rods. (see oval)

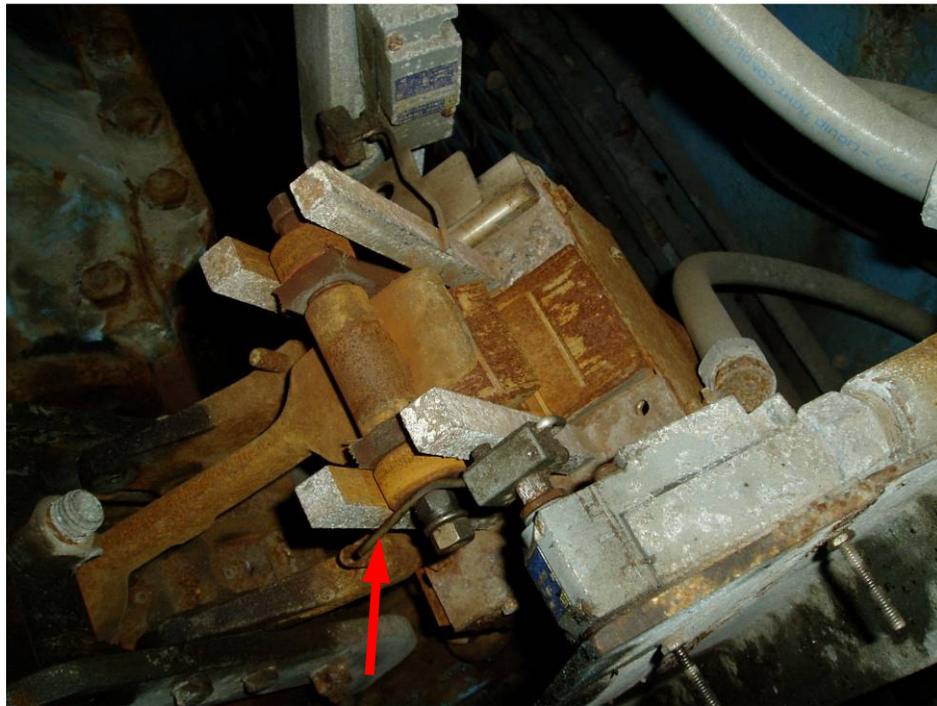
Photograph M17 – The emergency brake limit switch trip arms have been replaced with wire.

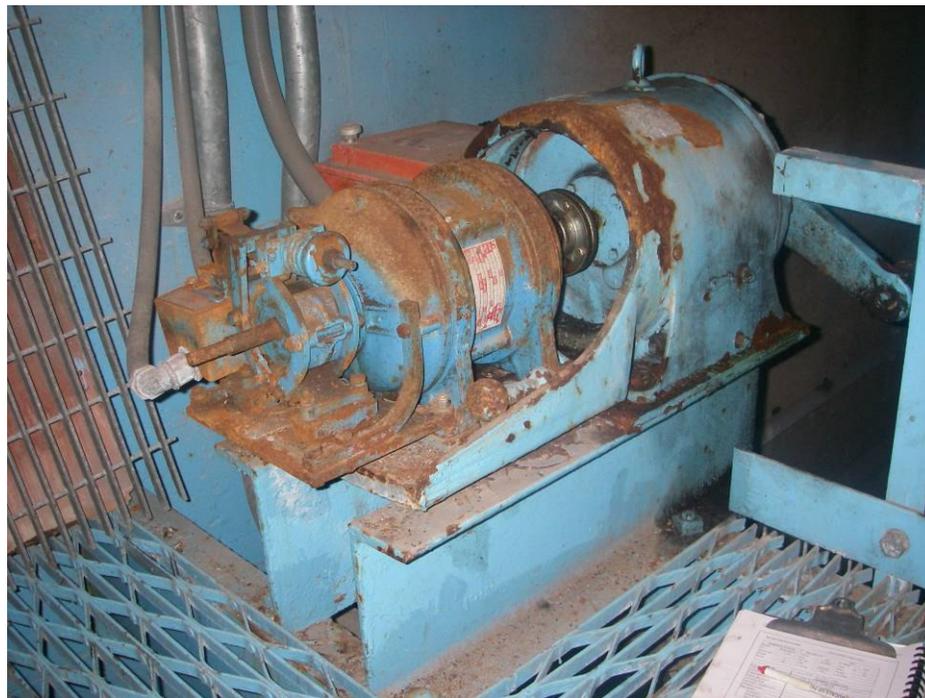
Photograph M18 – Typical condition at tail lock drive motor, reducer and brake.

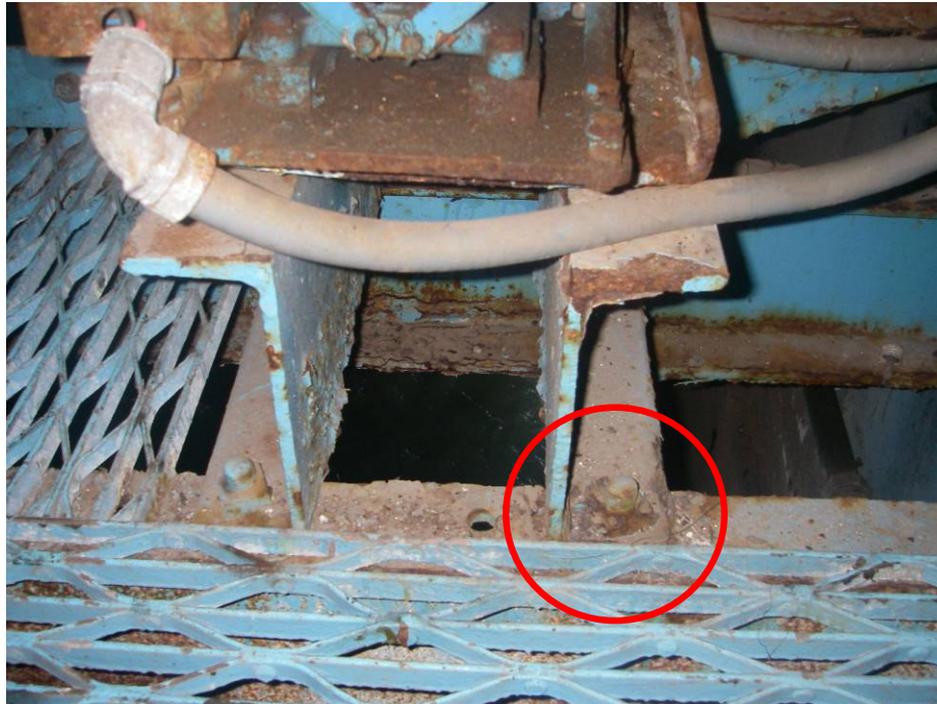
Photograph M19 – Severe corrosion of support frame mounting bolt at the northwest tail lock.

| Immediate Repairs (<2 years) | | | | |
|---|---|---|---|---|
| Replace all frame and motor mounting bolts at the tail lock assemblies. | LS | - | 6,000 | 6,000 |

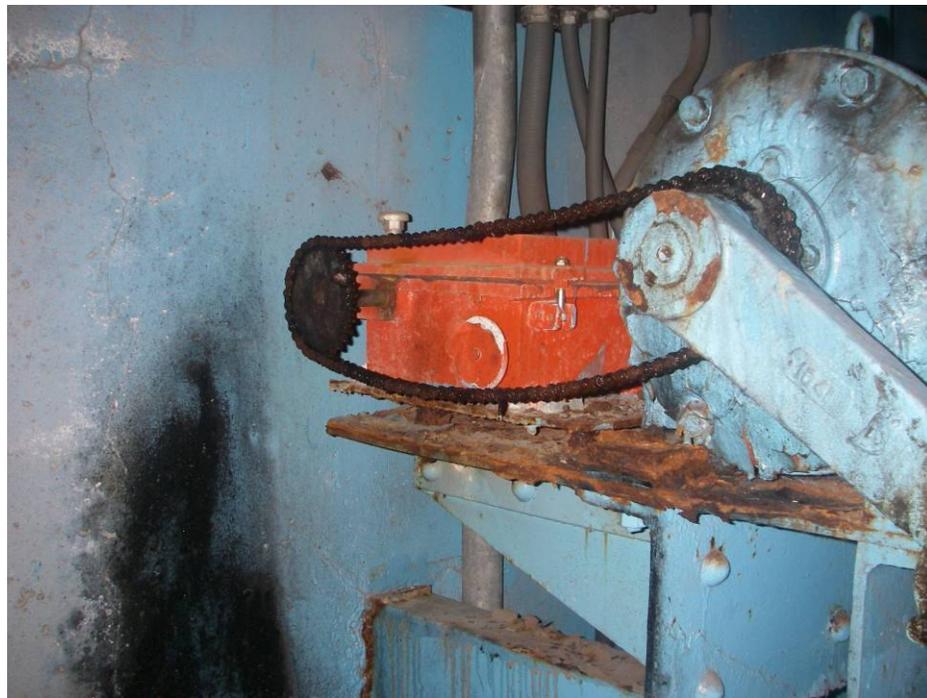
Photograph M20 – The northwest tail lock rotary cam limit switch drive chain is very loose.

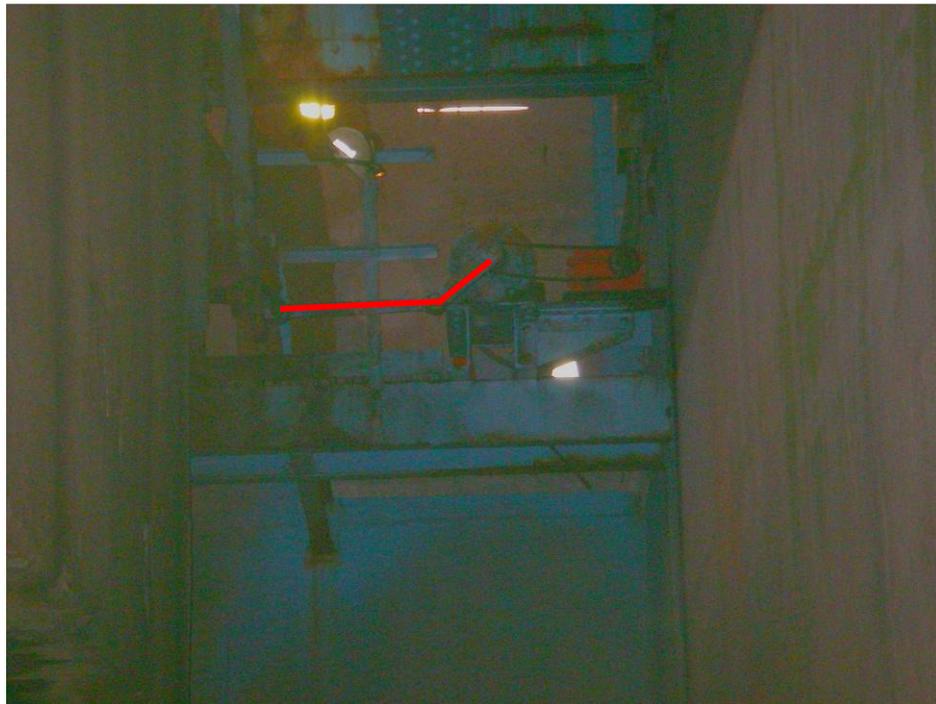
Photograph M21 – The northeast tail lock linkage is not in-line in the fully driven position. The rotary cam limit switch is maladjusted, and the brake for this assembly allows the weight of the linkage to back-drive the reducer when the motor de-energizes.

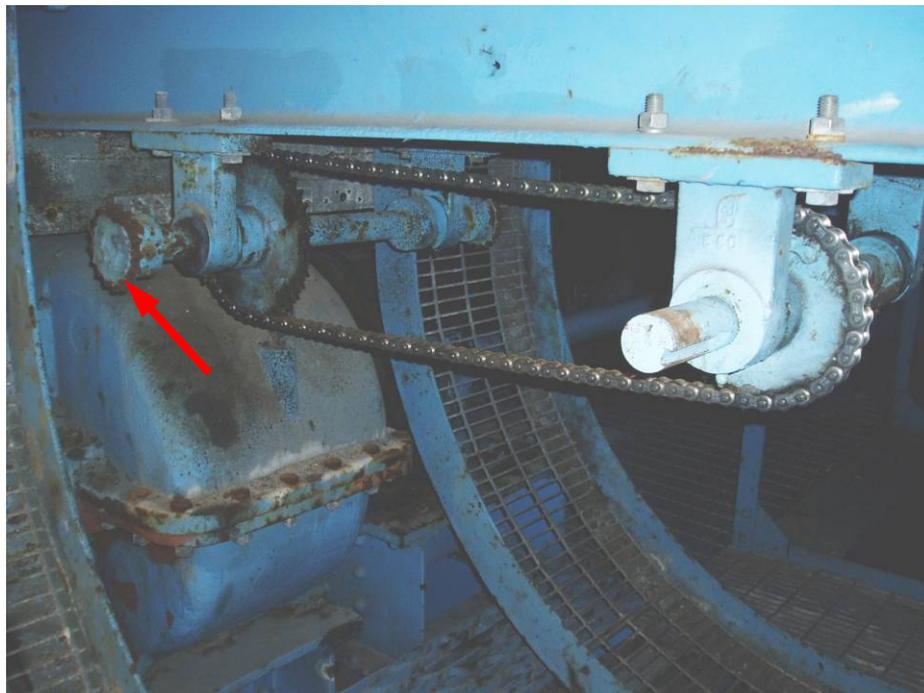
Photograph M22 – Typical auxiliary manual span drive chain. The hand cranks were located on the east leaf with no keys. The secondary chains were not found for 1 of 2 secondary sprockets (see arrow).

| Long Term Repairs (5 to 10 years) | | | | |
|---|---|---|---|---|
| Replace the manual auxiliary drive with electric gearmotor drive. | EA | 2 | 80,000 | 160,000 |

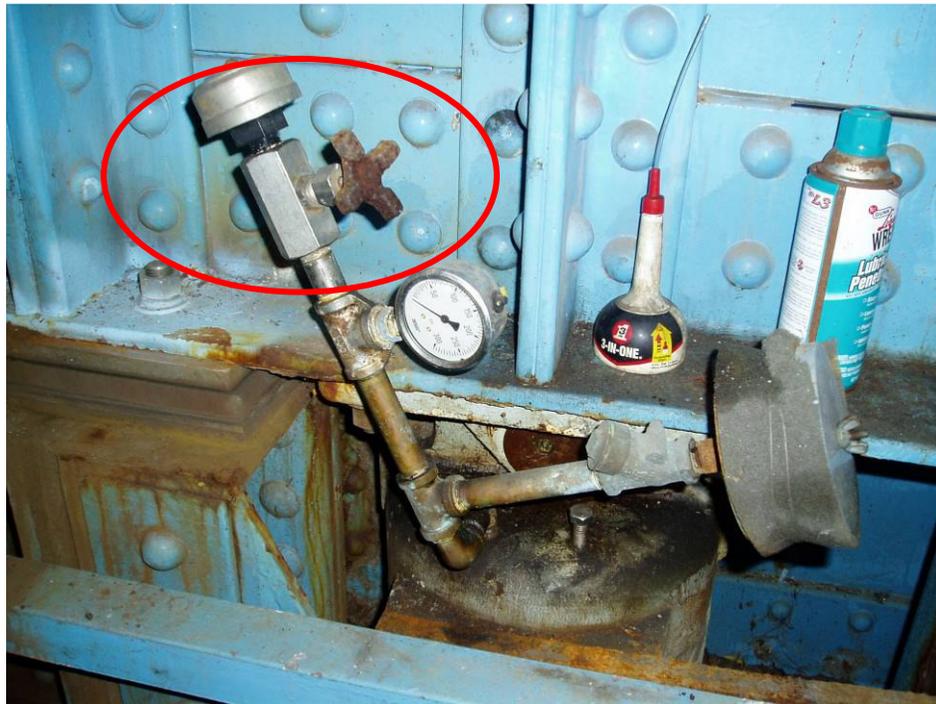
Photograph M23 – The needle valve handle on the air buffer piping exhibits moderate corrosion.

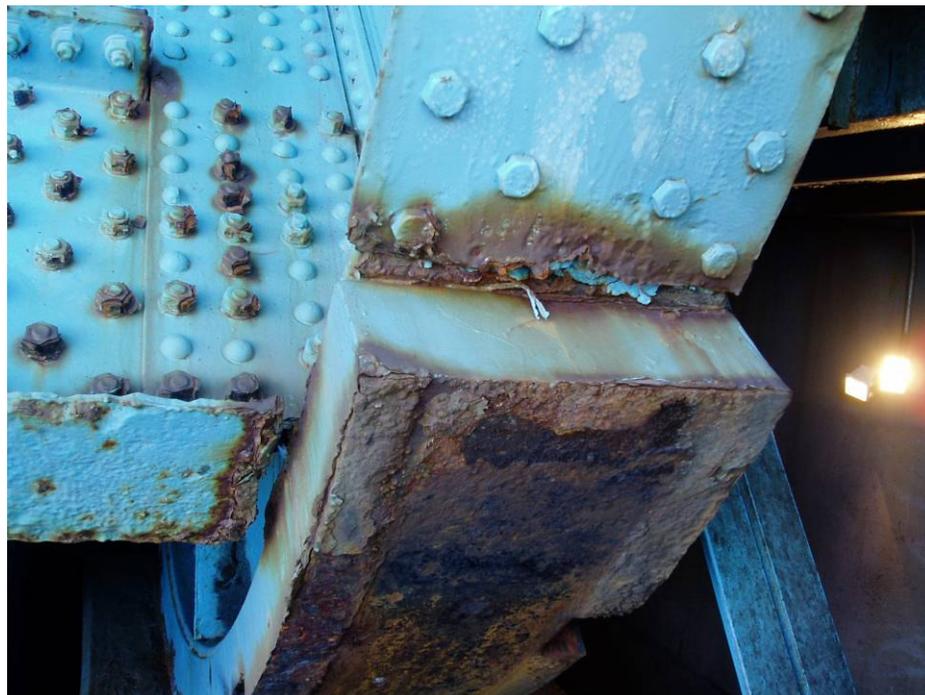
Photograph M24 – Typical severe corrosion and delamination of the tread facing the channel in the fully closed position.

| Long Term Repairs (5 to 10 years) | | | | |
|---|---|---|---|---|
| Replace tread and track fasteners which exhibit severe corrosion. | LS | - | 50,000 | 50,000 |

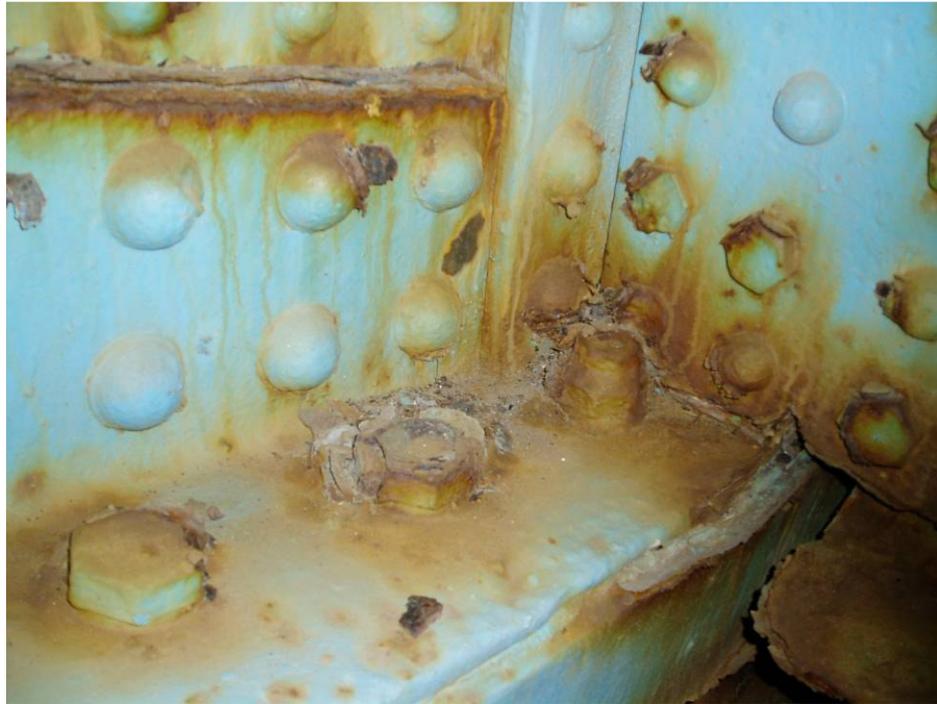
Photograph M25 – The segmental girders typically exhibit severe corrosion in the region closest to the channel.

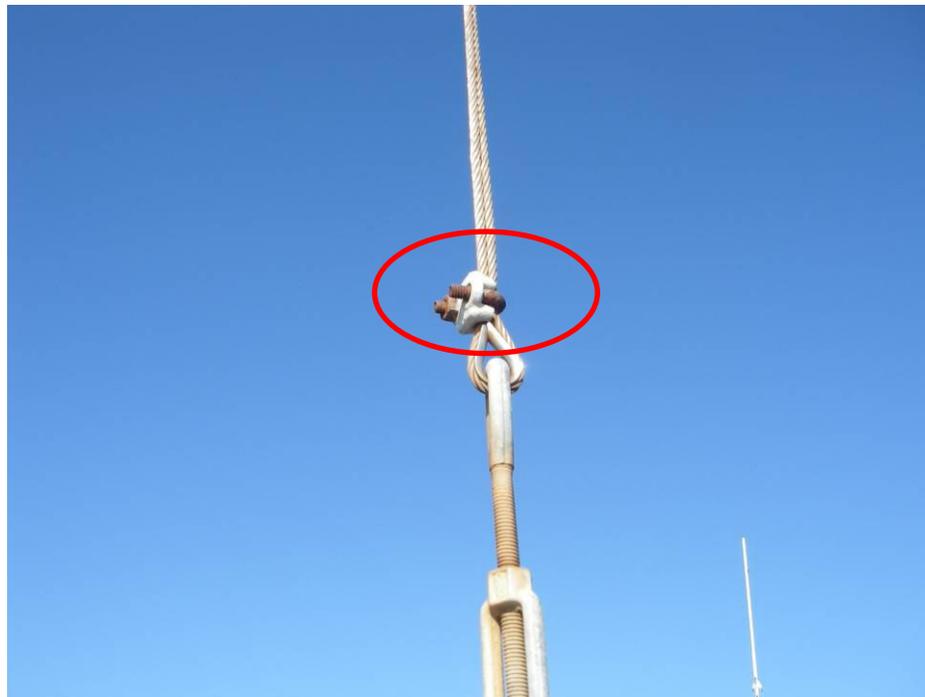
The southwest gate arm guy wire u-bolts exhibit moderate corrosion and one is missing a nut (see Photograph M28). The southeast anchor bolt for this gate exhibits minor corrosion (see Photograph M29).

Photograph M28 – The southwest warning gate guy-wire u-bolt exhibits moderate corrosion and one nut is missing.

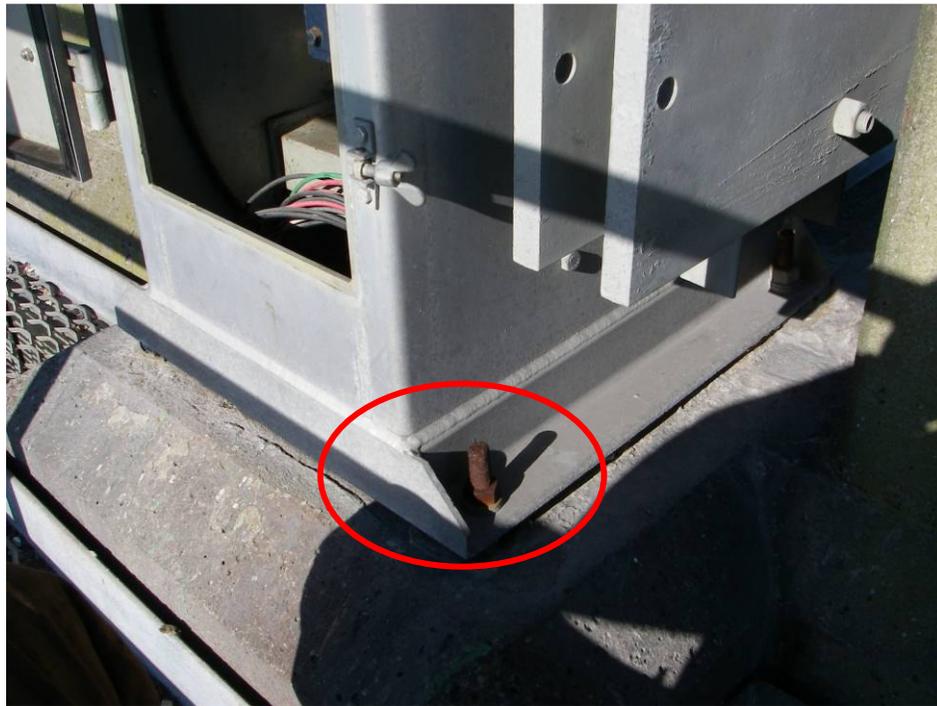
Photograph M29 – The southeast anchor bolt for the southwest warning gate exhibits minor corrosion.

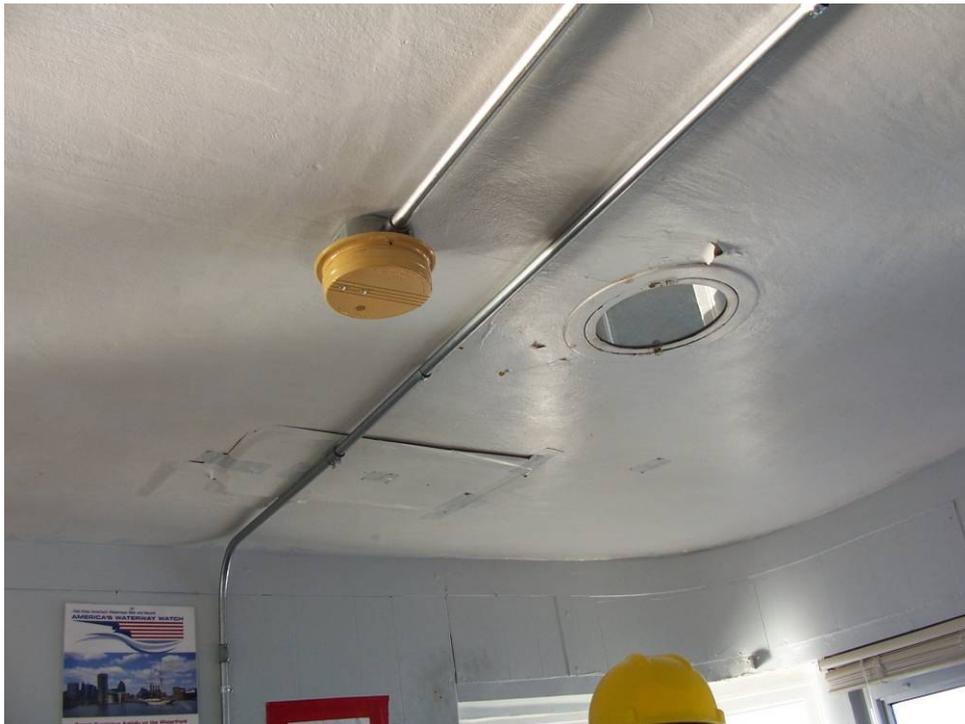
Lighting fixtures inside the tender house, see Photograph E6, and in front of motor control cabinet as seen in Photograph E18 are in poor condition. They need to be replaced with new.

Photograph E6 - Tender House Ceiling Mounted Lights in poor condition

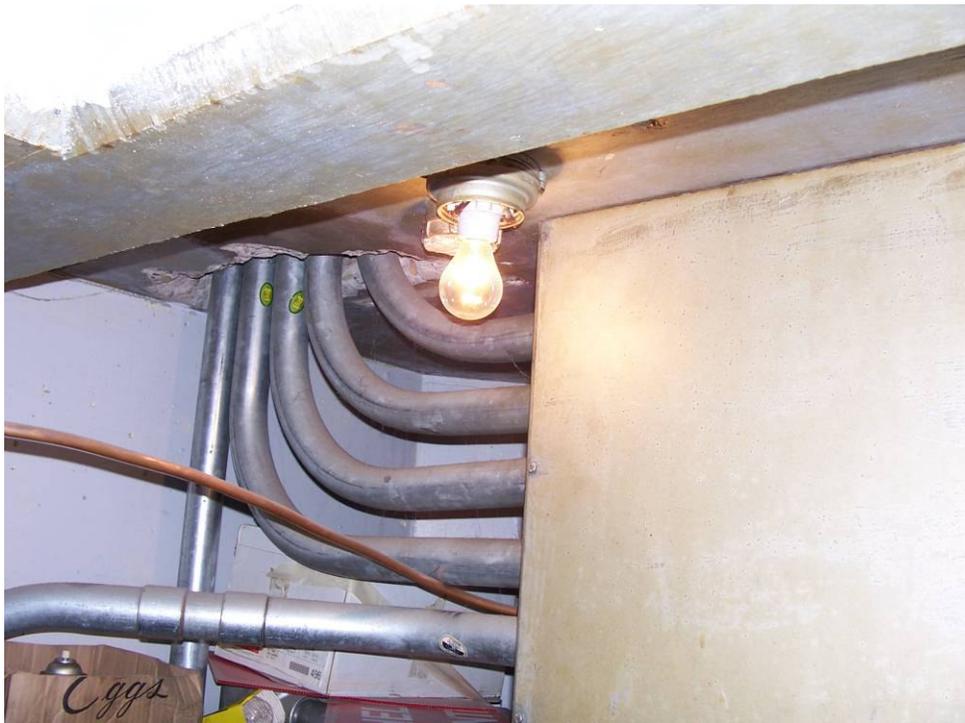
Photograph E18 - Lighting Fixture in front of motor control cabinet in poor condition

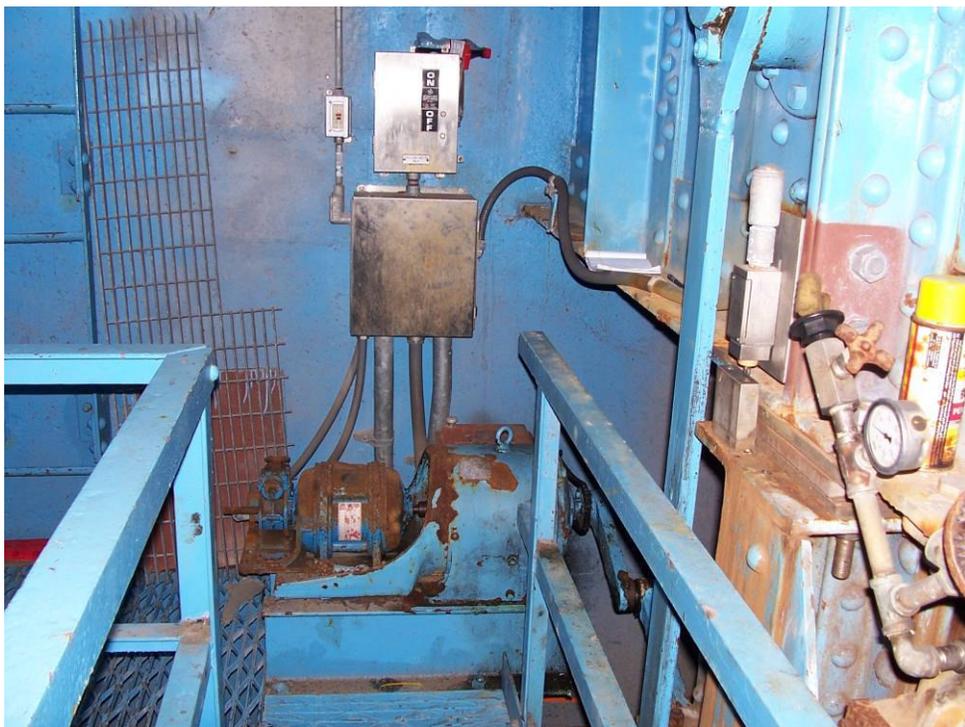
Photograph E20 - Span Lock Motor on North West side - rusted.

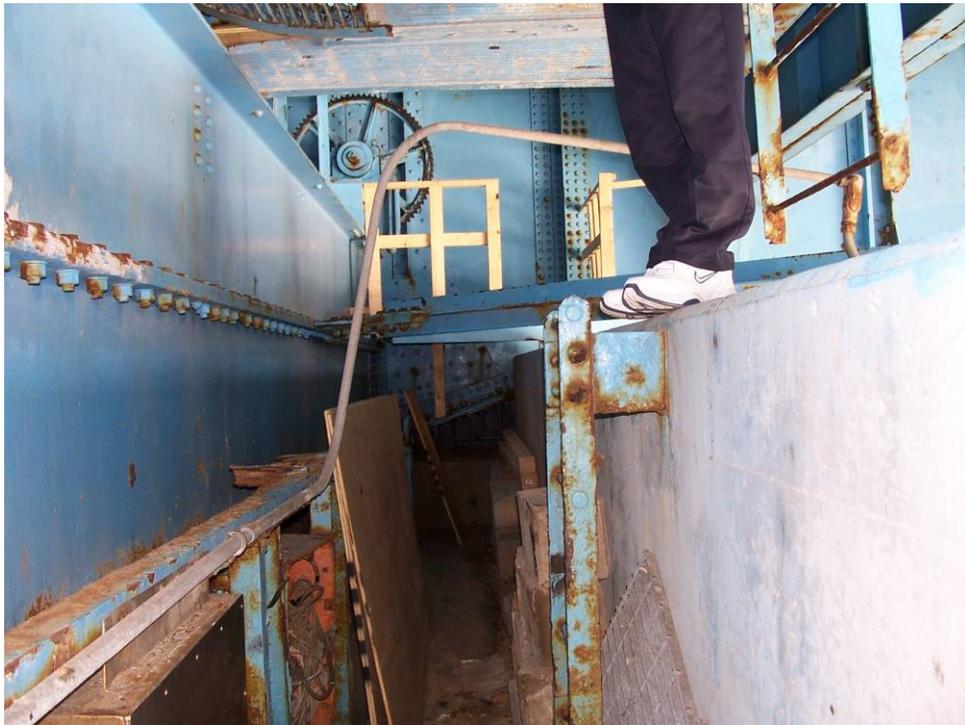
Photograph E21 - Unsupported raceway connecting to Navigational light.

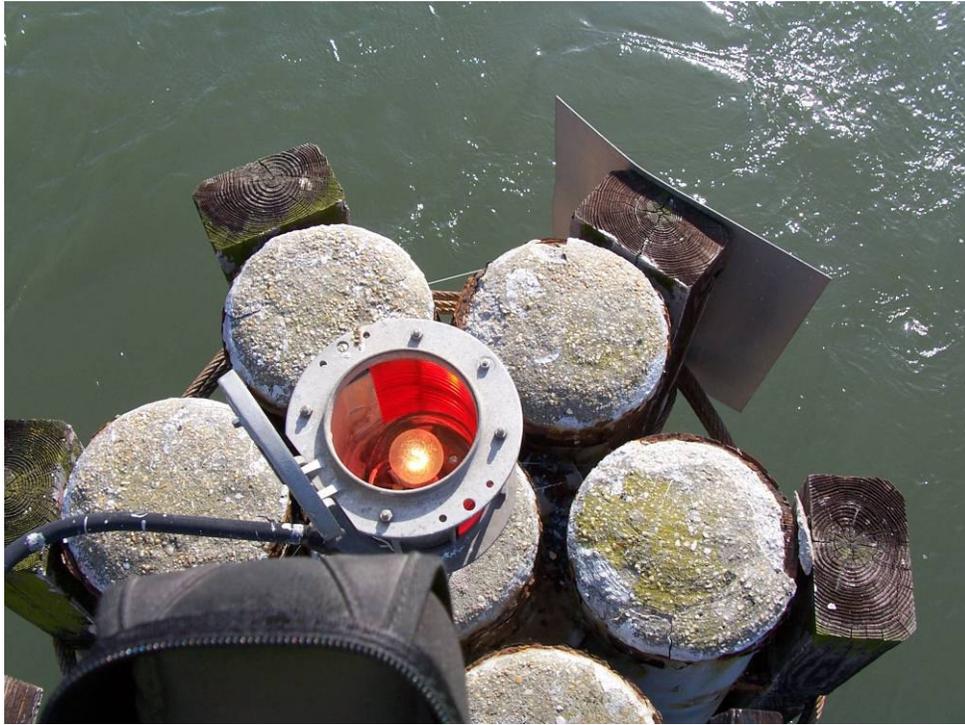
Photograph E25 - Navigation light on South west Fender with its lid locking Latch broken.

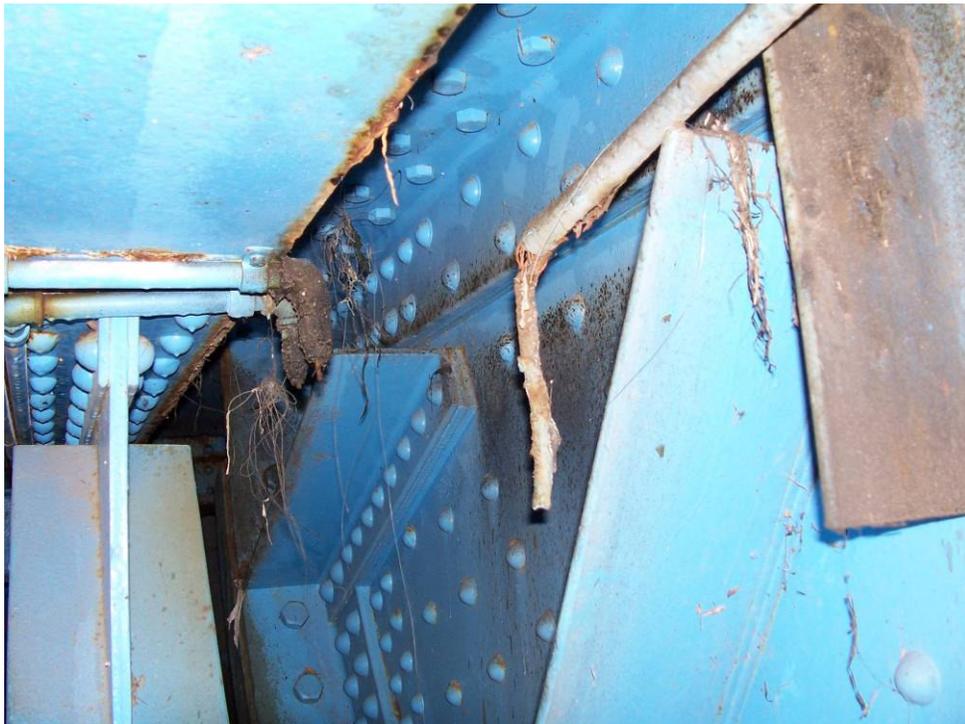
Photograph E26 - Abandoned Raceway and cables located on Far Span on North West side
