# MD 24 Slope Remediation Projects- Section A

Advisory Committee Meeting  
March 12, 2014

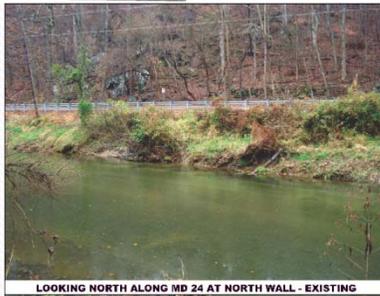
LOOKING NORTH ALONG MD 24 AT NORTH WALL - EXISTING

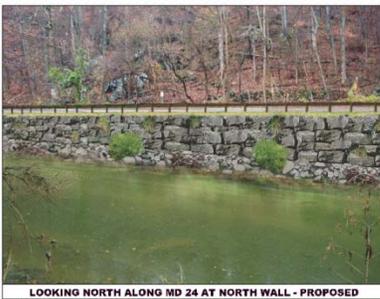
LOOKING NORTH ALONG MD 24 AT NORTH WALL - PROPOSED

## Northern imbricated wall:

- 500' long and 6-9' tall
- Two rolls of imbricated stones
- Concrete footing to bedrock: 16' deep in max
- Vegetated bench at the toe of the wall

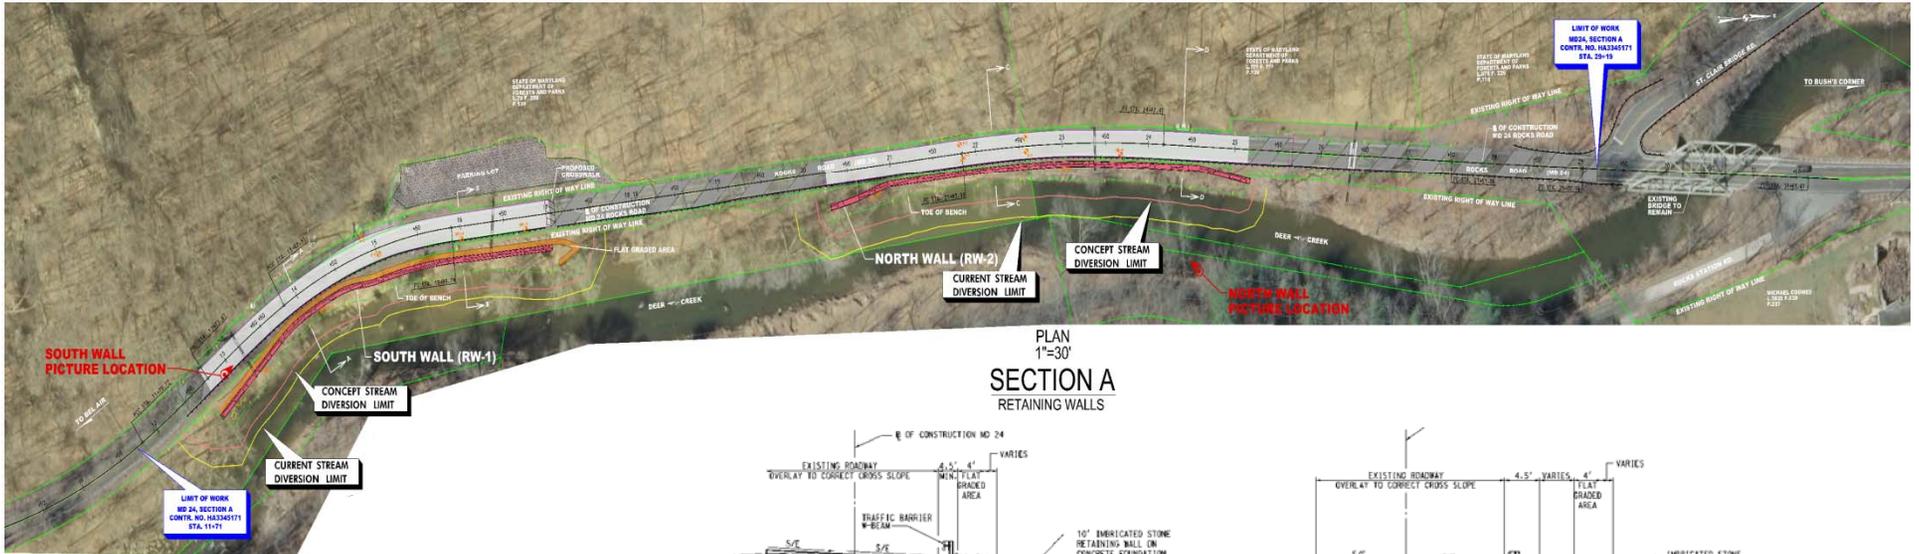
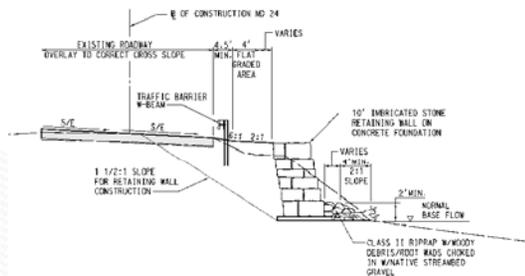
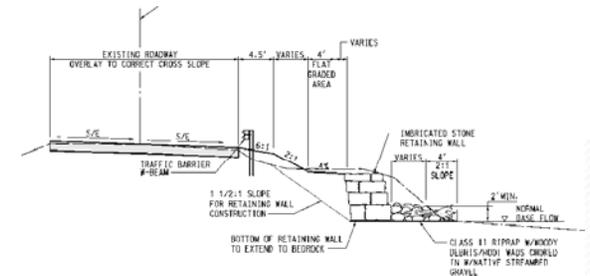
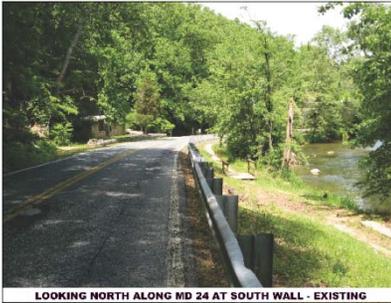
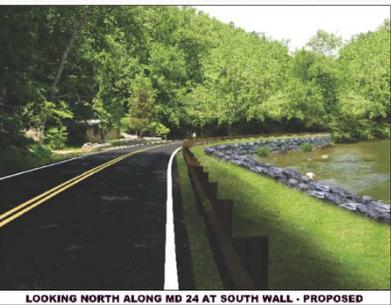
## Southern imbricated wall:

- 430' long and 3-9' tall
- Two rolls of imbricated stones
- Concrete footing to bedrock: 12' deep in max.
- Vegetated bench at the toe of the wall
- Flat grading area on the top

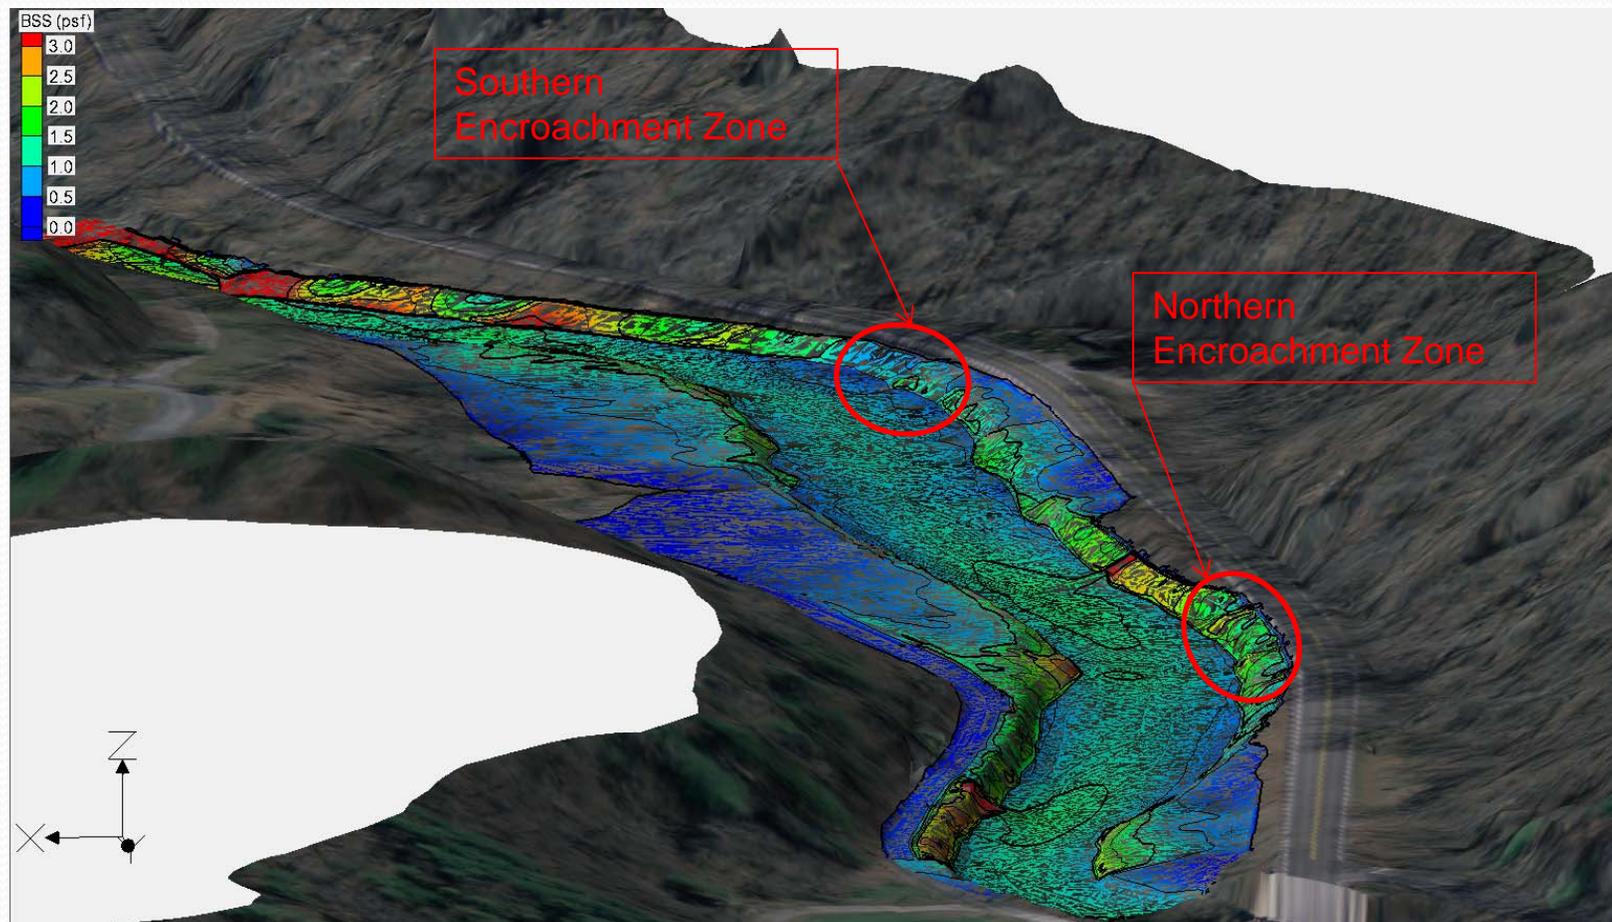
Existing Condition 6870 cfs Flow Boundary Shear Stress -Peak charge reported on Sept 30, 2010 storm

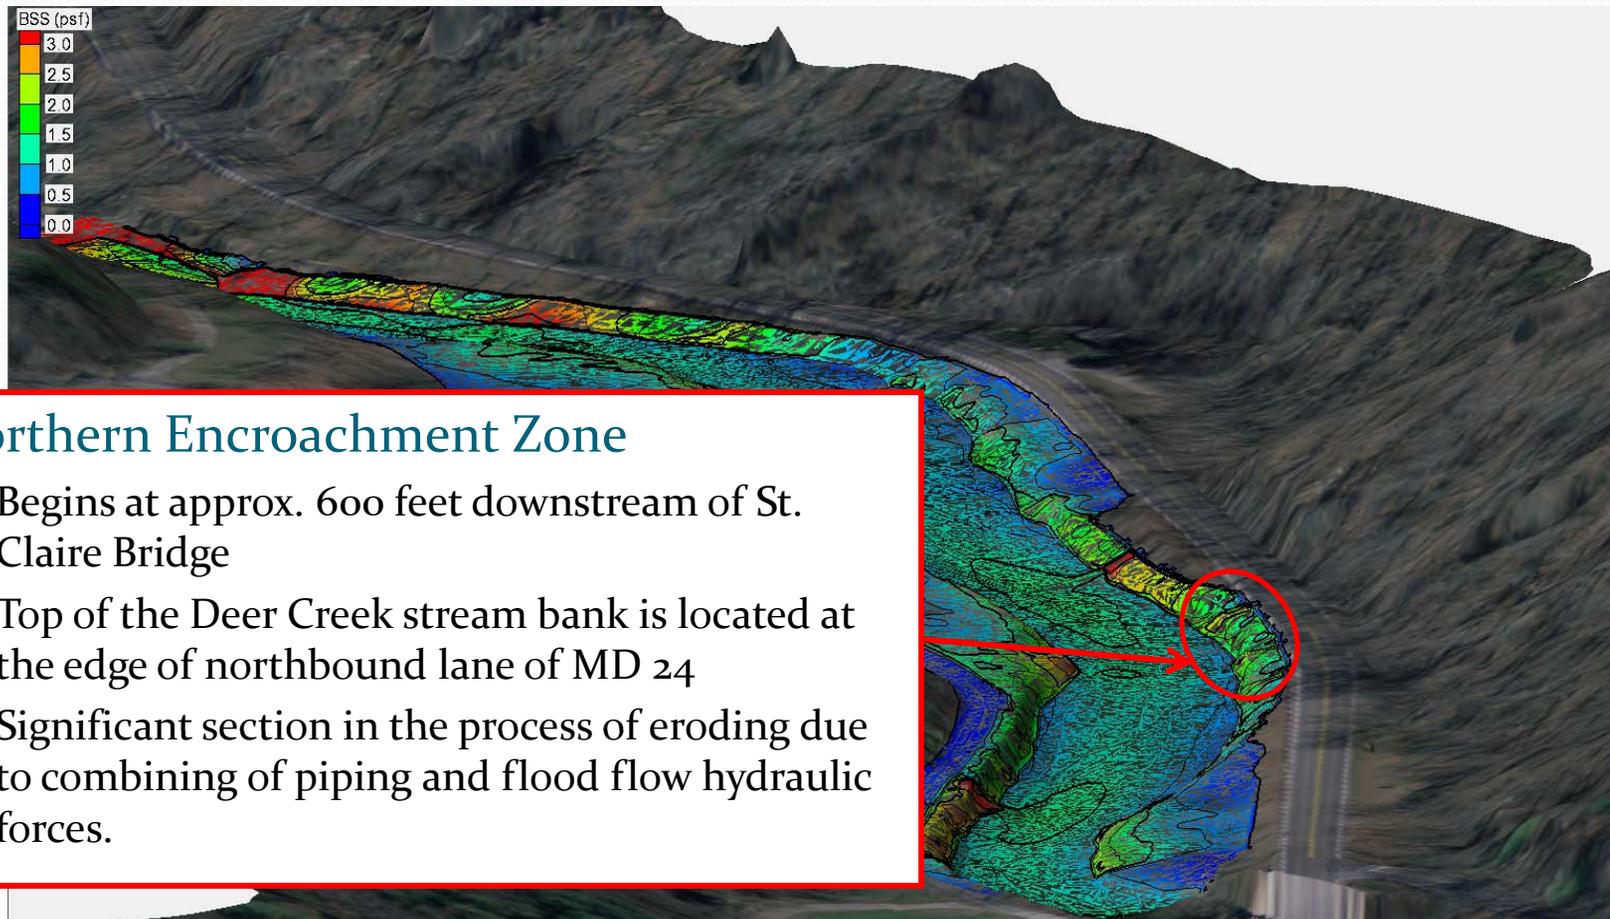
## Northern Encroachment Zone

- Begins at approx. 600 feet downstream of St. Claire Bridge
- Top of the Deer Creek stream bank is located at the edge of northbound lane of MD 24
- Significant section in the process of eroding due to combining of piping and flood flow hydraulic forces.

Existing Condition 6870 cfs Flow Boundary Shear Stress -Peak charge reported on Sept 30, 2010 storm

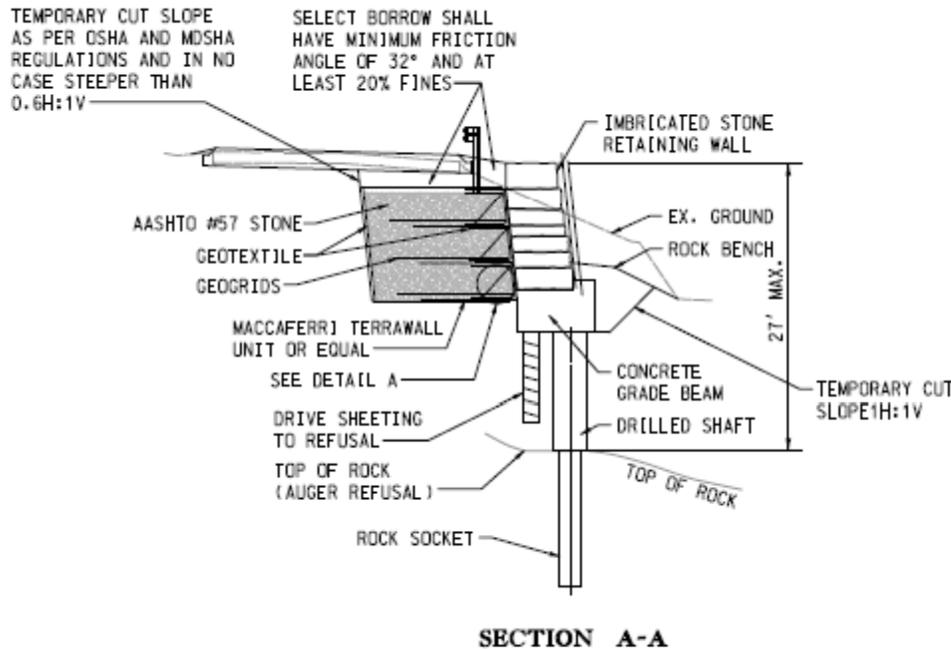
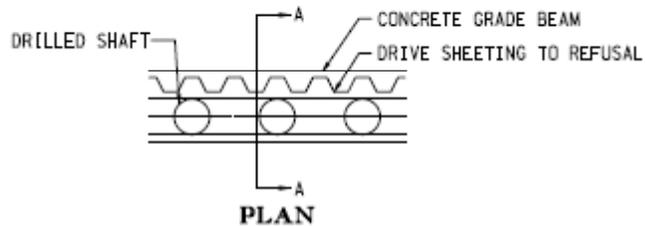
MECHANICALLY STABILIZED EARTH (MSE) WALL WITH IMBRICATED STONE RETAINING WALL ON CONCRETE PIER CAP WITH DRILLED PILES.

## Wall Foundation:

- Rock socket shaft
- Sheeting behind the shaft
- Concrete cap

## Wall Components:

- Geogrid Primary Reinforcement
- Terramesh wall System
- Geotextile fabric
- Imbricated Stones (one roll)

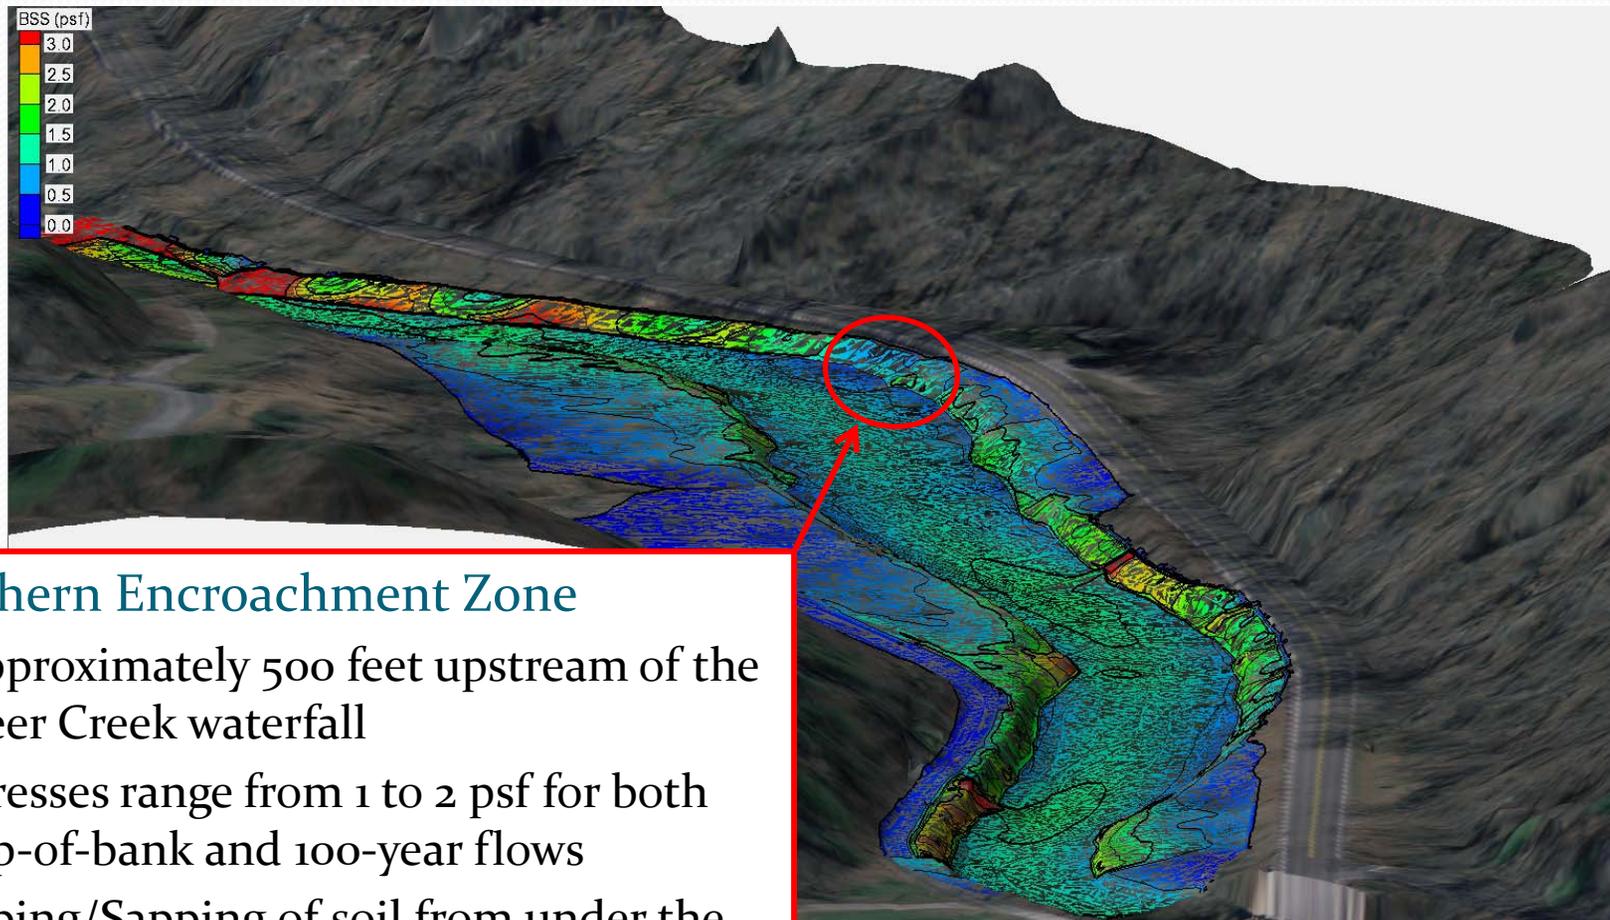
## Southern Encroachment Zone

- Approximately 500 feet upstream of the Deer Creek waterfall
- Stresses range from 1 to 2 psf for both top-of-bank and 100-year flows
- Piping/Sapping of soil from under the MD 24

Peak Stress - Peak charge reported on Sept 30, 2010 storm

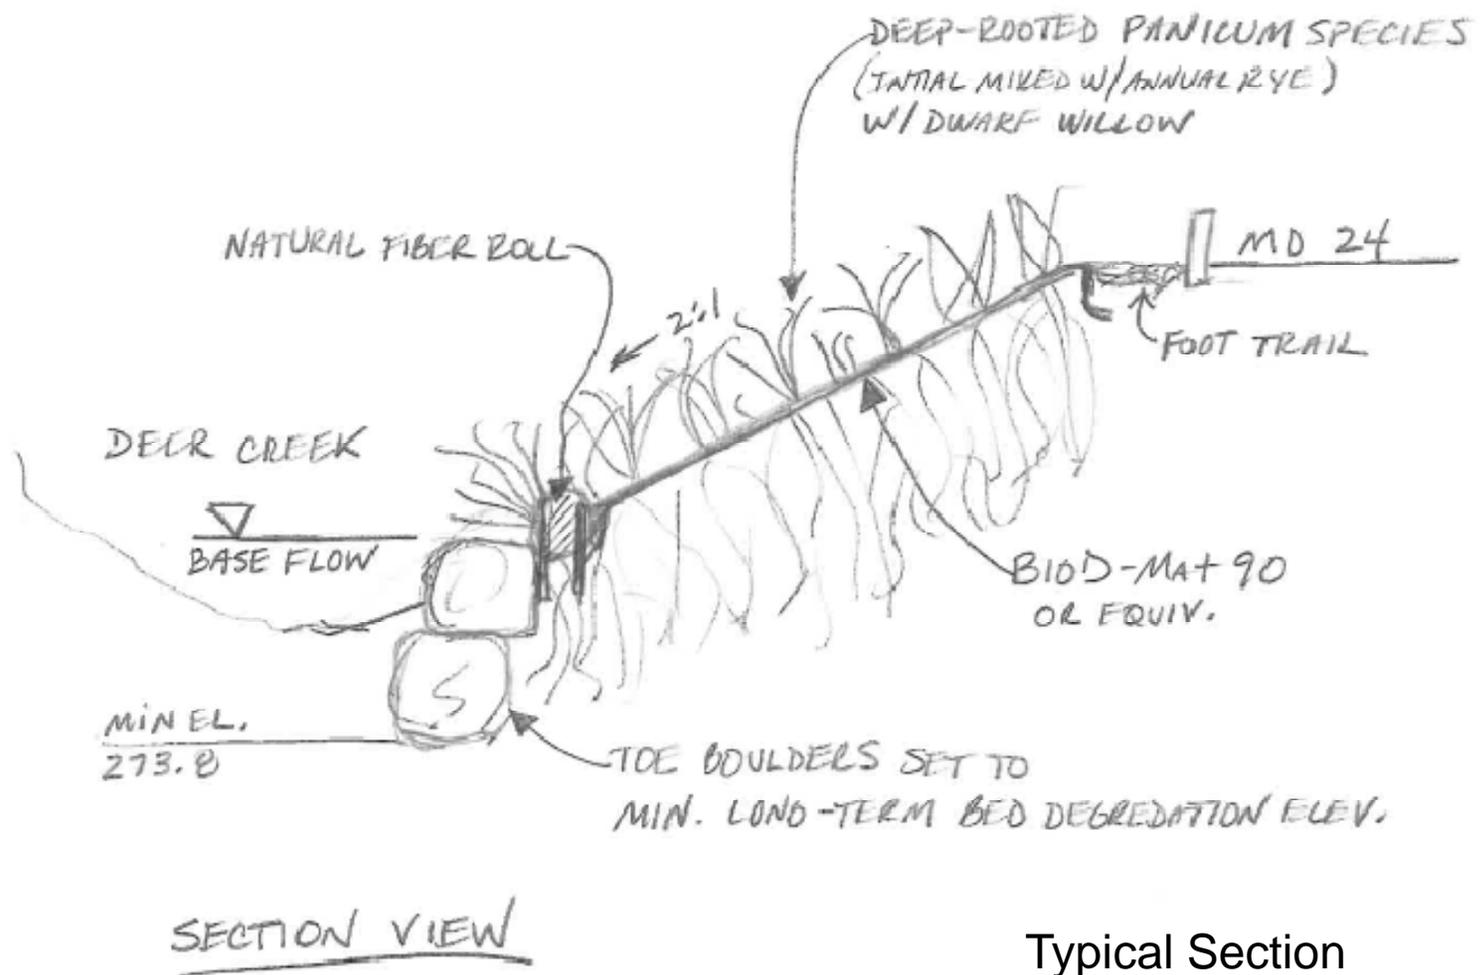
Typical Section

Project DEER CREEK @ MD 24 Job No. \_\_\_\_\_ of \_\_\_\_\_  
 Subject SOUTH WALL CONCEPT Sheet No. \_\_\_\_\_ Date \_\_\_\_\_  
 Computed By Fb Date 9/29/14 Checked By \_\_\_\_\_

- Significantly reduced environmental impacts
- Significantly reduced groundwater piping
- Perform future monitoring a given period to ensure the slope stability remains

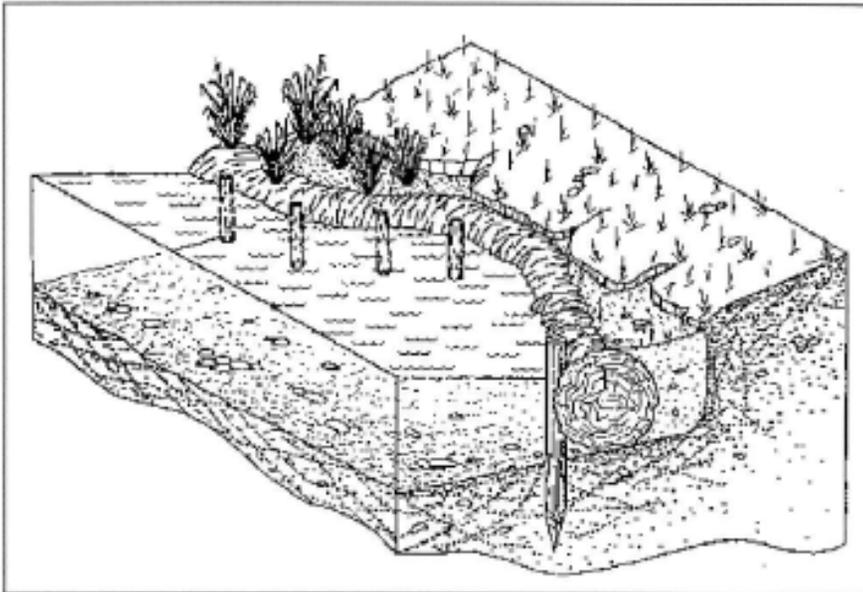
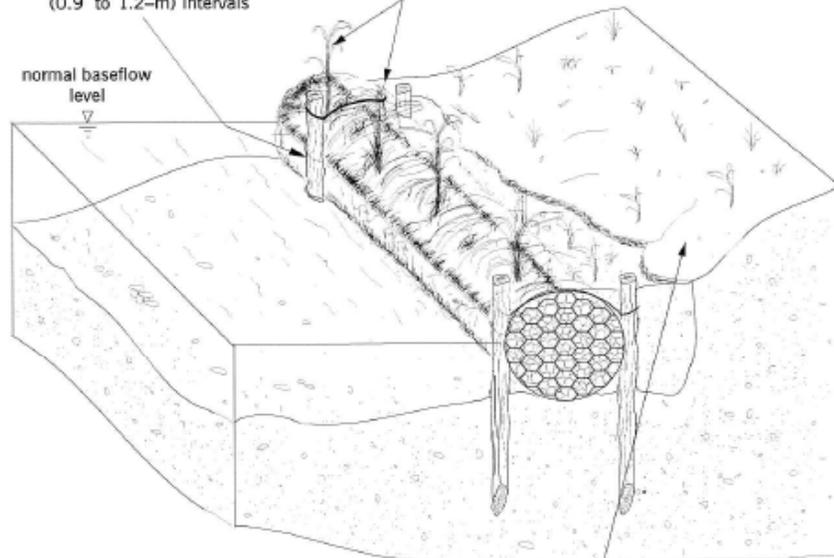
## Maryland's Guidelines To Waterway Construction DETAIL 2.6: NATURAL FIBER ROLLS

live or dead stakes, min. 3-ft (0.9-m) length, notched for twine or rope and spaced at 3 to 4-ft (0.9 to 1.2-m) intervals

plugs recommended by a plant specialist and spaced at appropriately – generally at 6 to 12-in (15 to 30-cm) intervals

slope shall be backfilled and protected with temporary erosion control measures until permanent vegetation is established

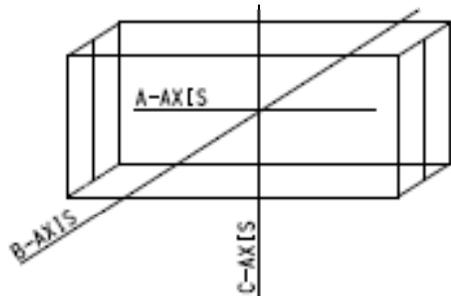
**IMBRICATED STONE**

ROCK SIZE	A-AXIS	B-AXIS	C-AXIS
MINIMUM SIZE, FEET	3.5	1.5	1.5
MAXIMUM SIZE, FEET	4	3	2

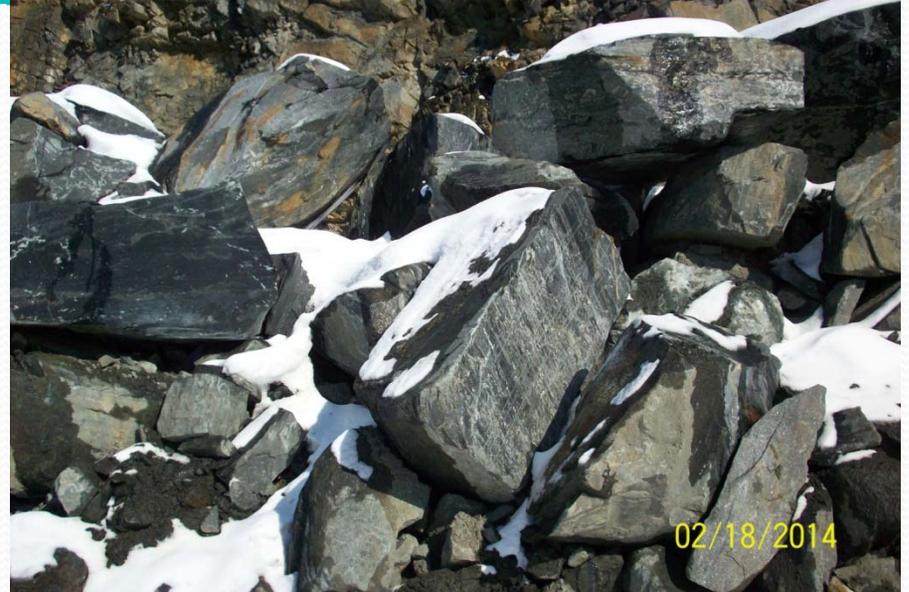
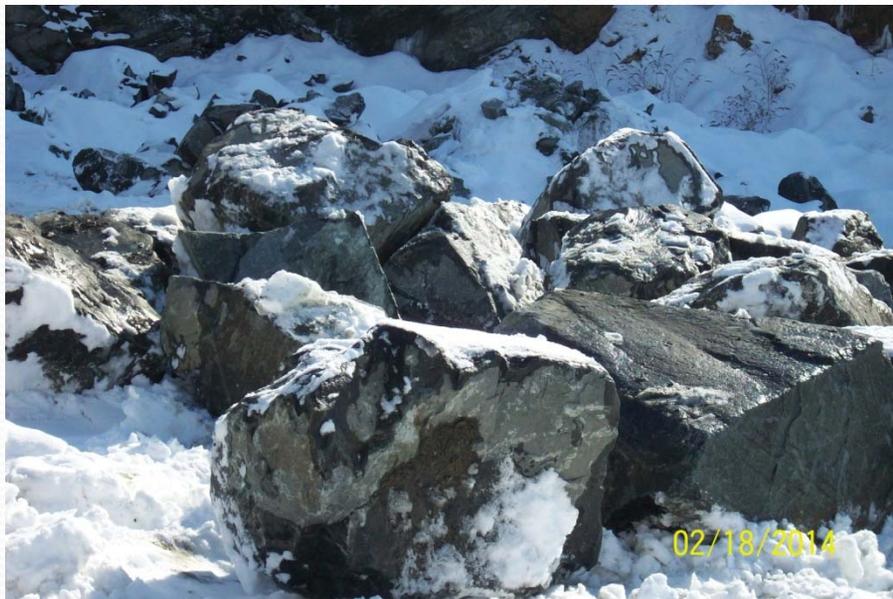
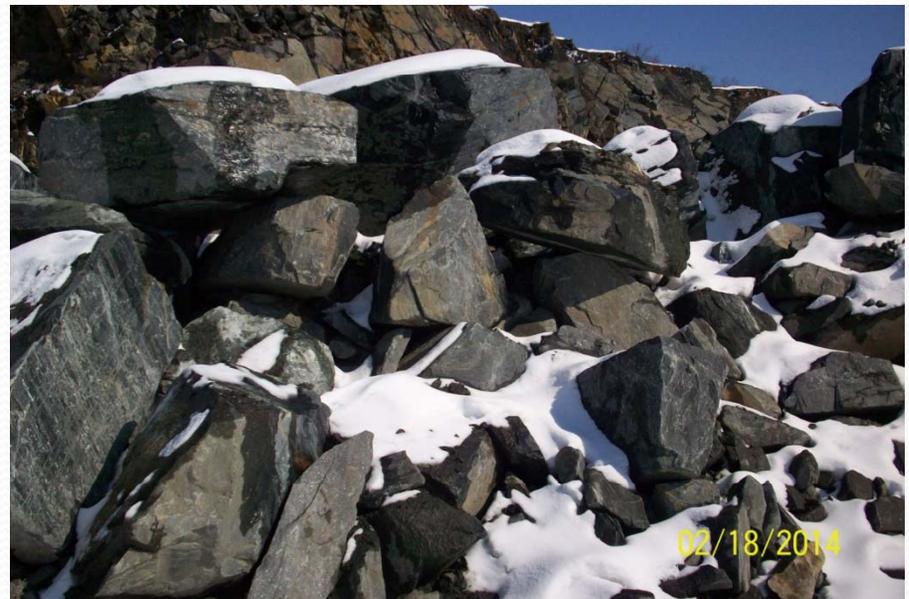
James Run Gneiss in Lafarge Churchville Quarry, Churchville, Maryland

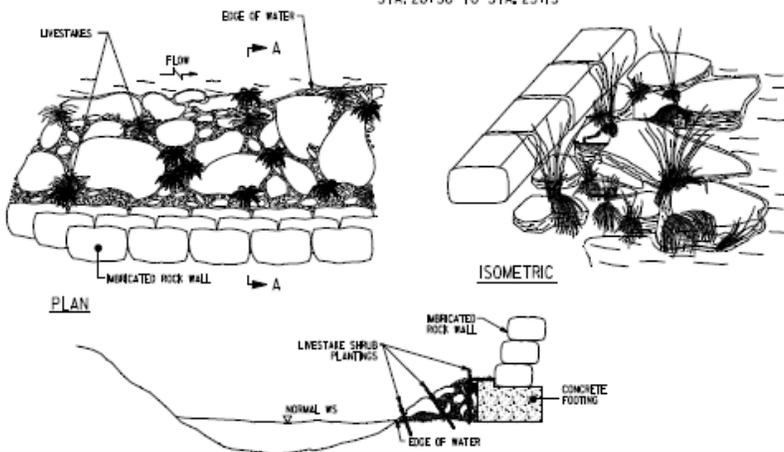
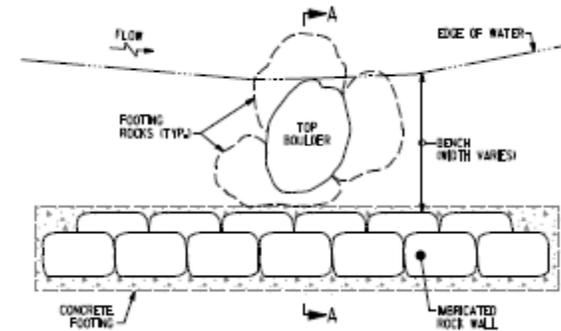
## BOULDER CLUSTER DETAIL

N.T.S.

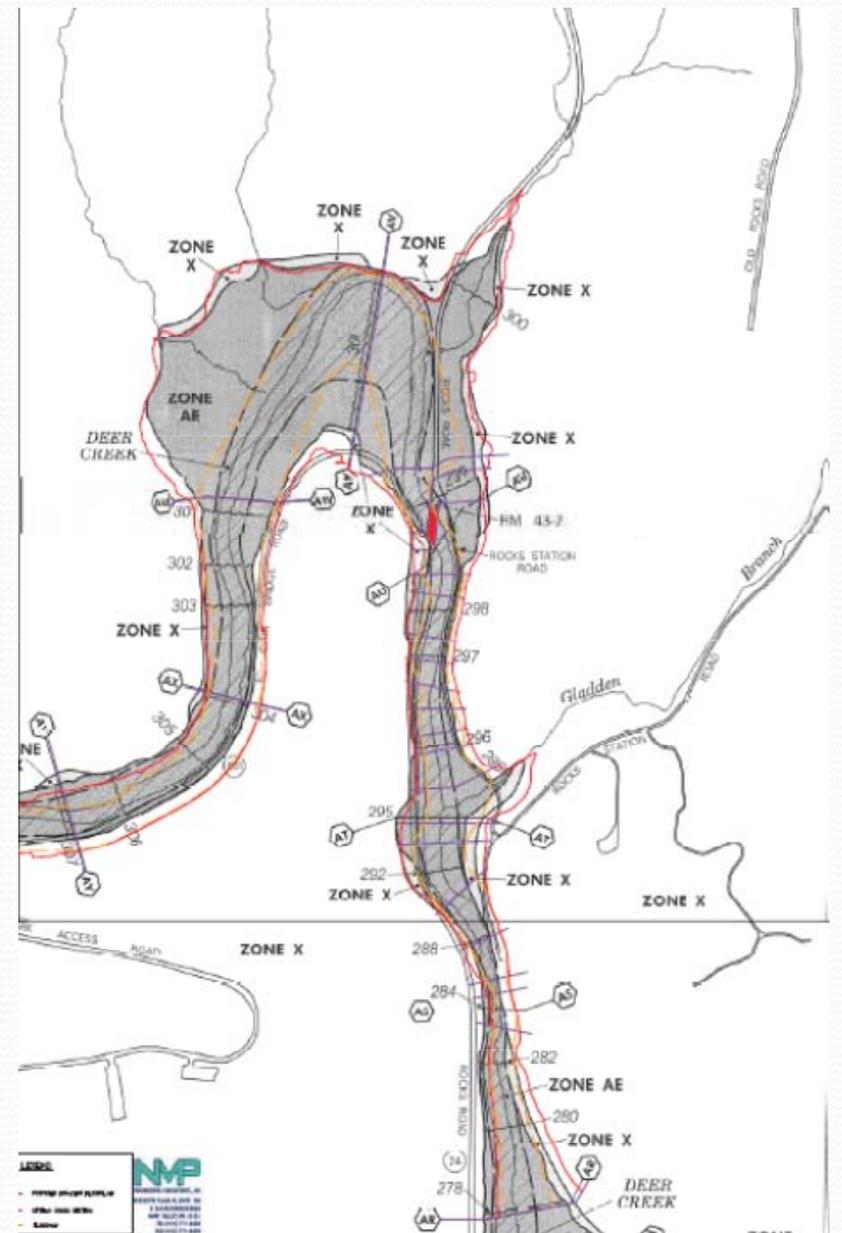
## Hydraulic Analysis for FEMA

- Revised floodplain boundary based on our Re-Study of Existing Conditions
- No “mappable” difference between our existing floodplain and the proposed floodplain - the increase in base flow elevation (100-year water surface elevation) is 0.36 inch (<math><3/8\text{''}</math>) for the FEMA model
