2007 Bridge Inspection Report

MARYLAND DEPARTMENT OF TRANSPORTATION
STATE HIGHWAY ADMINISTRATION
BRIDGE INSPECTION AND REMEDIAL ENGINEERING DIVISION
STRUCTURAL / MECHANICAL / ELECTRICAL
2007 BRIDGE INSPECTION REPORT

BRIDGE NO. 2300700
MD ROUTE 50 OVER SINEPUXENT BAY
WORCESTER COUNTY, MARYLAND

MODJESKI AND MASTERS, INC
CONSULTING ENGINEERS
HARRISBURG, PENNSYLVANIA

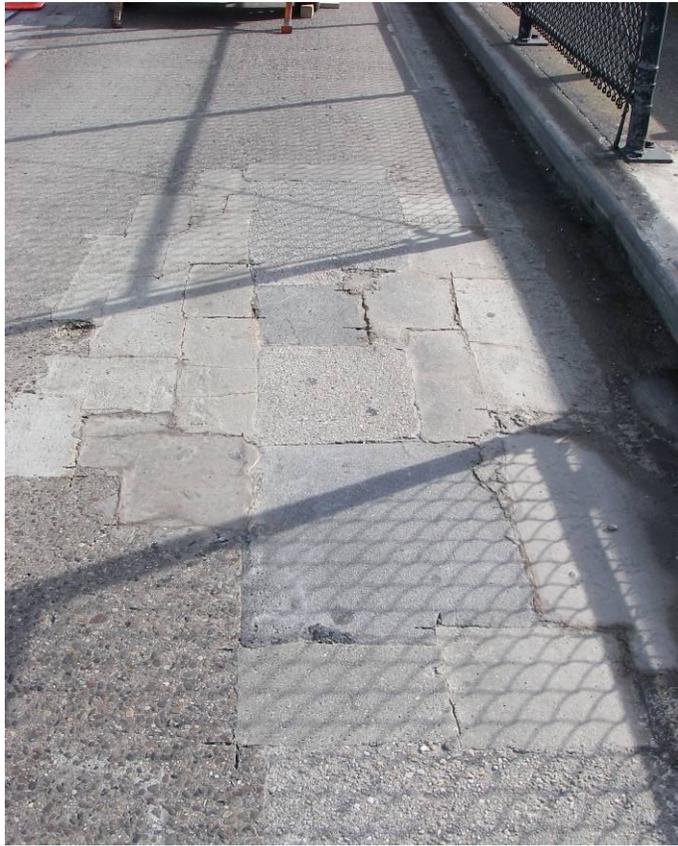
Photograph S11 - Span Unit 6.
View of a 12'-0" x
12'-0" area of
patches that
exhibit hairline
transverse crack
in Lane 4, 60'-0"
from the east
joint.

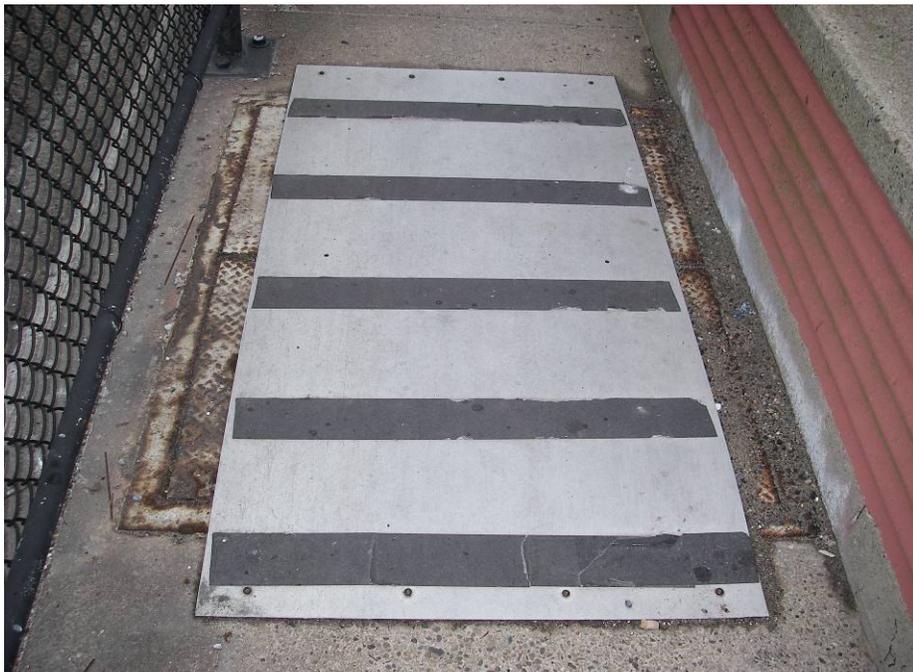
Photograph S22 - View of bascule access hatch bolted cover plates in the north sidewalk.

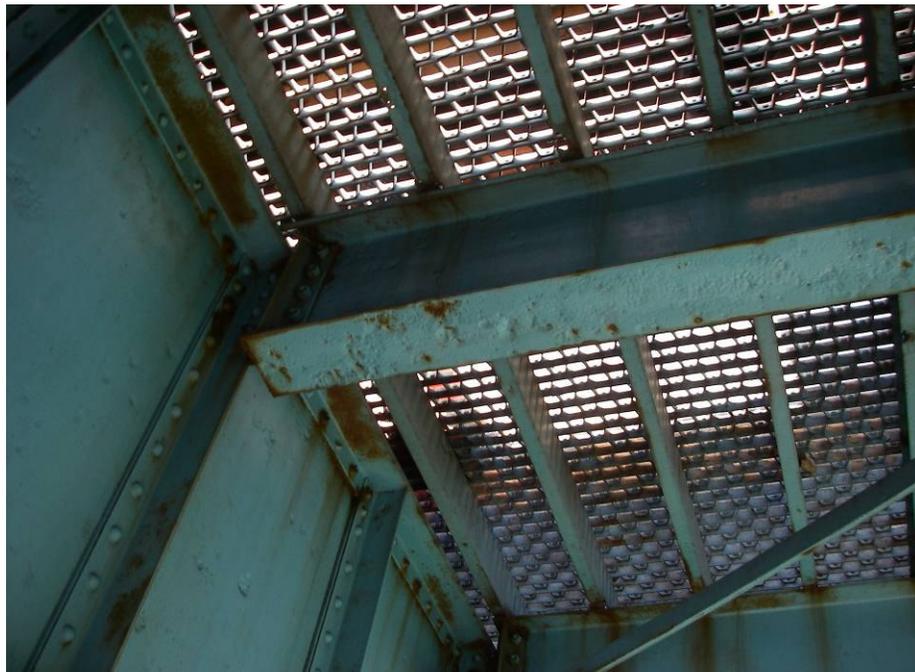
Photograph S34- Stringer 5, Floorbeams 2 to 3, east bascule leaf. View of typical pitting and corrosion on the bascule span stringers.

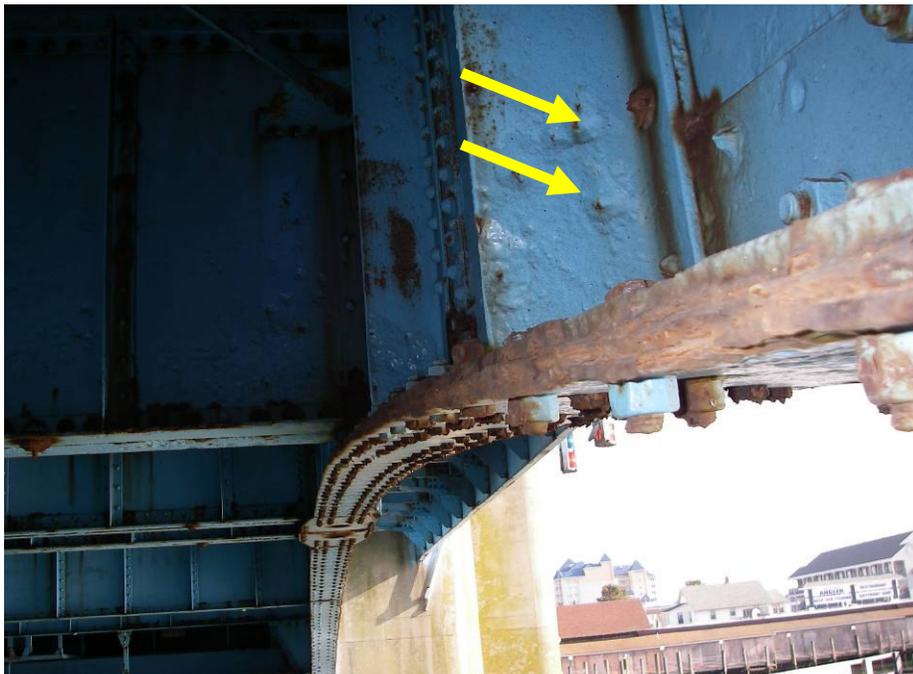
Photograph S38 - South bascule girder, west leaf, north edge. View of the minor to moderate corrosion, corrosion holes (arrows), and pitting.

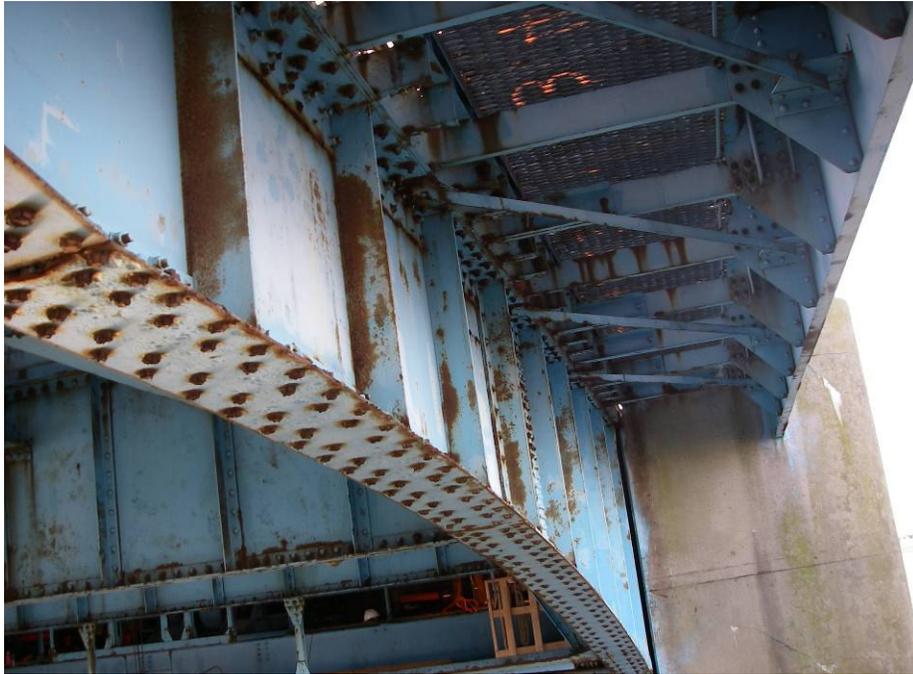
Photograph S39 - North bascule girder, west leaf, north edge. View of the minor to moderate corrosion.

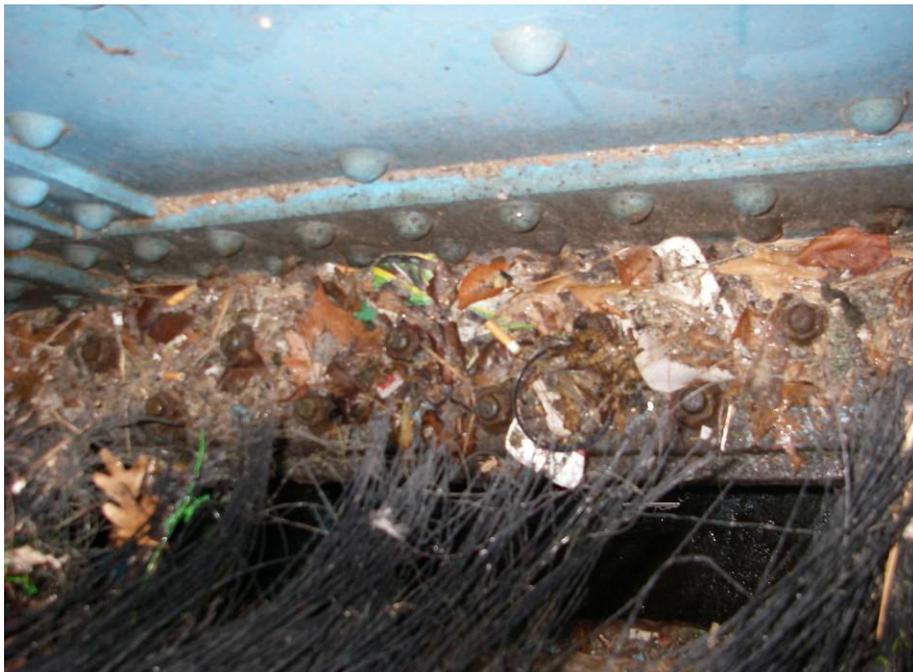
Photograph S40 - South bascule girder at rack girder, west leaf. View of the accumulation of debris on the bottom flange.

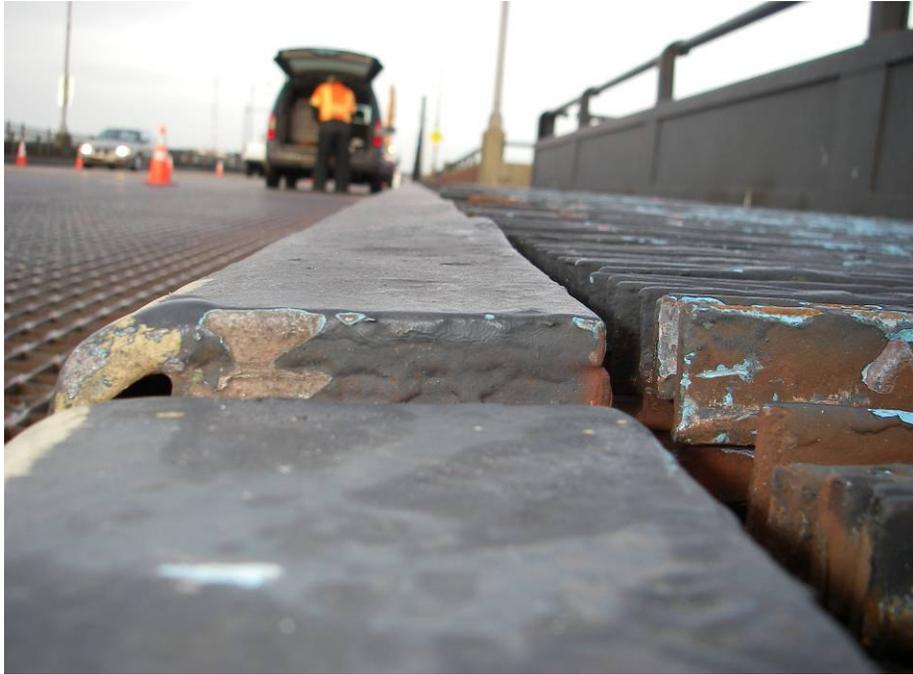
Photograph S41 - North lane west leaf. View of the approximate 1/2" height difference between the west leaf and the east leaf.

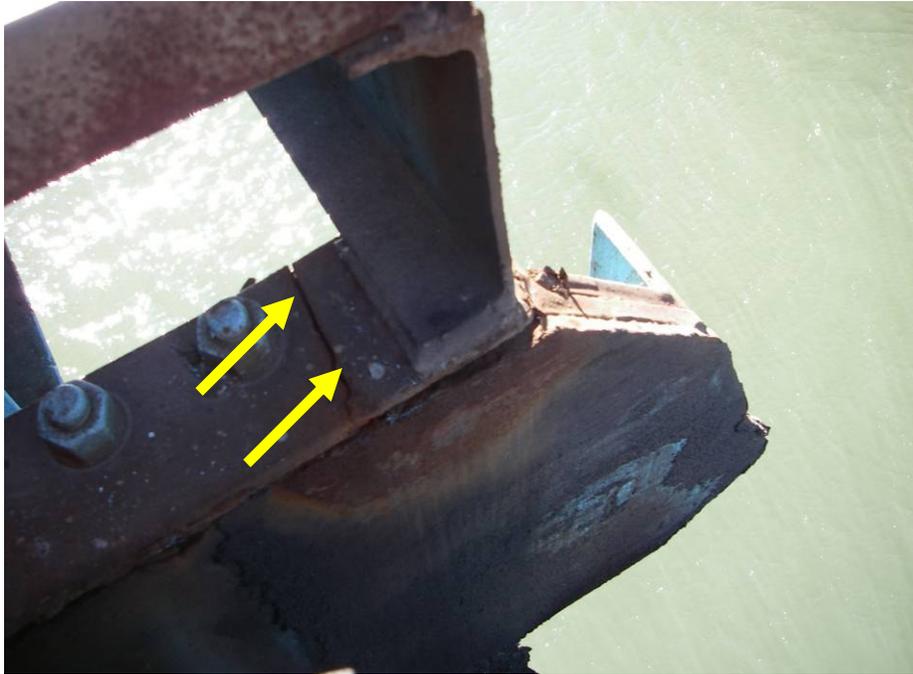
Photograph S43 - North bascule girder, north interlock. View of the crack in the roadway channel support plate (arrows).

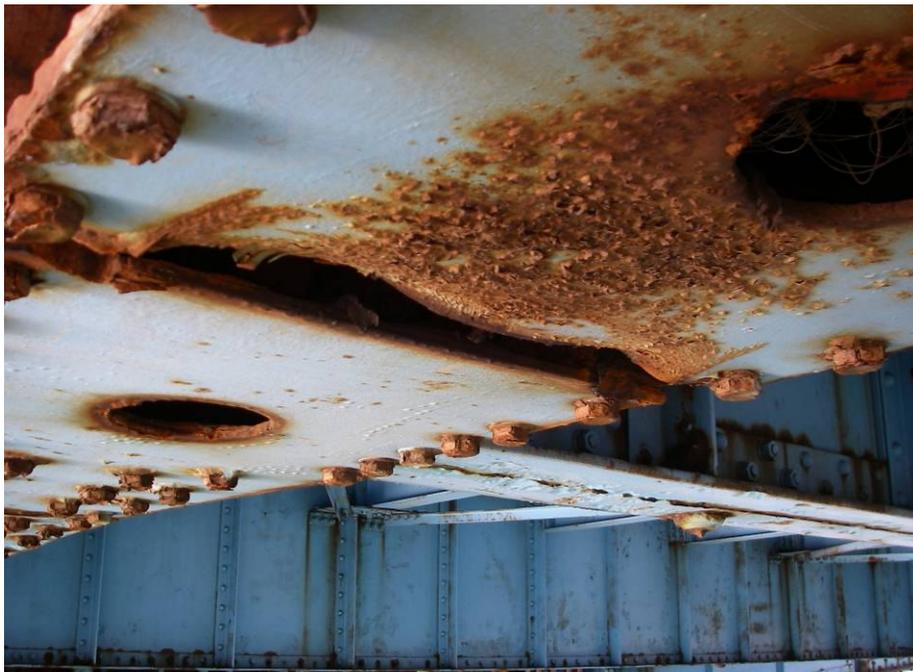
Photograph S44 - South bascule girder, south interlock. View of the minor impact damage. The north interlock has identical impact damages.

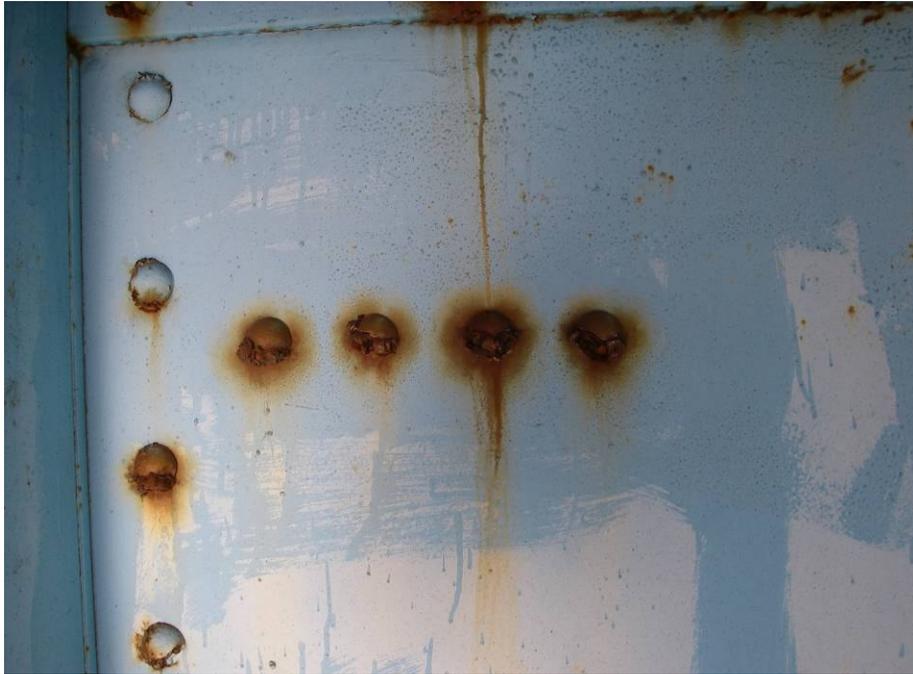
Photograph S45 - South bascule girder, west leaf, south face of the web. View of the typical deteriorated condition of the fastener heads.

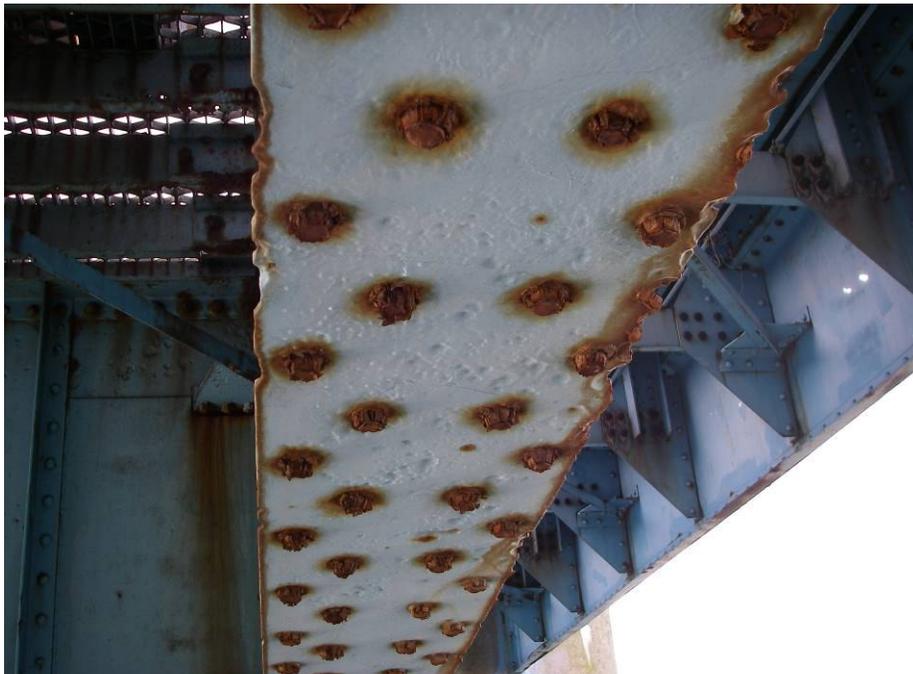
Photograph S46 - North bascule girder, east leaf, bottom flange. View of the typical deteriorated condition of the exposed portions of the fasteners.

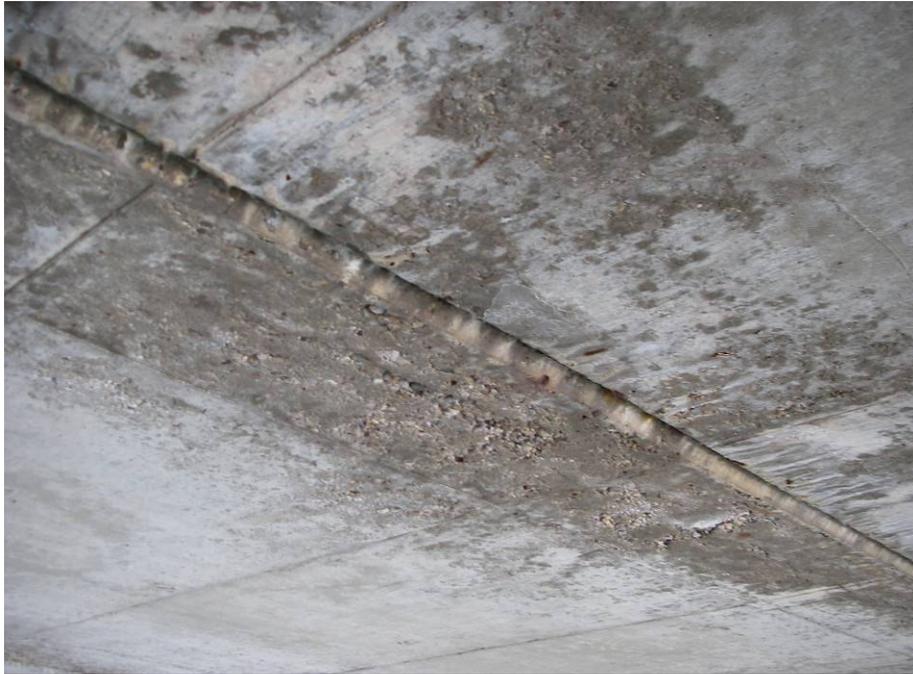
Photograph S47 - Span 15, 2nd longitudinal construction joint from the north. View of the typical minor scaling.

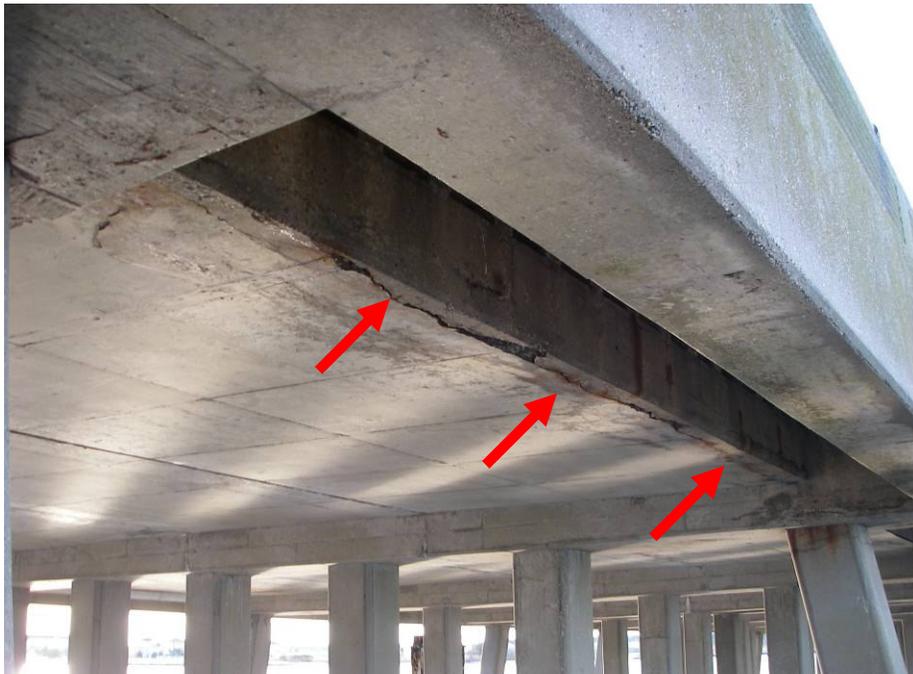
Photograph S48 - Span 17, north edge. View of a typical 3/8" crack (arrows) and surrounding delamination.

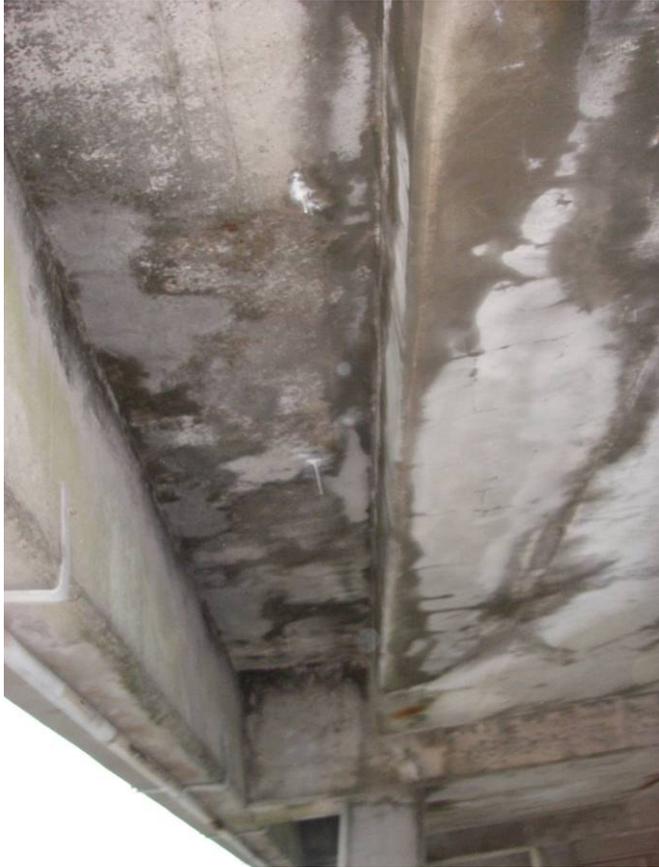
Photograph S49 – Span 33, north sidewalk soffit. View of the typical spalled areas, failed shotcrete repairs, and delamination.

| Immediate Repairs (< 2 years) | | | | |
|---|---|---|---|---|
| Clean and paint exposed reinforcing steel and repair areas of spalled and unsound concrete in the deck soffit | SF | 5500 | 50 | 275,000 |

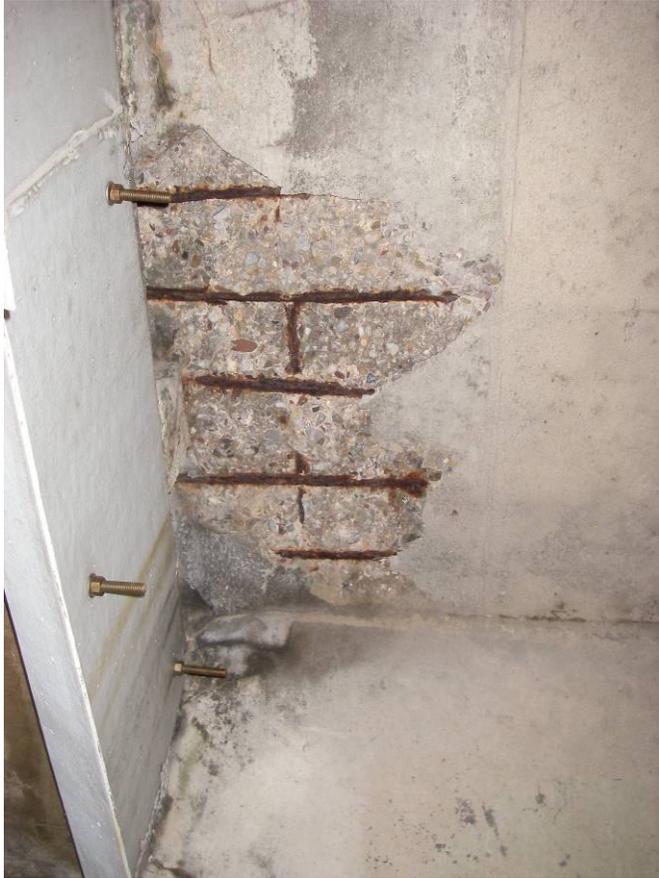
Photograph S50 – Span 51, south sidewalk soffit. View of the typical spalling with exposed reinforcing steel adjacent to fiberglass sheeting.

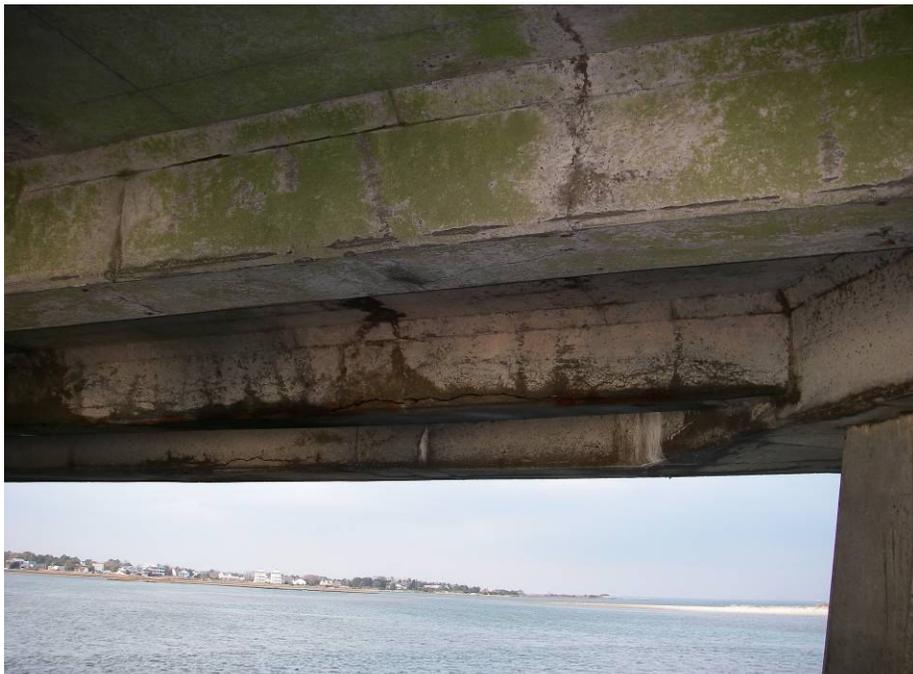
Photograph S53 - Span 74, T-beams 1, 2, and 3. View of severe cracks along the bottom of the beams measuring full length and up to 2" wide with surrounding delamination.

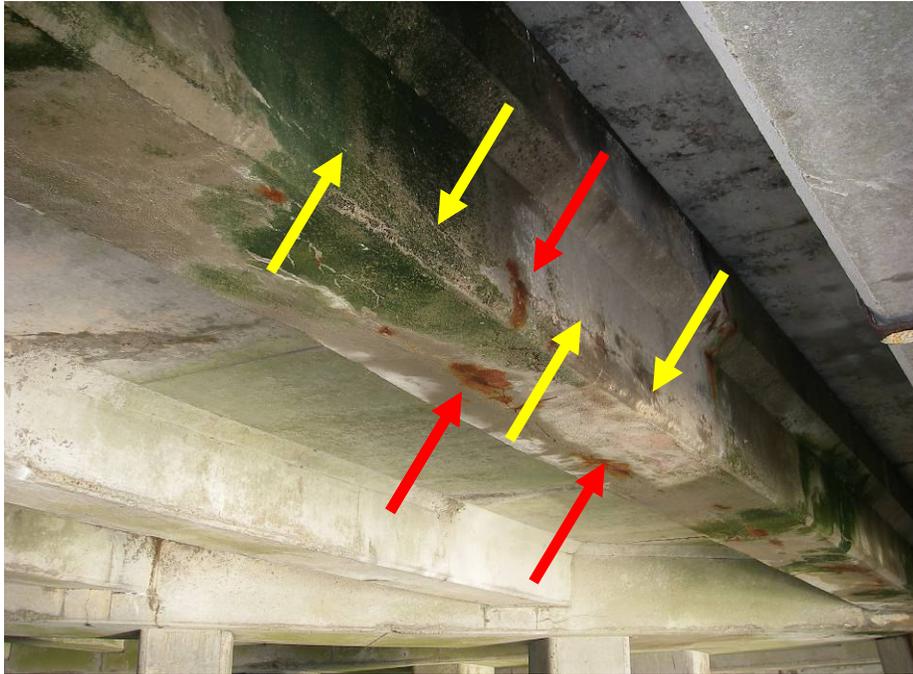
Photograph S54- Span 75, T-beam 8. View of the corrosion staining (red arrows) and hairline cracks (yellow arrows).

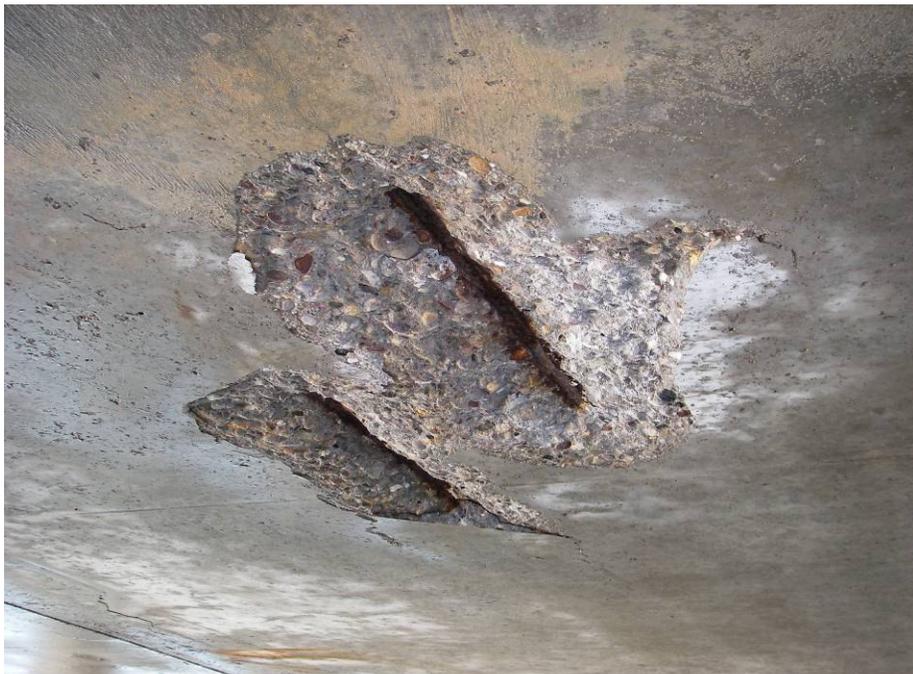
Photograph S55- Span 85, Bent 2 to 3, north edge. View of a 2" wide delaminated area surrounding the 3'-0" diameter x 2" deep spall.

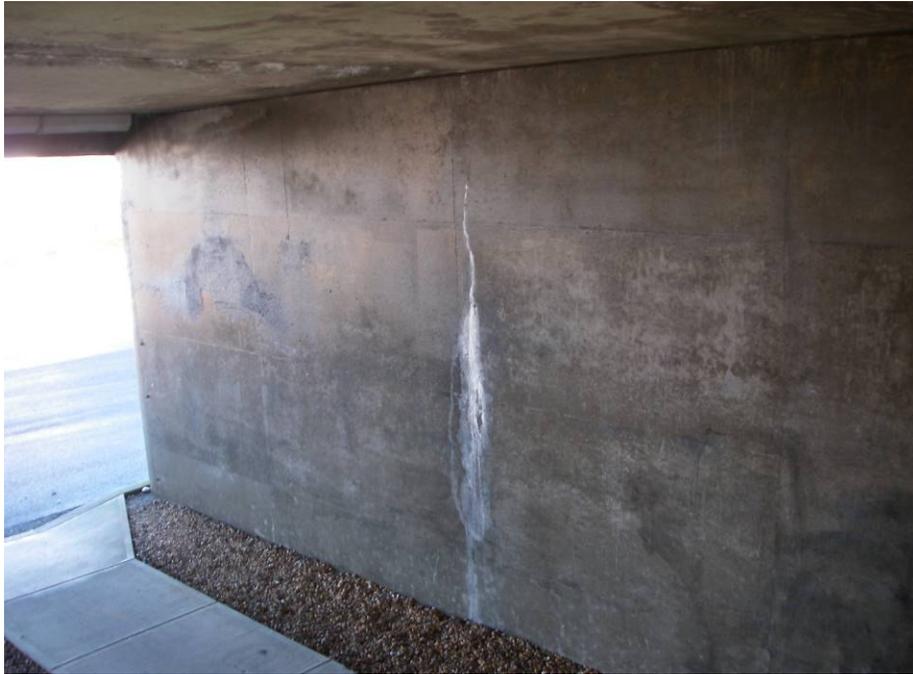
Photograph S58 - East abutment. View of a hairline crack with efflorescence.

| Immediate Repairs (< 2 years) | | | | |
|---|---|---|---|---|
| Seal the cracks in the abutments, piers, and pier caps | LF | 750 | 50 | 37,500 |

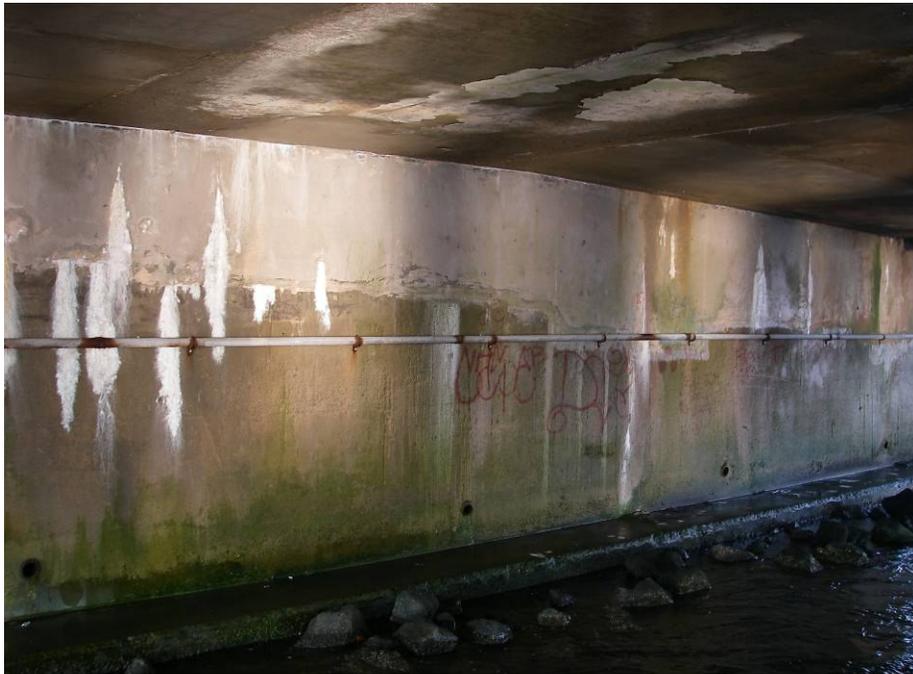
Photograph 59 - West abutment. View of the hairline cracks with efflorescence.

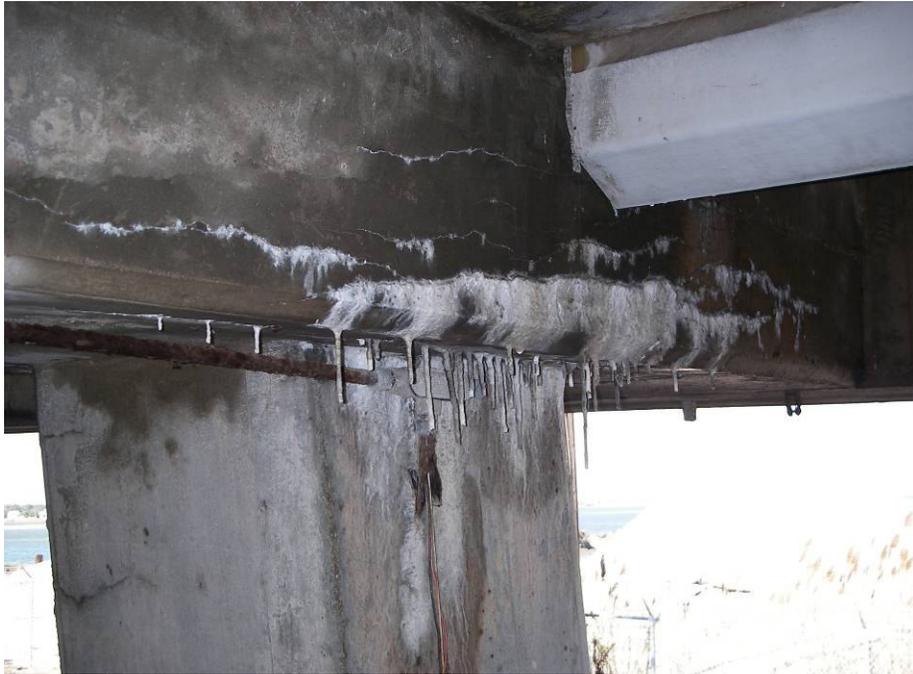
Photograph S60 - Bent 1, Pile 1, east face. View of several minor cracks with efflorescence.

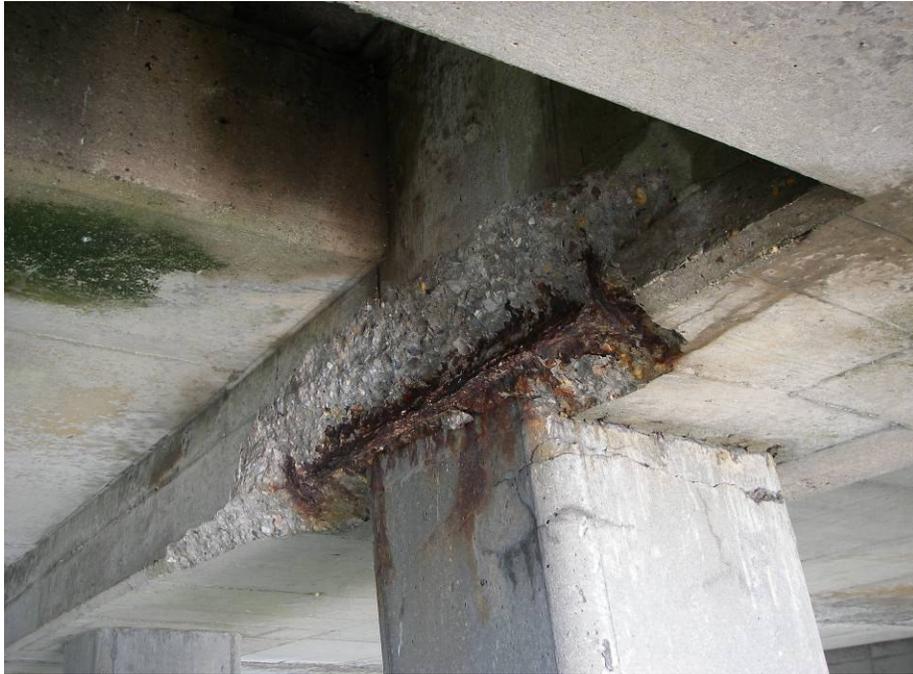
Photograph S62 - Bent 14, Pile 7, west face. View of typical spalling with exposed reinforcing steel.

| Immediate Repairs (< 2 years) | | | | |
|---|---|---|---|---|
| Clean and paint exposed reinforcing steel and repair areas of spalled and unsound concrete in the piers and pier caps | SF | 500 | 50 | 25,000 |

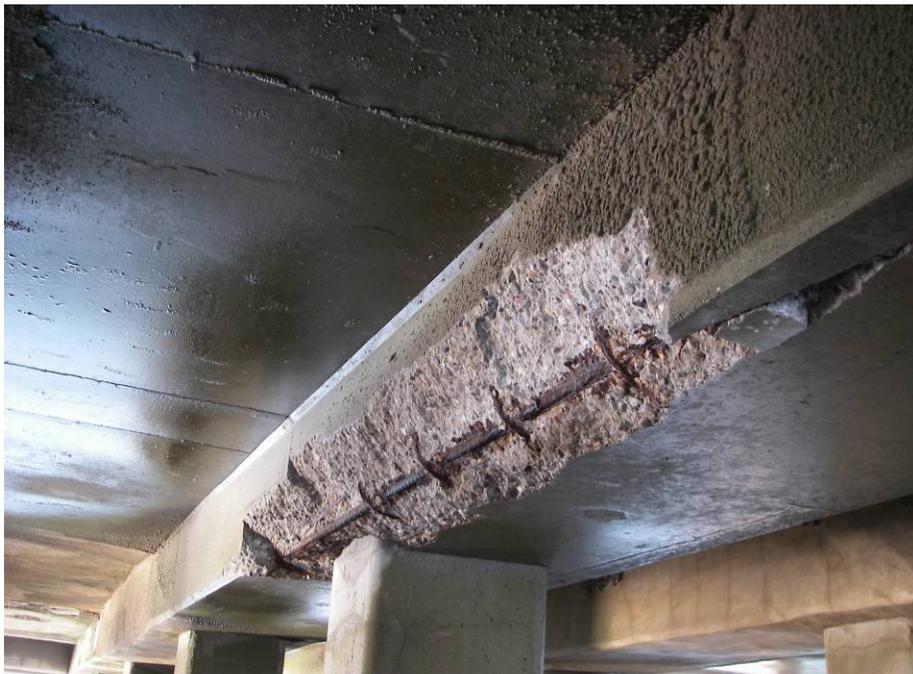
Photograph S63 - Bent 83, Piles 3 to 4, east face. View of large spall with exposed reinforcing steel.

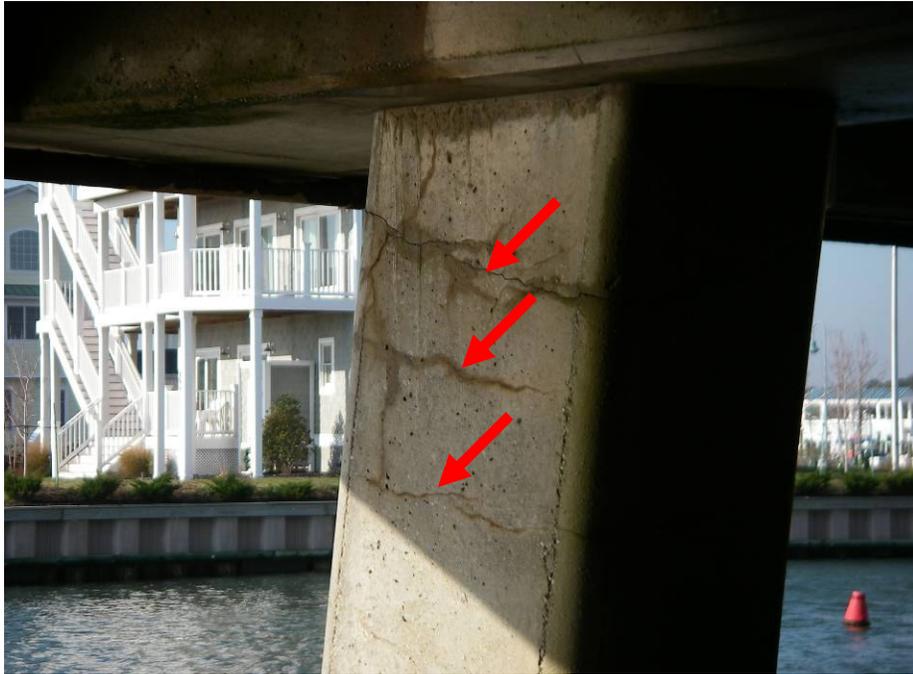
Photograph S64 - Bent 92, Pile 5, east face. View of four typical horizontal hairline cracks (arrows).

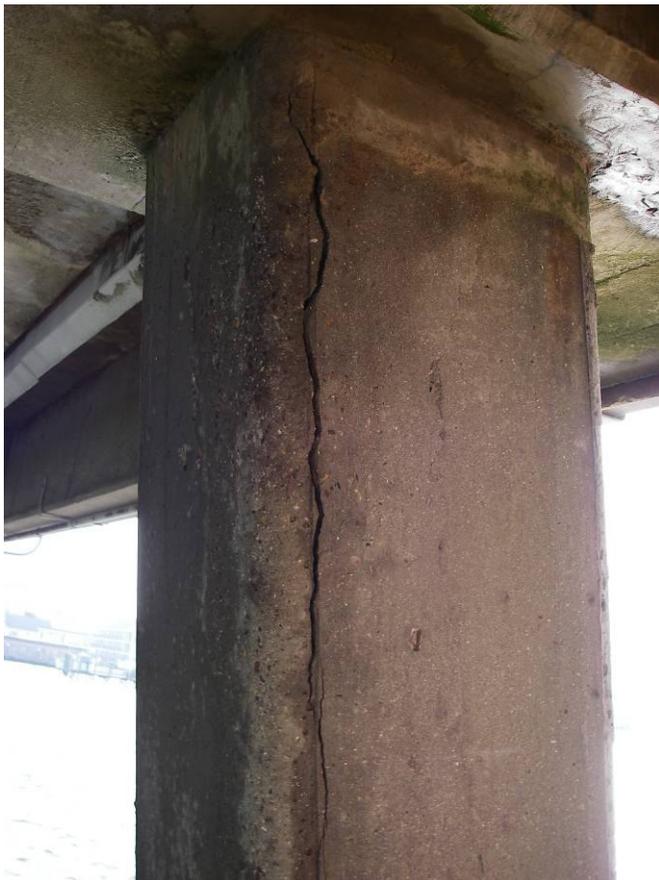
Photograph S65 - Bent 25, Pile 7, west face. View of a 1/16" wide vertical crack.

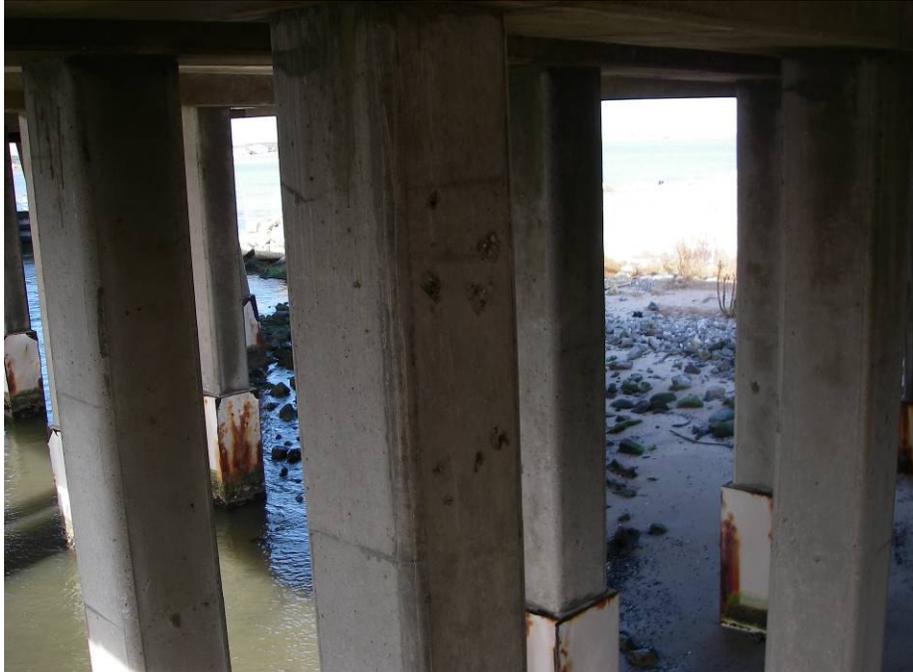
Photograph S66 - Bent 5, Pile 4, east face. View of the minor surface spalls.

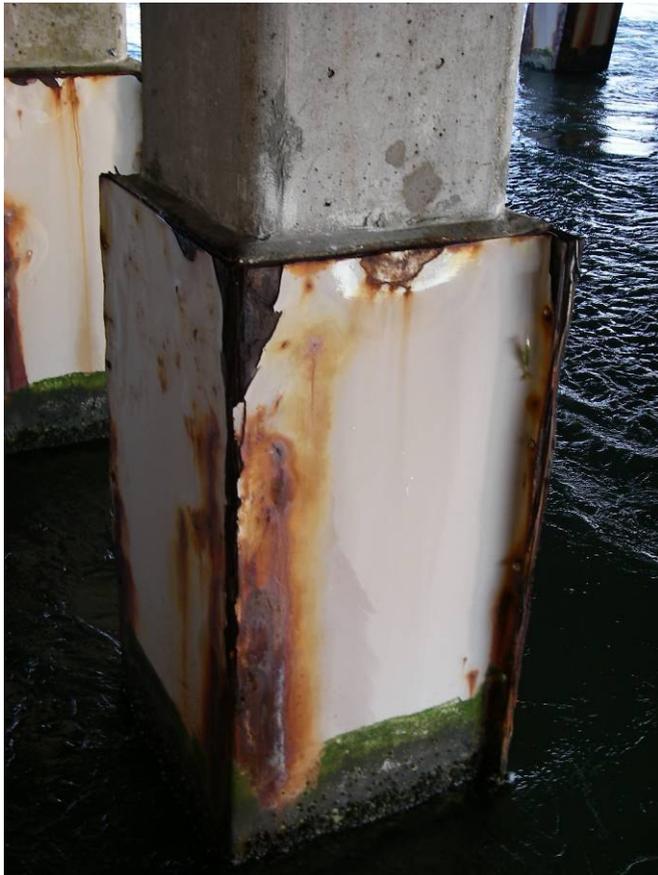
Photograph S67 - Bent 92, Pile 3.
View of typical
severe corrosion of
the pile jacket

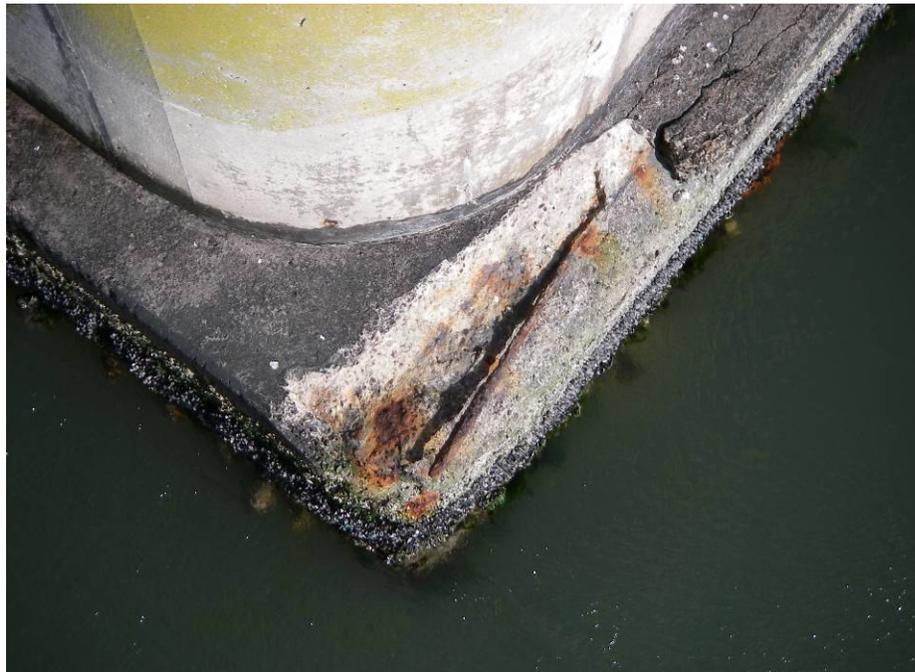
Photograph S69 - West bascule pier, southwest corner. View of the 12" x 4'-0" x 5" deep corner spall with exposed corroded reinforcing steel.

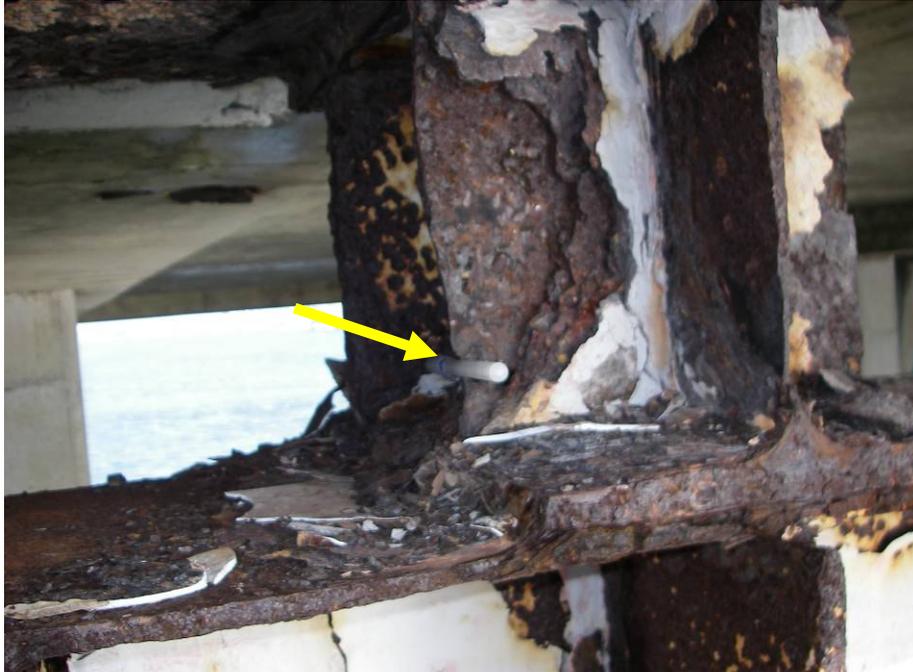
Photograph S72- Bent 19, Pile 5, east upper built-up W-section. View of the severe section loss. A pen was placed in the 100% thickness loss area (arrow).

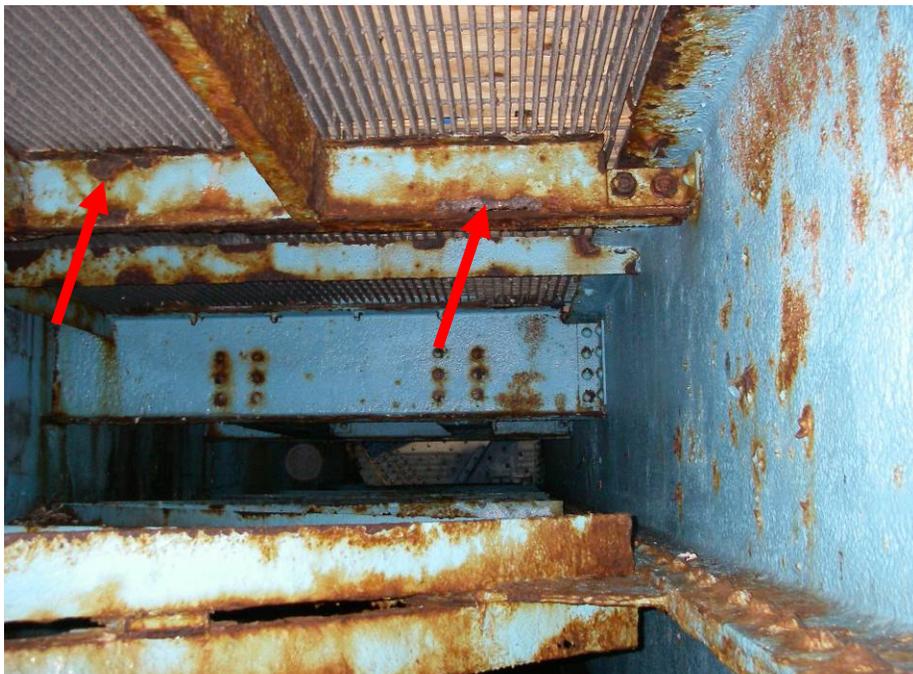
Photograph S73- Machinery platform, west bascule pier, south of bridge centerline. View of the large amount of severe corrosion, and section loss with holes (arrows).

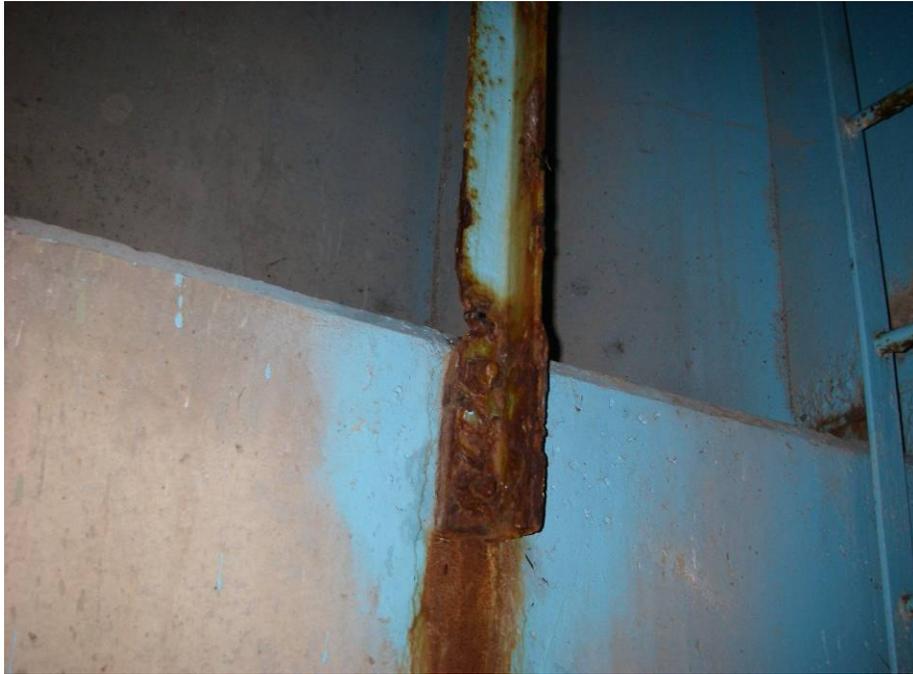
Photograph S74 - East bascule pier, east handrail. View of the large amount of section loss near the connection to the pier.

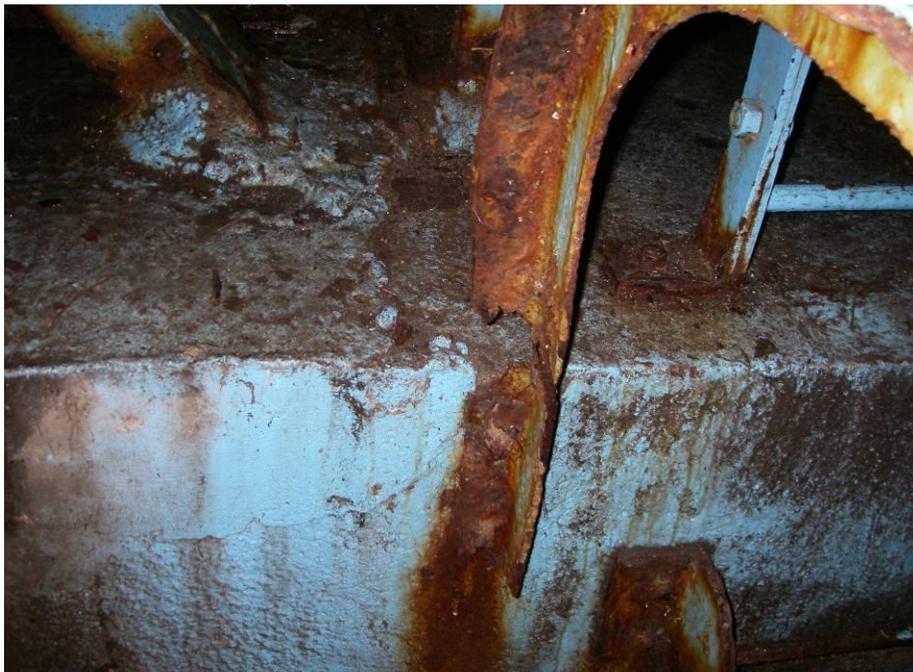
Photograph S75 - West bascule pier, south, counterweight pit entrance rail. The handrail is disconnected from the floor connection.

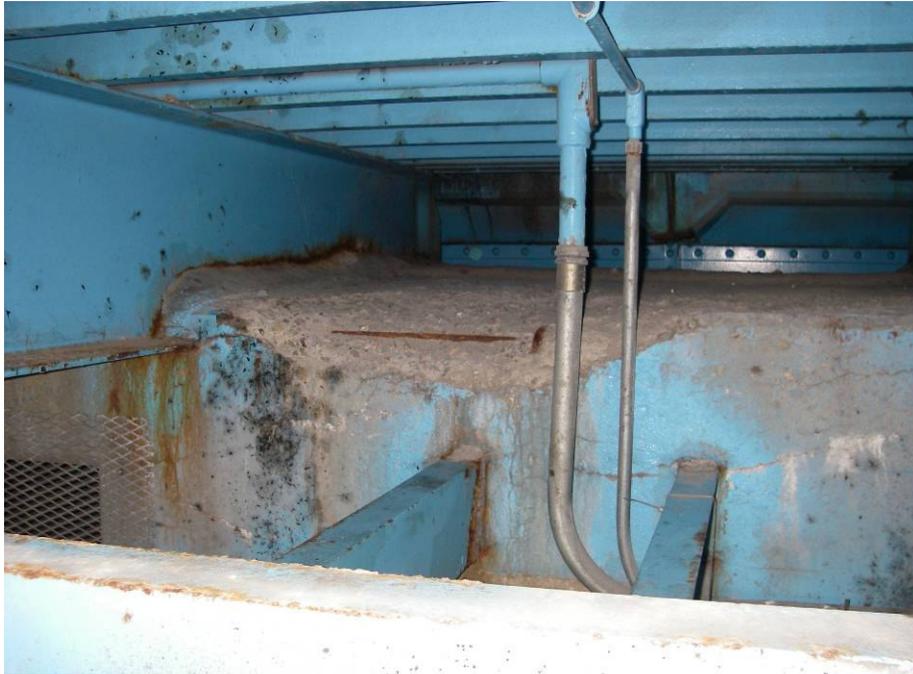
Photograph S76 - West bascule pier counterweight. View of the large spall in the upper northeast edge.

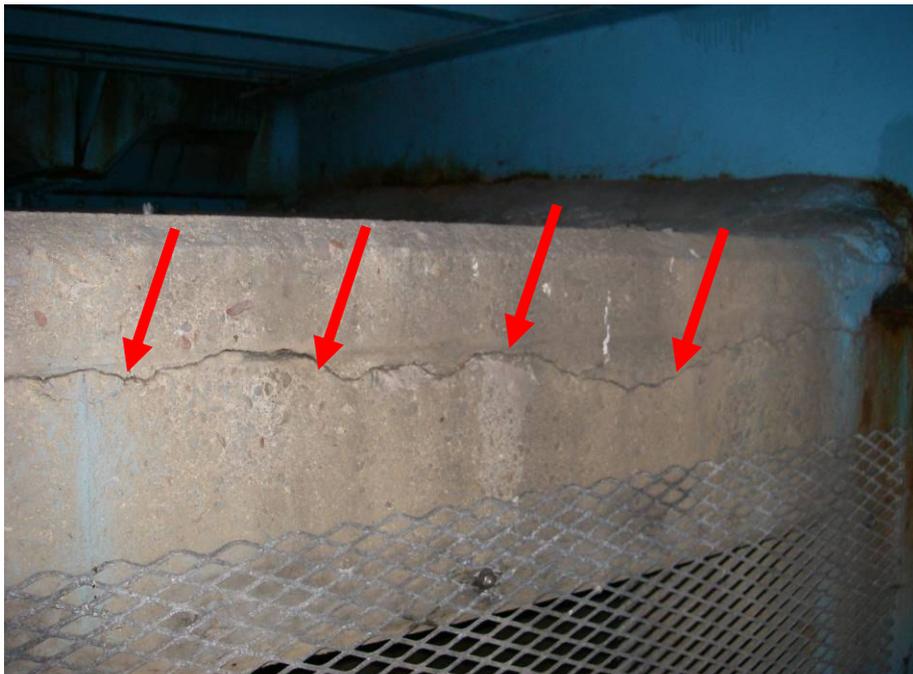
Photograph S77 - West bascule pier counterweight. View of the crack above the counterweight access hole, northeast edge (arrows).

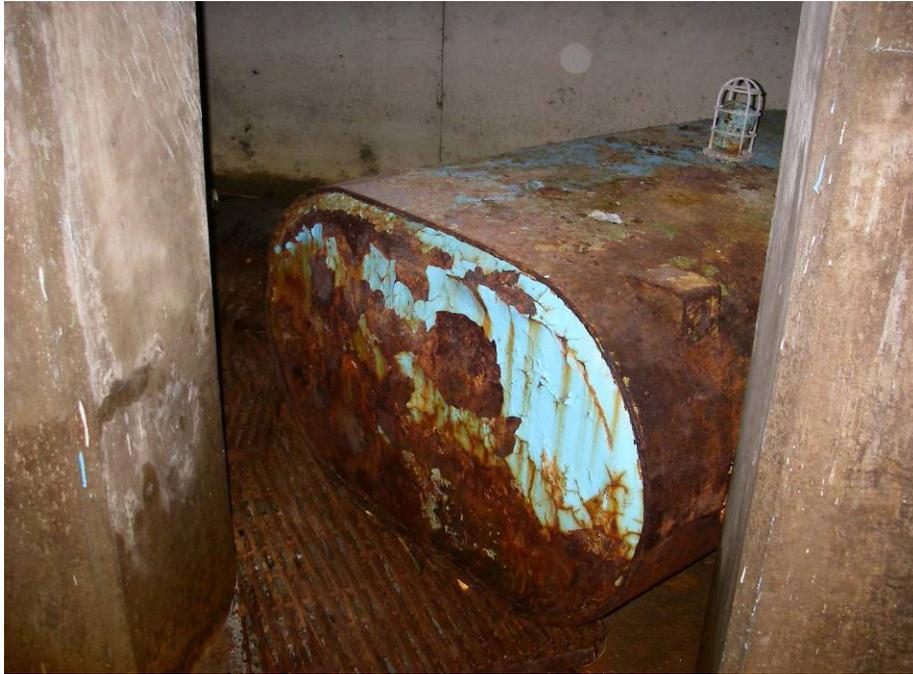
Photograph S78 - View of an abandoned tank and grating in the room below the operator's house.
