2007 Bridge Inspection Report

MARYLAND DEPARTMENT OF TRANSPORTATION
STATE HIGHWAY ADMINISTRATION
BRIDGE INSPECTION AND REMEDIAL ENGINEERING DIVISION
STRUCTURAL / MECHANICAL / ELECTRICAL
2007 BRIDGE INSPECTION REPORT

BRIDGE NO. 2300700
MD ROUTE 50 OVER SINEPUXENT BAY
WORCESTER COUNTY, MARYLAND

MODJESKI AND MASTERS, INC
CONSULTING ENGINEERS
HARRISBURG, PENNSYLVANIA

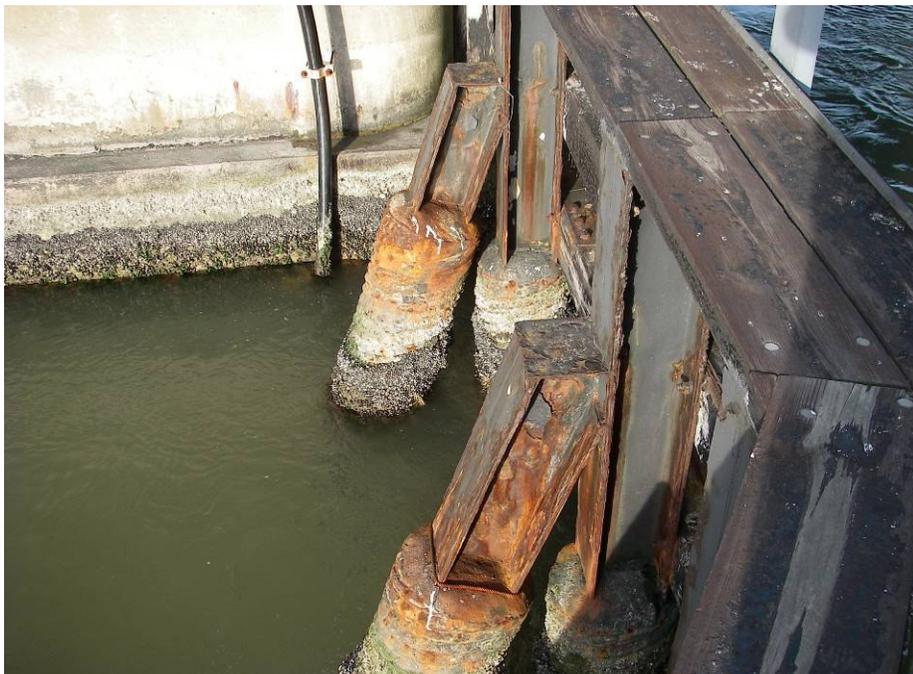
Photograph S79 - West fender near the south end of the west bascule pier. View off the moderately corroded pile condition.

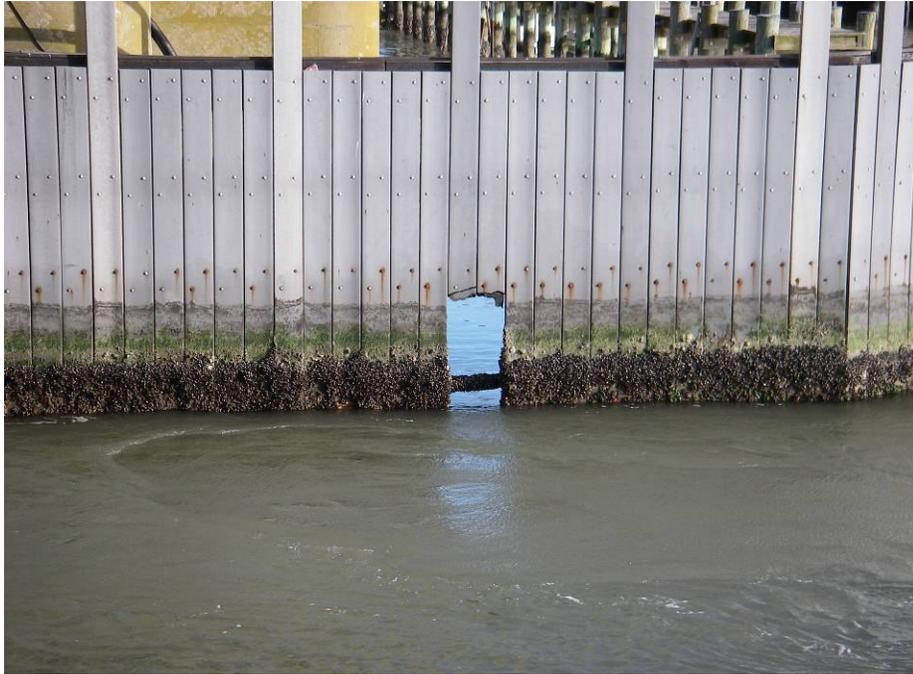
Photograph S80- East fender near the south end of the east bascule pier. View of the two broken sheeting boards.

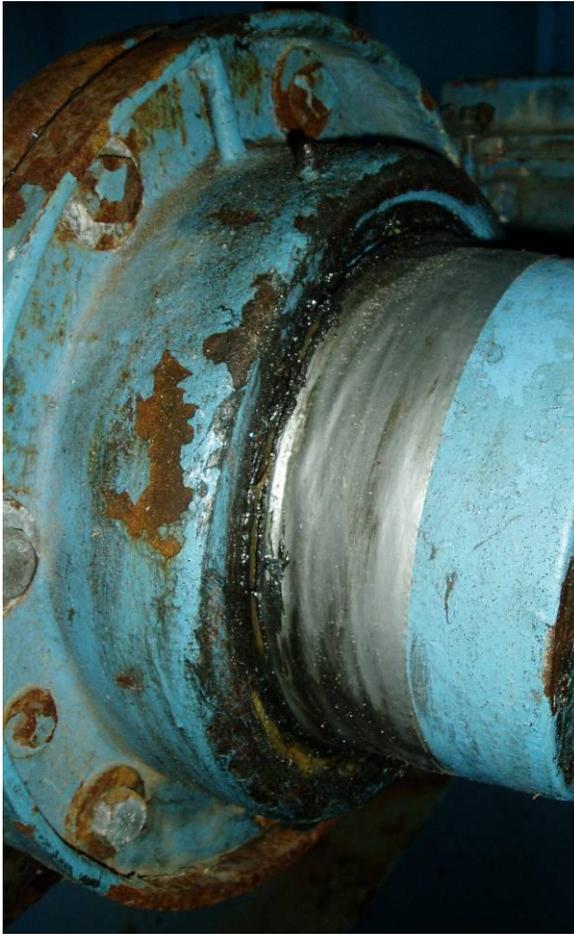
Photograph M13 – Northeast coupling C4, tape used in areas of hub to cover seals.

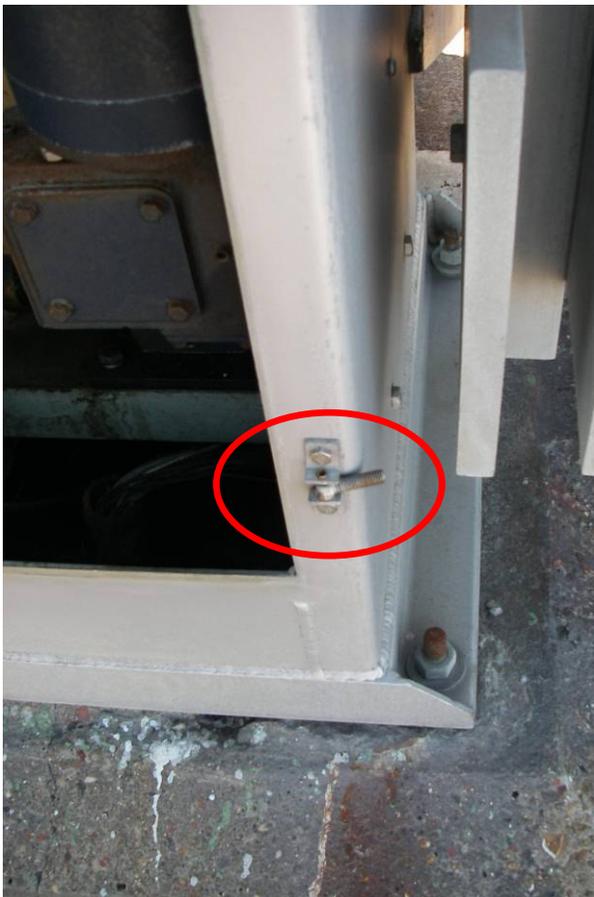
Photograph M26 – Missing access door latch wing nut at the southwest warning gate.

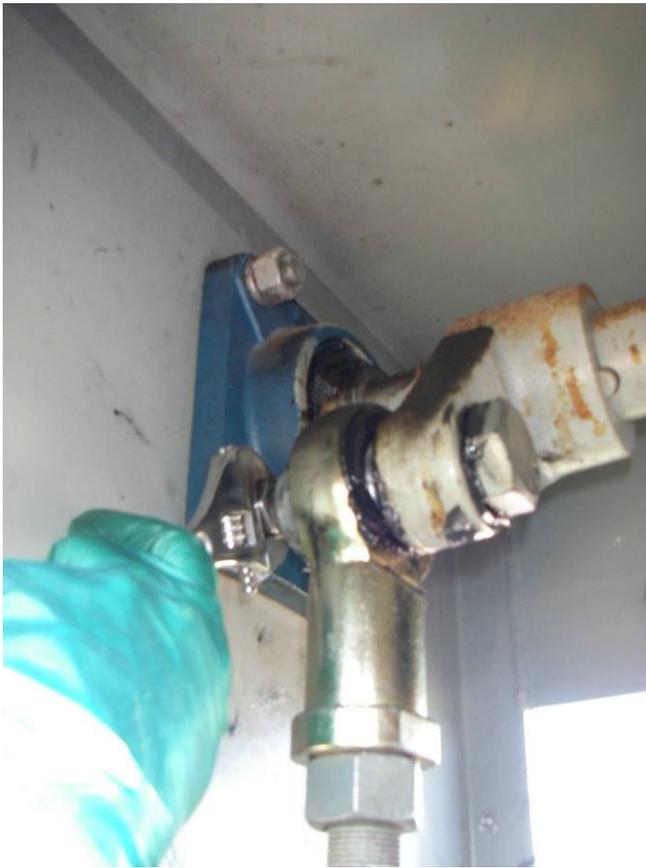
Photograph M27 – A majority of the warning gate cross shaft flange bearing mounting bolts were not tight.

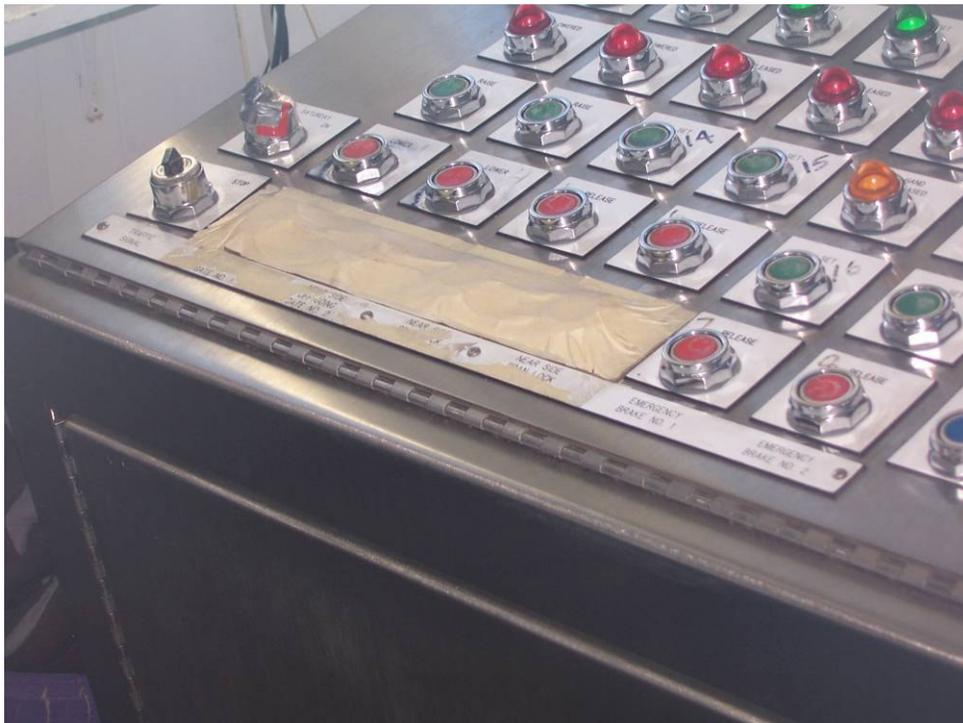
Photograph E4 - Control Console with masking Tape covering unused functions.

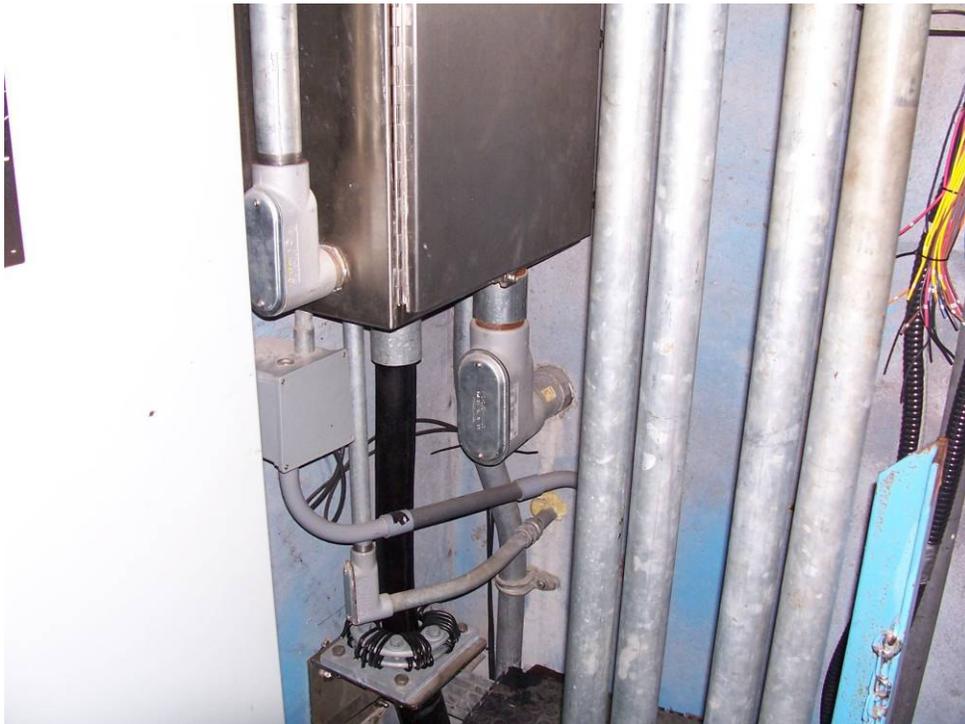
Photograph E14 - New Submarine & Abandoned MC cables located under far side span.

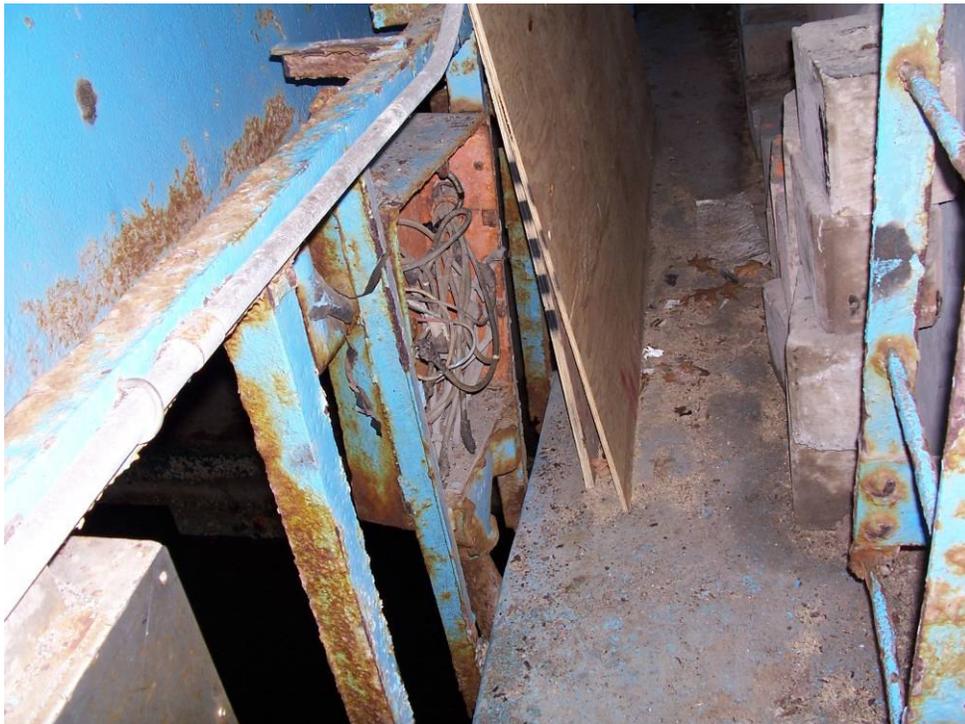
Photograph E22 - Abandoned Wires and Box under far side span.

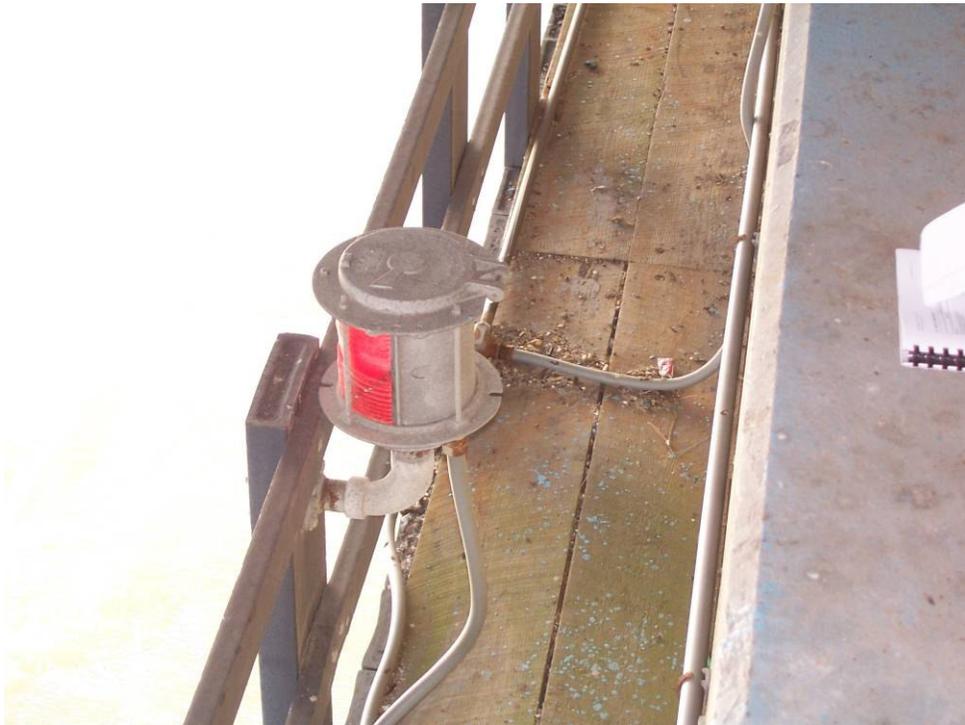
Photograph E23 - Navigation Light Raceway crossing walkway.

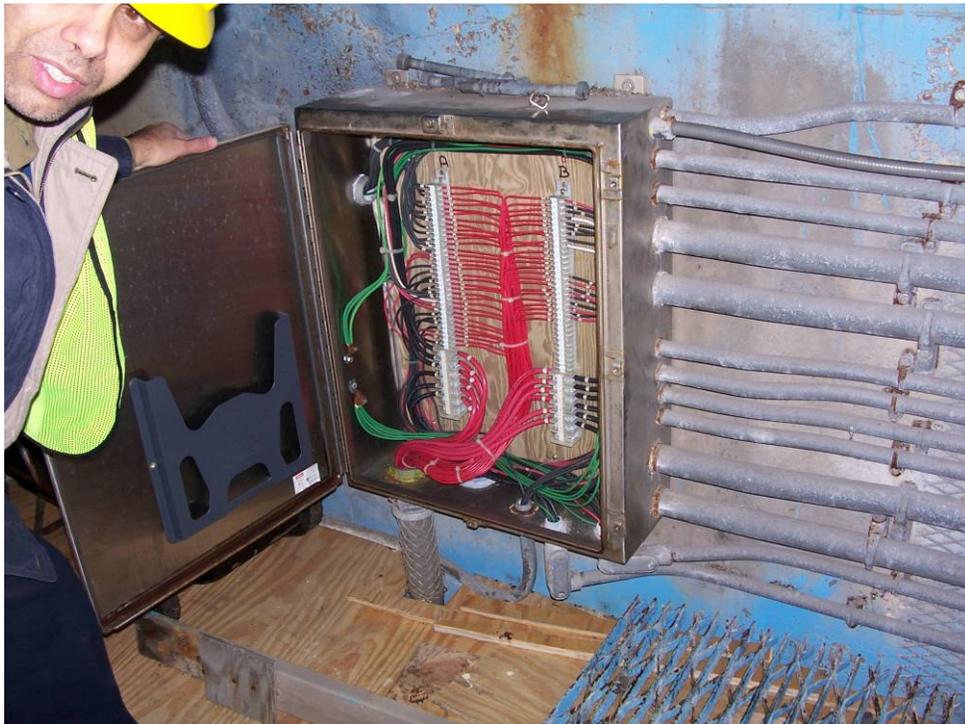
Photograph E24 - Moveable droop cable terminal box with wooden board.
